RAILROAD ACCIDENT INVESTIGATION

REPORT NO. 4160

SOUTHERN RAILWAY COMPANY

OCTOBER 26, 1969

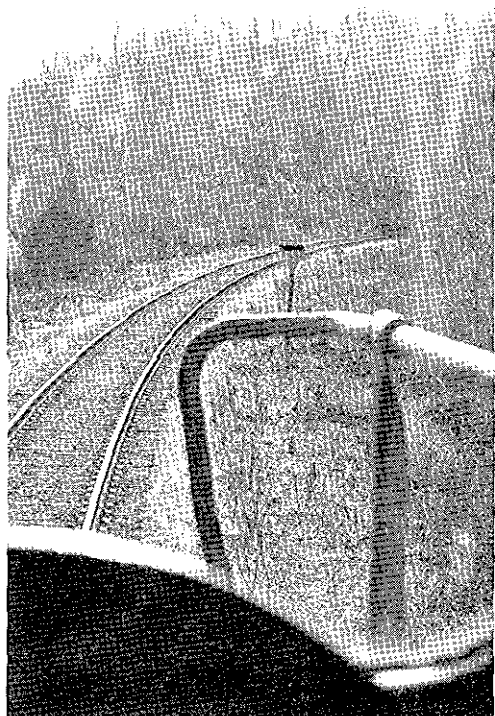
PLATE NO. 2

View eastward 460 feet to collision point (caboose).

Because of track curvature and trees along both sides of the railroad, the maximum range of vision between a caboose standing at the collision point and an approaching eastbound locomotive is 460 feet (see Plate No. 2).

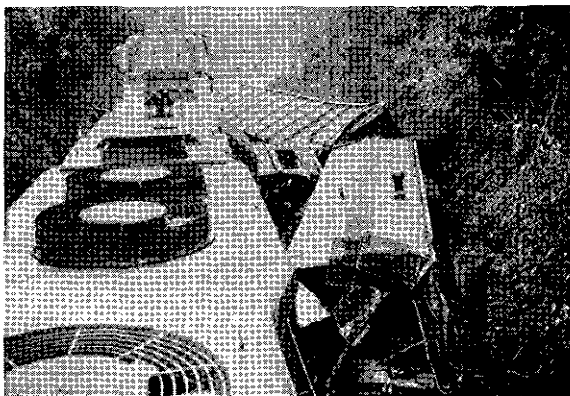
PLATE NO. 3Photo No. 1

The caboose and last two cars of this train were derailed. The caboose overrode the underframe at the front of the first locomotive unit of Third 120 and dropped to the ground along the south side of the track, stopping upright between locomotive units of Third 120 and a wall of a cut (see Photo

Caboose and last car of Second 120  
alongside locomotive of Third 120.

No 1, Plate 3) It was destroyed The last car overturned and stopped immediately in front of the caboose It was heavily damaged The next-to-last car stopped on and in line with the track structure ahead of the last car It was slightly damaged

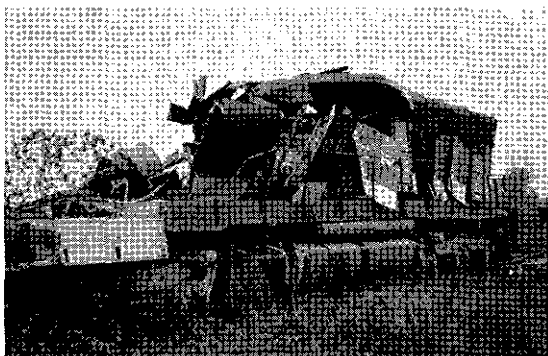
Photo No. 2

First locomotive unit of Third 120.

This train stopped with its front end 86 feet east of the collision point Only the first locomotive unit derailed It stopped on and in line with the track structure The control compartment at the front of that unit was destroyed as a result of being struck by the caboose of Second 120 after the initial impact (see Photo No 2, Plate 3) The first locomotive unit was destroyed The second unit was damaged considerably

14. The tragic consequences resulting from the Leadvale Jct collision and similar slow-speed collisions investigated by the FRA appear to be preventable. Had the leading end of the first diesel-electric unit of Third 120 been provided with a crash bar device of sufficient size and strength to protect the control compartment by absorbing the impact of the overriding caboose and/or diverting the caboose to one side, there is a possibility the employees in the control compartment would have escaped the accident unharmed.
