RAILROAD ACCIDENT INVESTIGATION

Report No. 4133 - 4/4/67

SOUTHERN RAILWAY COMPANY

LOCKHART, S. C

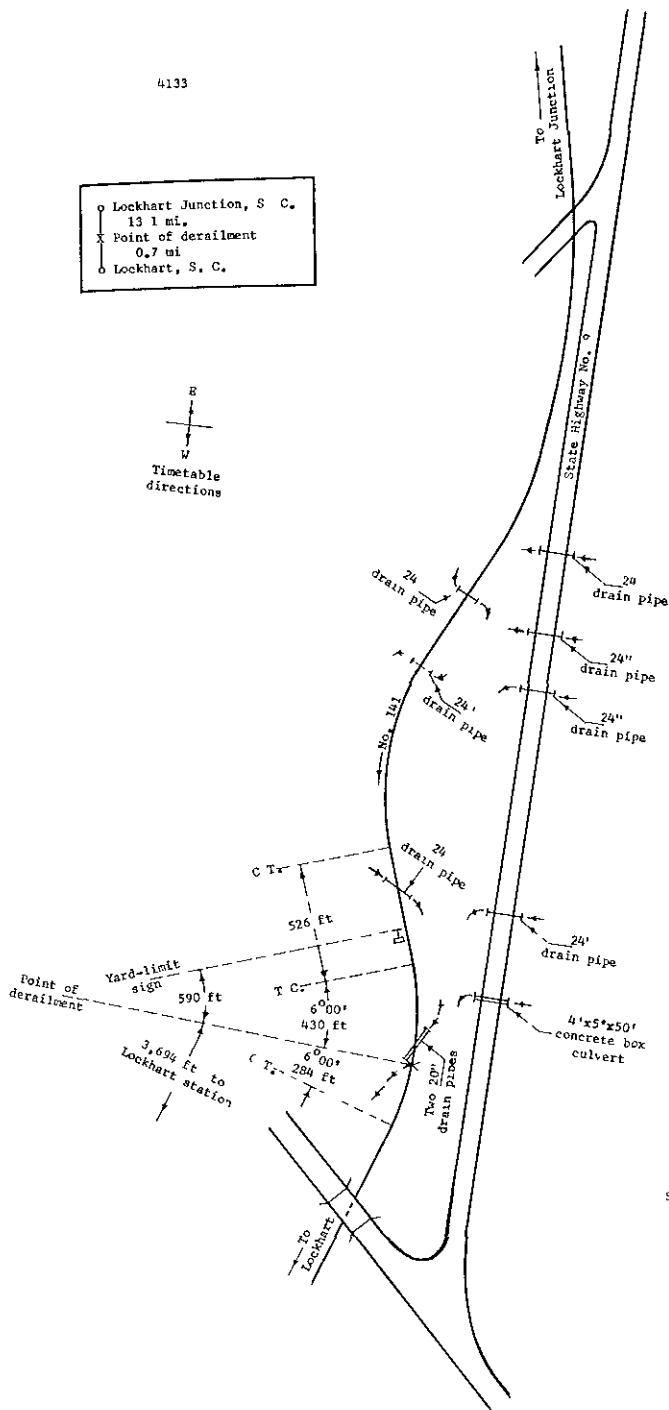
Southern Railway
 Lockhart, S. C.
 August 23, 1967

The derailment occurred on the main track, within yard limits, 3,694 feet east of the Lockhart station.

In the derailment area, State Highway No. 9 parallels the railroad on the south at distances varying between 100 and 450 feet. The highway is laid on a fill having an average elevation of 15.4 feet above the rails of the railroad. In this area, the main track is laid on a clay fill, which is approximately 7 feet high on the south side and 22 feet high on the north side. The grade in this area is 2.6 percent descending westward. Two vitrified clay drainage pipes, 20-inches in diameter and 150 feet in length, extend diagonally through the fill about 100 feet east of the derailment point. The flow lines through the pipes are 20 to 24 feet below the rails. Another drainage pipe, 24 inches in diameter, extends through the fill about 1,176 feet east of the derailment point. Water from an area of about 130 acres between the fills of the railroad and State Highway No. 9 drains northward through the railroad fill via the aforesaid three drainage pipes. Two additional drainage pipes, each 24 inches in diameter, extend through the railroad fill 790 and 2,141 feet east of the derailment point. Water from the north side of the railroad fill flows southward through these pipes into the 130-acre area. A 4'x5'x50' concrete box culvert and four clay drainage pipes, each 24 inches in diameter, extend through the highway fill at points, respectively, 321, 641, 1,803, 2,144 and 2,456 feet east of the derailment point. Water from the south side of the highway fill flows northward through the culvert and four drainage pipes into the 130-acre area between the highway and railroad fills.

Examination of the track structure after the accident disclosed that in the derailment area, the fill was washed out and collapsed throughout its width to a depth of approximately 12 feet below the bottom of the ties. The depression caused by the washout and collapse was about 32 feet long.

It is evident that because of the heavy rainfall in the 30-hour period preceding the accident, the flow of water from the 130-acre area between the railroad and State Highway fills exceeded the capacity of the existing drainage pipes extending through the railroad fill. As a result, the water impounded in the 130-acre area saturated and weakened the railroad fill, causing a portion of this fill to wash away sometime before the train approached. The train was moving on the fill at slow speed and stopped just short of the washout area. However, because of the adjacent washout and the saturated condition of the fill, that portion of the fill under the front portion of the train locomotive was weakened to the extent that it collapsed under the weight of the locomotive, causing the accident.

Subsequent to the accident, the carrier placed an additional concrete drainage pipe, 36 inches in diameter, through the railroad fill at a point about 5 feet above the location of the existing two 20-inch drainage pipes. This pipe was installed to insure proper drainage of the 130-acre area between the highway and railroad fills.
