NATIONAL TRANSPORTATION SAFETY BOARD

RAILROAD ACCIDENT REPORT

**SIDE COLLISION OF
SOUTHERN RAILWAY COMPANY
TRAINS NOS. 1 AND 152
SPENCER, NORTH CAROLINA
OCTOBER 8, 1977**

REPORT NUMBER: NTSB-RAR-78-3

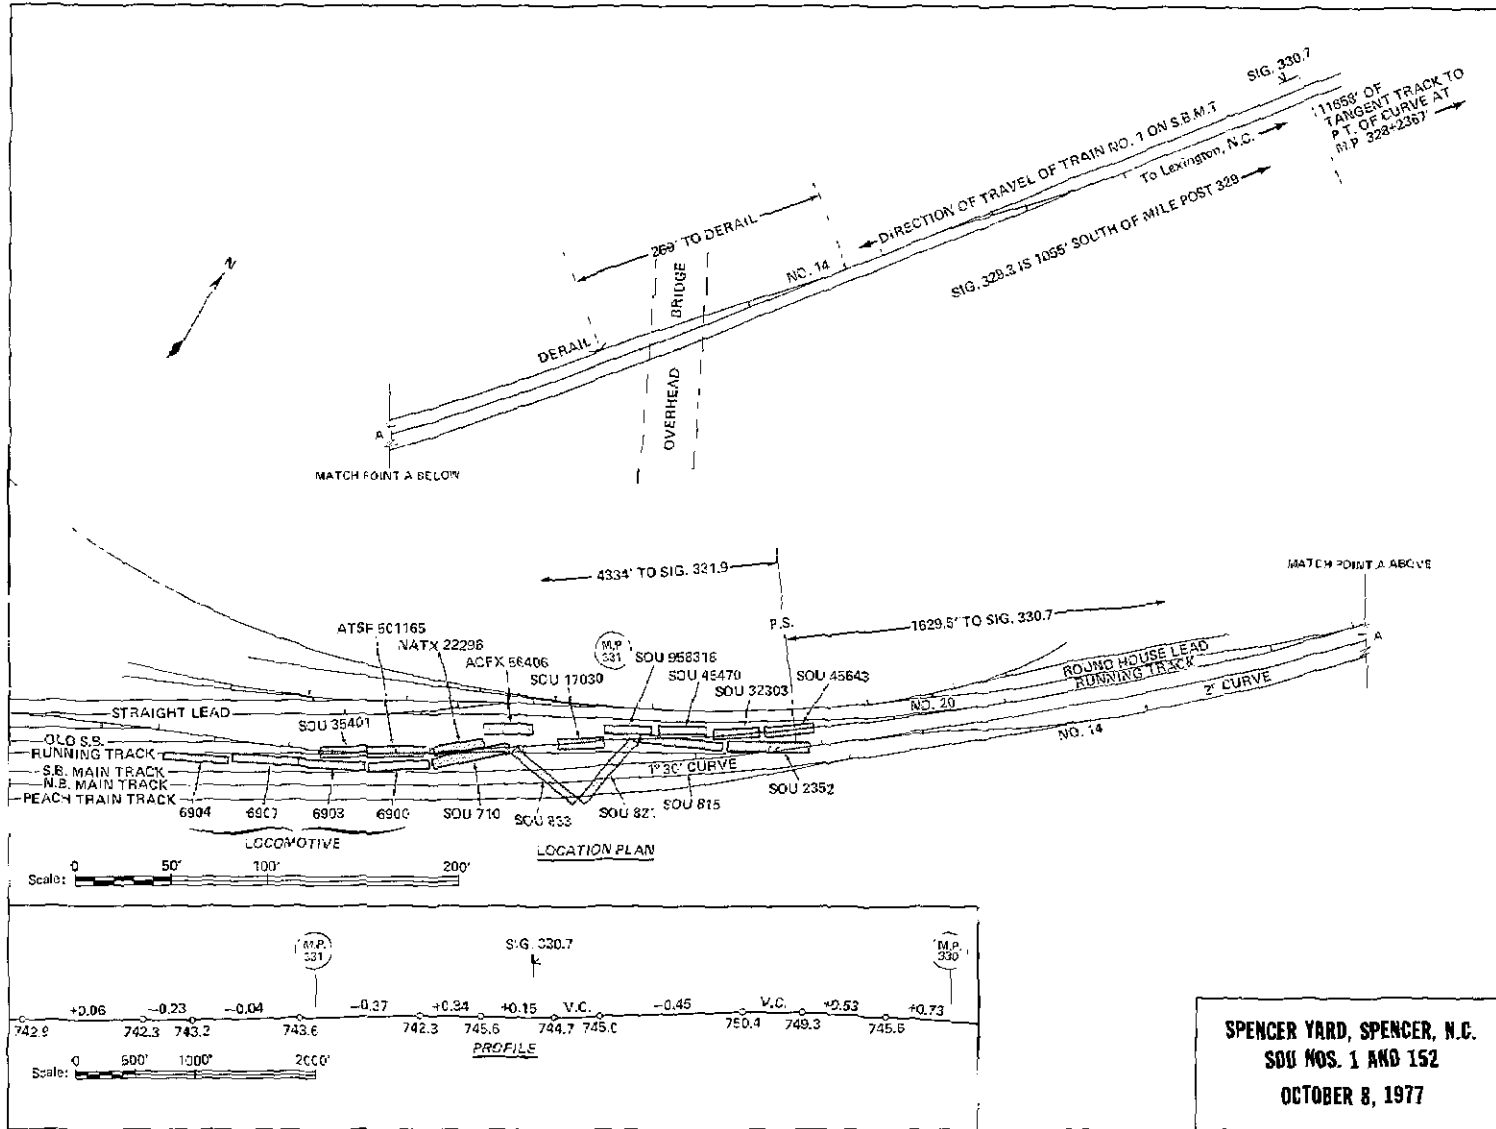
Figure 1. Accident site.

Shortly after The Crescent passed signal 330.7, it entered the north switch of the crossover and was routed from the main track to the running track in the Spencer Yard where it collided with the freight cars of train No. 152.

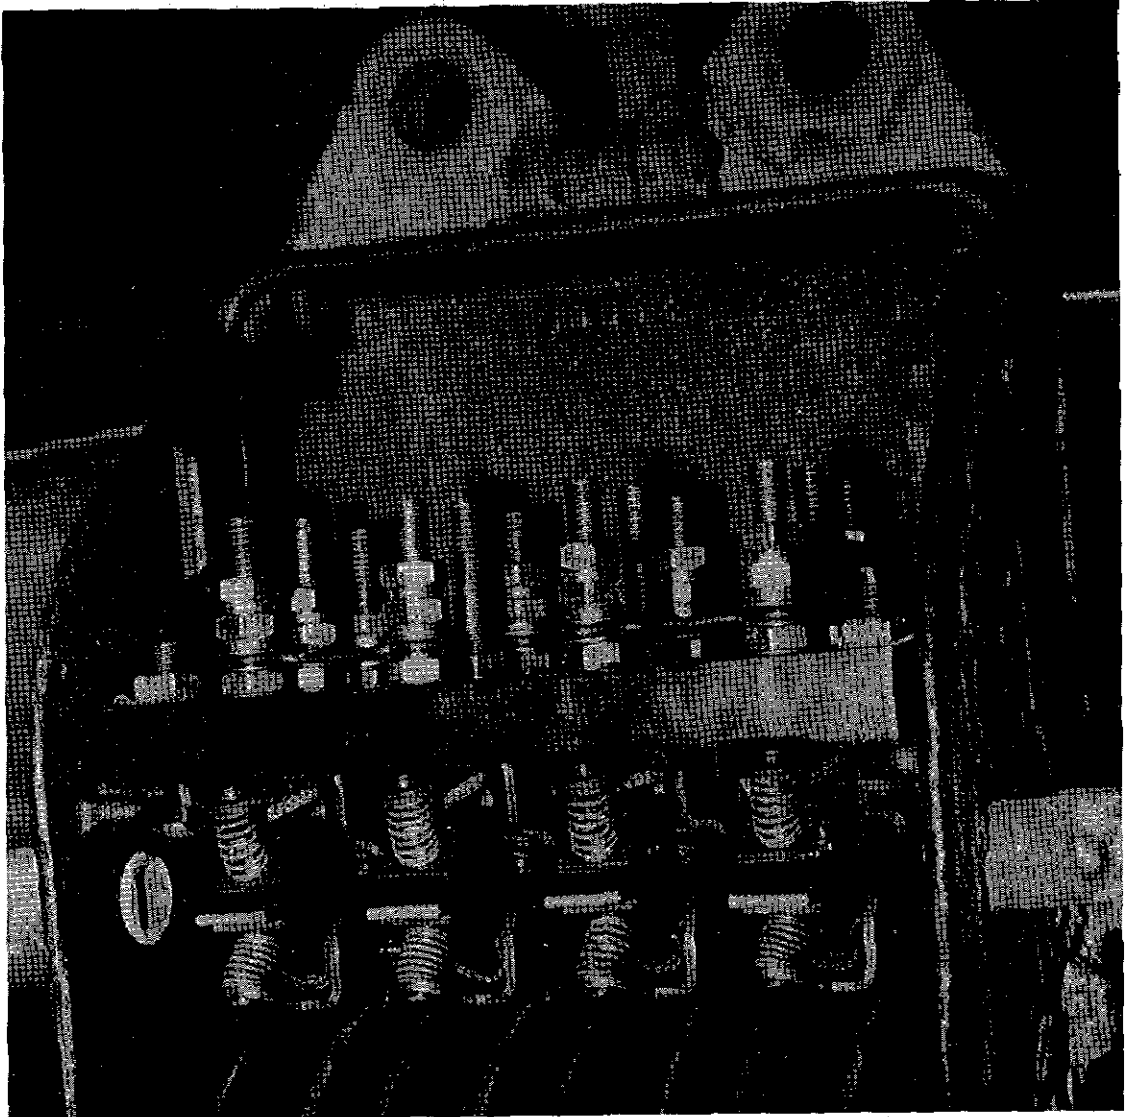
Figure 2. Circuit controller showing contacts and contact jumpers on terminal board.

A red signal aspect on signal 330.7 can be caused, among other reasons, by a shunt circuit ^{2/} between the two running rails. A shunt circuit can be imposed by the presence of a train or by a switch that either is not fully closed in a normal position, or is in a full reverse position. The shunt removes the track voltage from the track relay; this causes the signal to display a red aspect. Federal regulations (49 CFR 236.6) require that when a facing-point, hand-operated switch equipped with a circuit controller connected to the switch points is operated 1/4 inch or more from its normal position, track or control circuits will be opened or shunted or both. The shunt at Spencer Yard was imposed by the closing of electrical contacts within a circuit controller. (See Appendix C and figure 2.)

On October 12, 1977, the circuit controller unit was removed from service for further testing and inspection. When the circuit controller was operated a number of times, it was found that contacts Nos. 1, 2, and 3 failed to close completely. The phenolic terminal board, which contains part of the contact assemblies, was loose. The controller box was disassembled for a detailed inspection and a flat spot, not considered significant, was found on the No. 1 operating cam. Excessive play also was observed in the No. 4 contact roller.

"Require that the track shunt circuit imposed by contact closure in a circuit controller be phased out as soon as practicable and a series break-type circuit, which will satisfy the requirements of the FRA's Rules, Standards, and Instructions, be used in place thereof. (Class II, Priority Action) (R-78-23)"

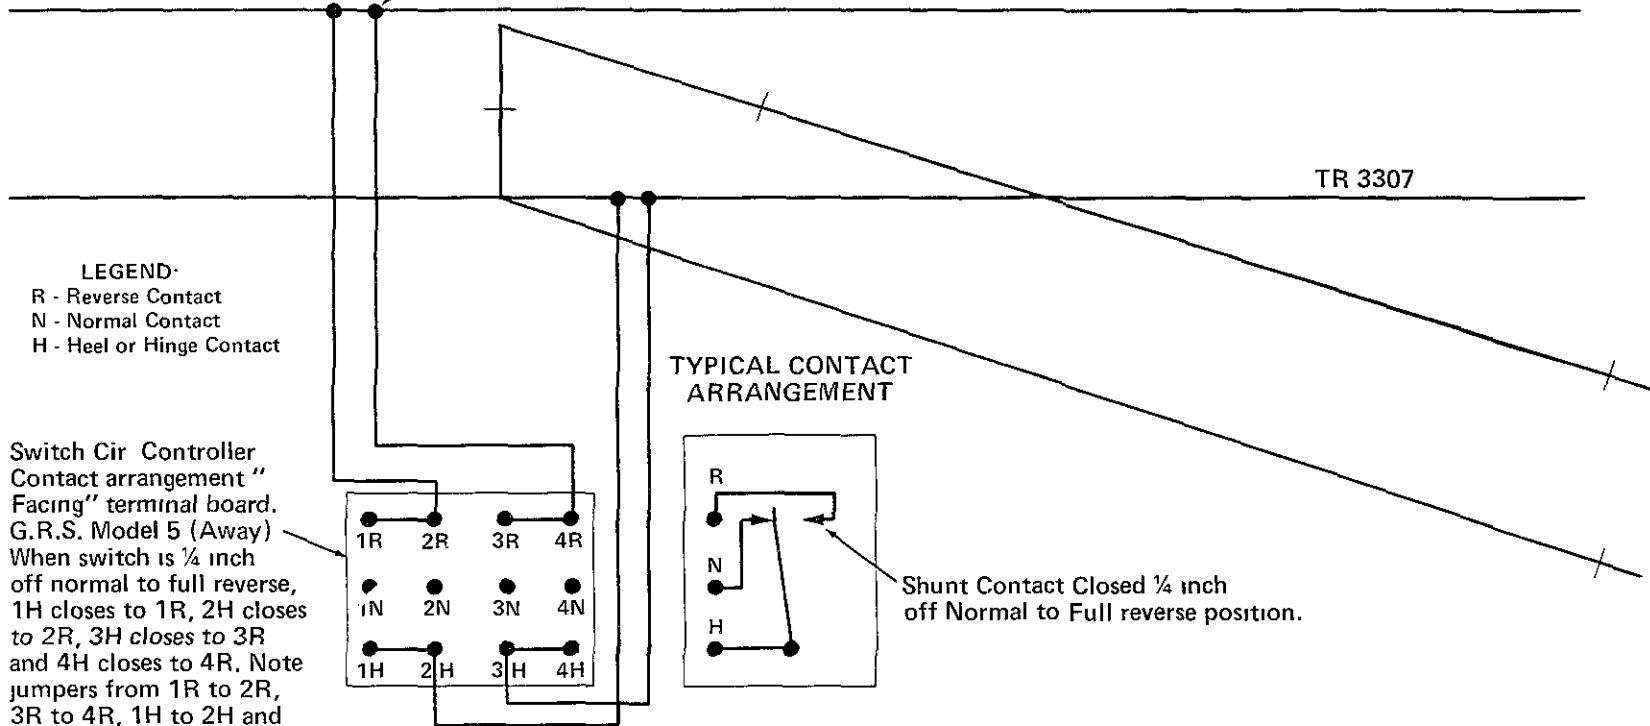
Rail Connector replaced after track forces accidently broke connection on Saturday, Oct. 8, 1977

Switch Cir Controller Contact arrangement "Facing" terminal board, G.R.S. Model 5 (Away) When switch is 1/4 inch off normal to full reverse, 1H closes to 1R, 2H closes to 2R, 3H closes to 3R and 4H closes to 4R. Note jumpers from 1R to 2R, 3R to 4R, 1H to 2H and 3H to 4H.

NOTE: The wire arrangement shown above is "EXACT" as existed at time of investigation, Oct. 12, 1977, Southern Railway, North end of "Old Spencer Depot" Crossover, 1629 feet south of ABS Signal 330.7 Switch Circuit Controller Contacts 1, 2 and 3 failed to shunt TR 3307 with switch in 1/4 inch off normal to full reverse switch position. Eastern Division - Eastern Lines.
