RAILROAD ACCIDENT INVESTIGATION

REPORT NO. 4174

SOUTHERN RAILWAY SYSTEM

OCTOBER 24, 1970

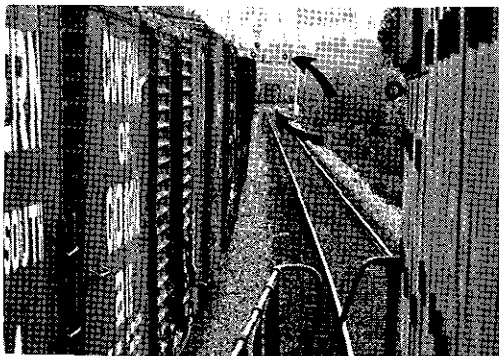
Because of track curvature, signal 1406 cannot be seen from an approaching northbound locomotive on track No 1 at a distance greater than 1228 feet when a southbound train on track No 2 is passing the location of that signal (see following photograph)

Signal 1406 (top arrow) from distance of 1228 feet. Caboose shown (bottom arrow) is standing on track at rear-end collision point, 545 feet north of signal 1406.

1228 feet from signal 1406 (see photograph on Page 4) He does not recall having noticed the aspect displayed by that signal. He stated, however, that he immediately applied the brakes of his train in emergency when he saw No 150 standing a short distance beyond signal 1406, and that he called a warning to the front brakeman at the same time. Due to track curvature to the left causing the long engine hood to obstruct his view from the right side of the locomotive control compartment, the front brakeman was unable to see either signal 1406 or the train stopped ahead when he heard the engineer's warning. He immediately crossed over to the engineer's side of the control compartment and simultaneously saw that signal 1406 was displaying a Restricted-Proceed aspect and that the caboose of No 150 was stopped on track No 1 a short distance beyond the signal.

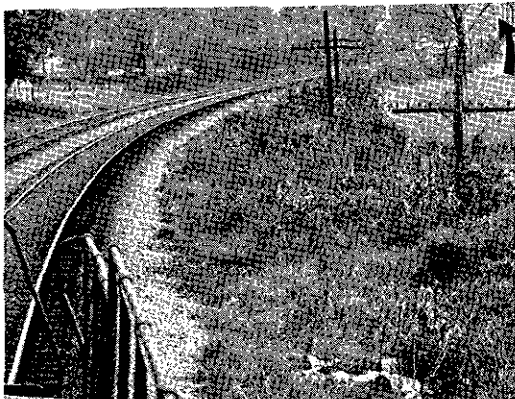
This train was moving on a 2°00' curve to the right when signal 11R came into the front brakeman's view from the right side of the locomotive control compartment at a distance of 2243 feet (see following photograph).

Signal 11R (arrow) from distance of 2243 feet.

The front brakeman said that signal 11R was displaying a Clear aspect when he saw it come into view, and that he promptly called "Clear Block" to the engineer. The signal first became visible to the engineer at a distance of 1709 feet, when the front of the train was about to move off the north end of the 2°00' curve and enter tangent track (see following photograph)

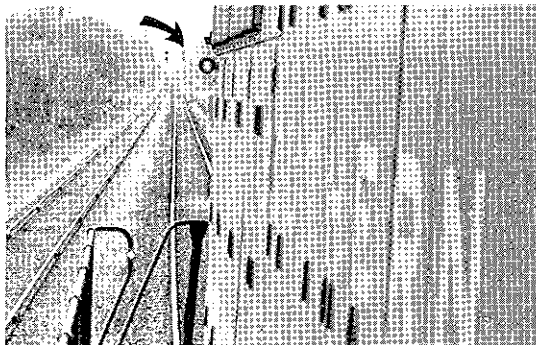
Signal 11R (arrow) from distance of 1709 feet.

The engineer said signal 11R was displaying a Clear aspect when it came within his range of vision, and he then acknowledged the front brakeman's call by responding "Clear Block". Both the engineer and front brakeman said the signal continued to display a Clear aspect as their locomotive approached and passed it.

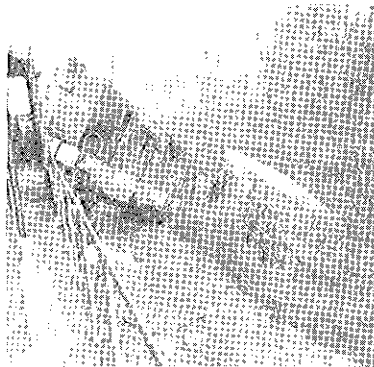
caboose, were derailed. The derailed cars jackknifed from the train and stopped on the east side of track No. 1. The caboose overturned on one side, and stopped on an embankment on the east side of track No. 1 (see following photograph). The caboose and two of the derailed cars were destroyed or heavily damaged.

Caboose of No. 190 at right. First and second locomotive units of Extra 3016 North also shown.

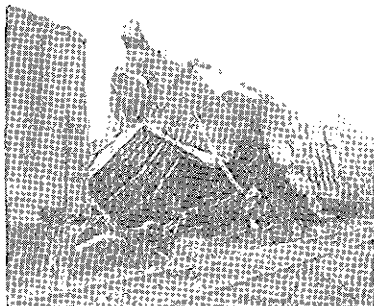
This train stopped with the front end 106 feet north of the rear-end collision point. The first and second locomotive units, and the fourth to seventh cars, inclusive, were derailed. Both derailed locomotive units stopped upright as shown in the foregoing photograph. The fourth and seventh cars stopped upright on and in line with the structure of track No. 1. The fifth car buckled from the train, and stopped overturned on the east side of track No. 1. The sixth car buckled, struck the east side of No. 229, and stopped on track No. 1 as shown in the following photograph. It was destroyed. The other three derailed cars and the first two locomotive units were heavily damaged.

Sixth car of Extra 3016 North at center. Fourth and seventh cars of train also shown.

Several trailers on flat cars were struck by the buckled sixth car of Extra 3016 North, and the trucks at the rear of the 42nd and 45th cars were derailed. Both of those cars stopped upright on and in line with the structure of track No. 2. They were flat cars and were destroyed, and six other trailers were slightly damaged.
