NATIONAL TRANSPORTATION SAFETY BOARD

RAILROAD/HIGHWAY ACCIDENT REPORT

COLLISION OF A SOUTHERN RAILWAY WORK TRAIN
WITH A POLK DISTRICT SCHOOLBUS AT

ARAGON, GEORGIA

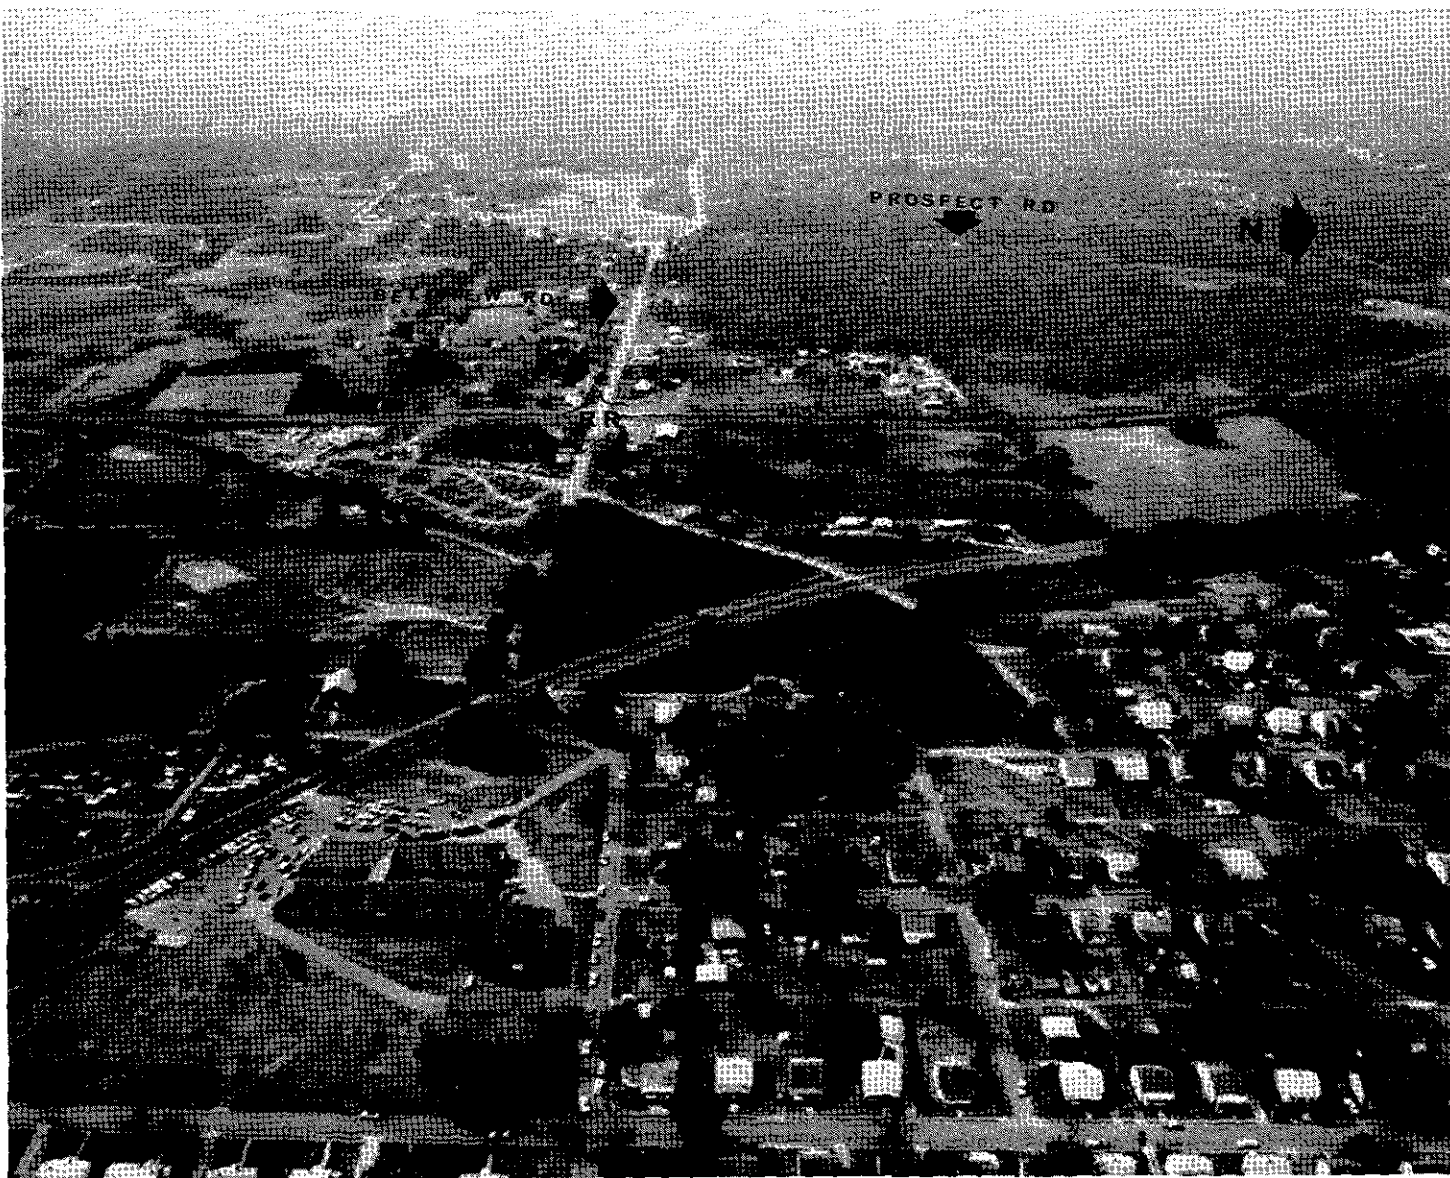
Figure 1. Aerial view of the area surrounding the accident site.

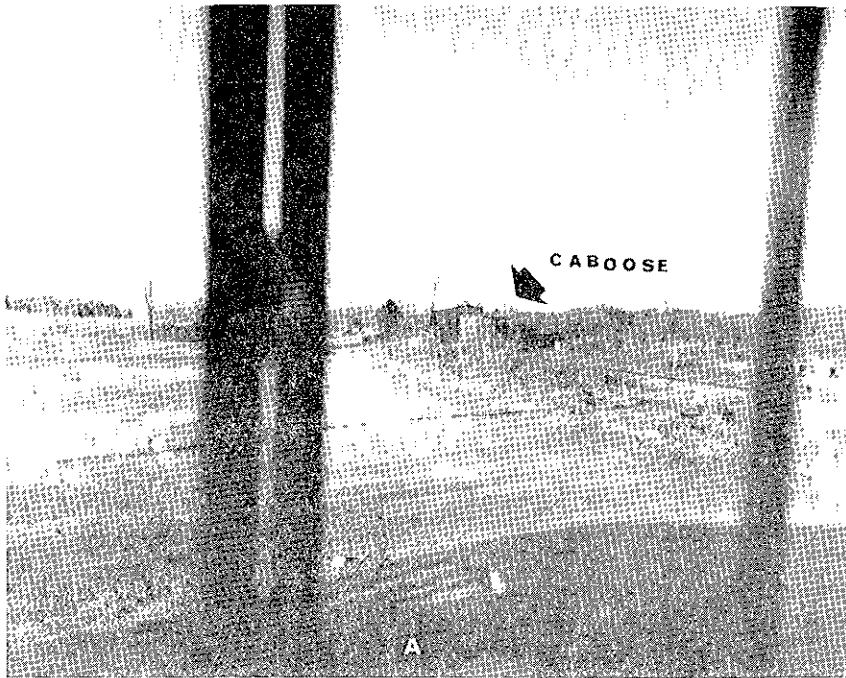
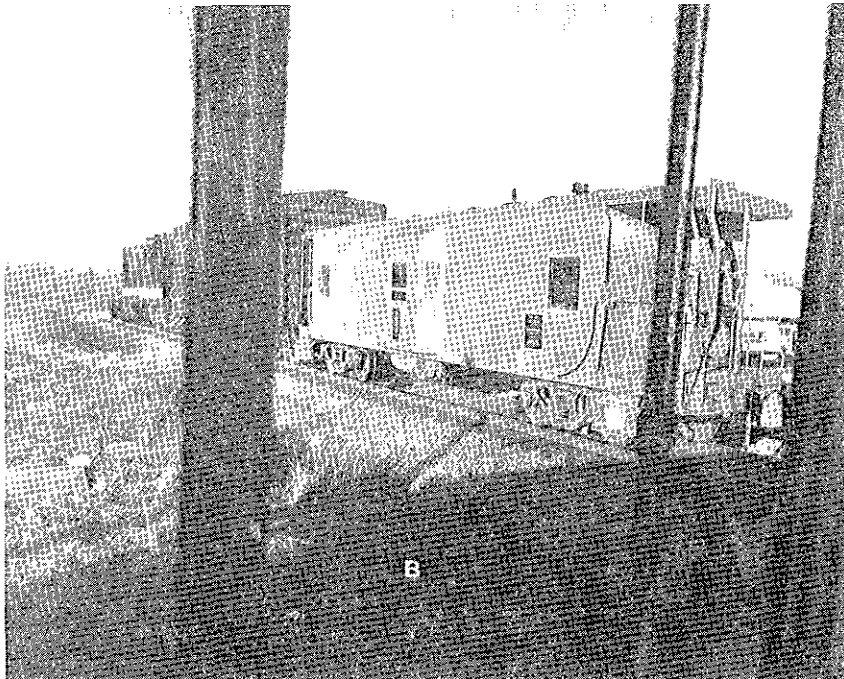
About 750 feet from the crossing the busdriver applied the brakes, shifted into fourth gear, and slowed the bus to an estimated speed of 15 to 20 mph. When the bus was about 100 feet from the track, he sighted the "top part" of the caboose on his left, north of Bellview Road. He was under the impression at that time that the train was stopped. (See Figure 2.)

Figure 2. Views of the caboose from driver's eye level in a schoolbus:
(A) Front bumper of bus 50 feet west of west rail and south end of caboose 369 feet north of center of crossing; (B) front bumper of bus 20 feet west of west rail and caboose 25.6 feet north of center of crossing.

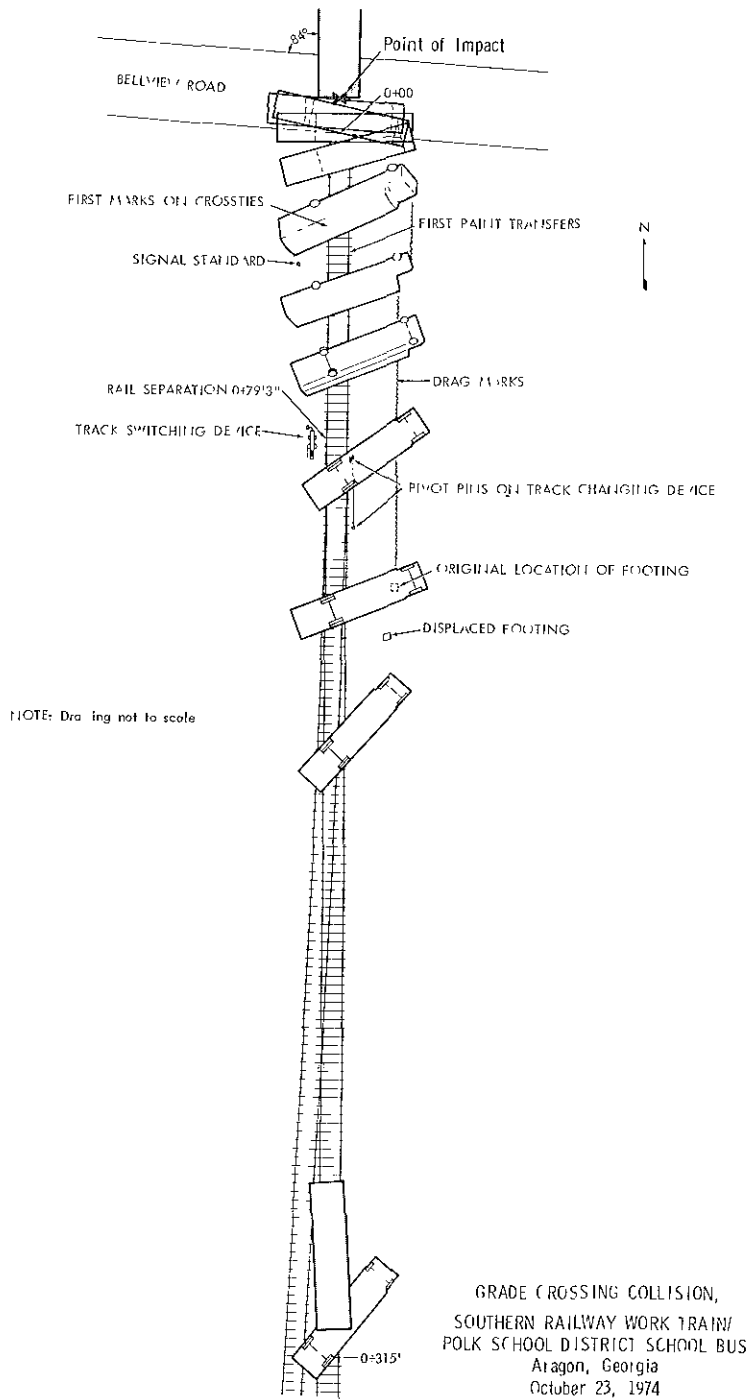
As the bus was shoved southward, the right rear tires dropped off the pavement and into a ditch which was located on the shoulder south of the pavement edge and west of the track. This, in combination with its sideward movement, caused the bus to begin a rotation around its longitudinal axis which continued as the right rear tires came in contact with crossties on the west side of the track.

As the bus rolled to its right, the lower body wall made contact with the steel rails of the track. Almost simultaneously the bus struck and knocked down a railroad signal post and its concrete base. (See Figure 3.) Under these forces, the bus rolled onto its right side and the coupler of the caboose made contact with the underside of the vehicle. As the train continued to shove the bus southward, the bus rolled under the coupler and upward leverage provided by the bus structure on the coupler lifted the south end of the caboose off the track. Because the truck was not pinned to the caboose frame (a normal condition), the caboose lifted off its south truck.

When the bus had rolled 180 degrees, the roof was in full contact with the rails of the track. Contact by the bus at that moment with a track switching device and other parts associated with the separation of the mainline and switch track, some 80 feet south of the pavement edge, was the source of additional damage to the roof of the bus. Evidence of contact between the bus, its occupants, and those devices was found throughout that section of track.

Figure 3. Crash sequence.

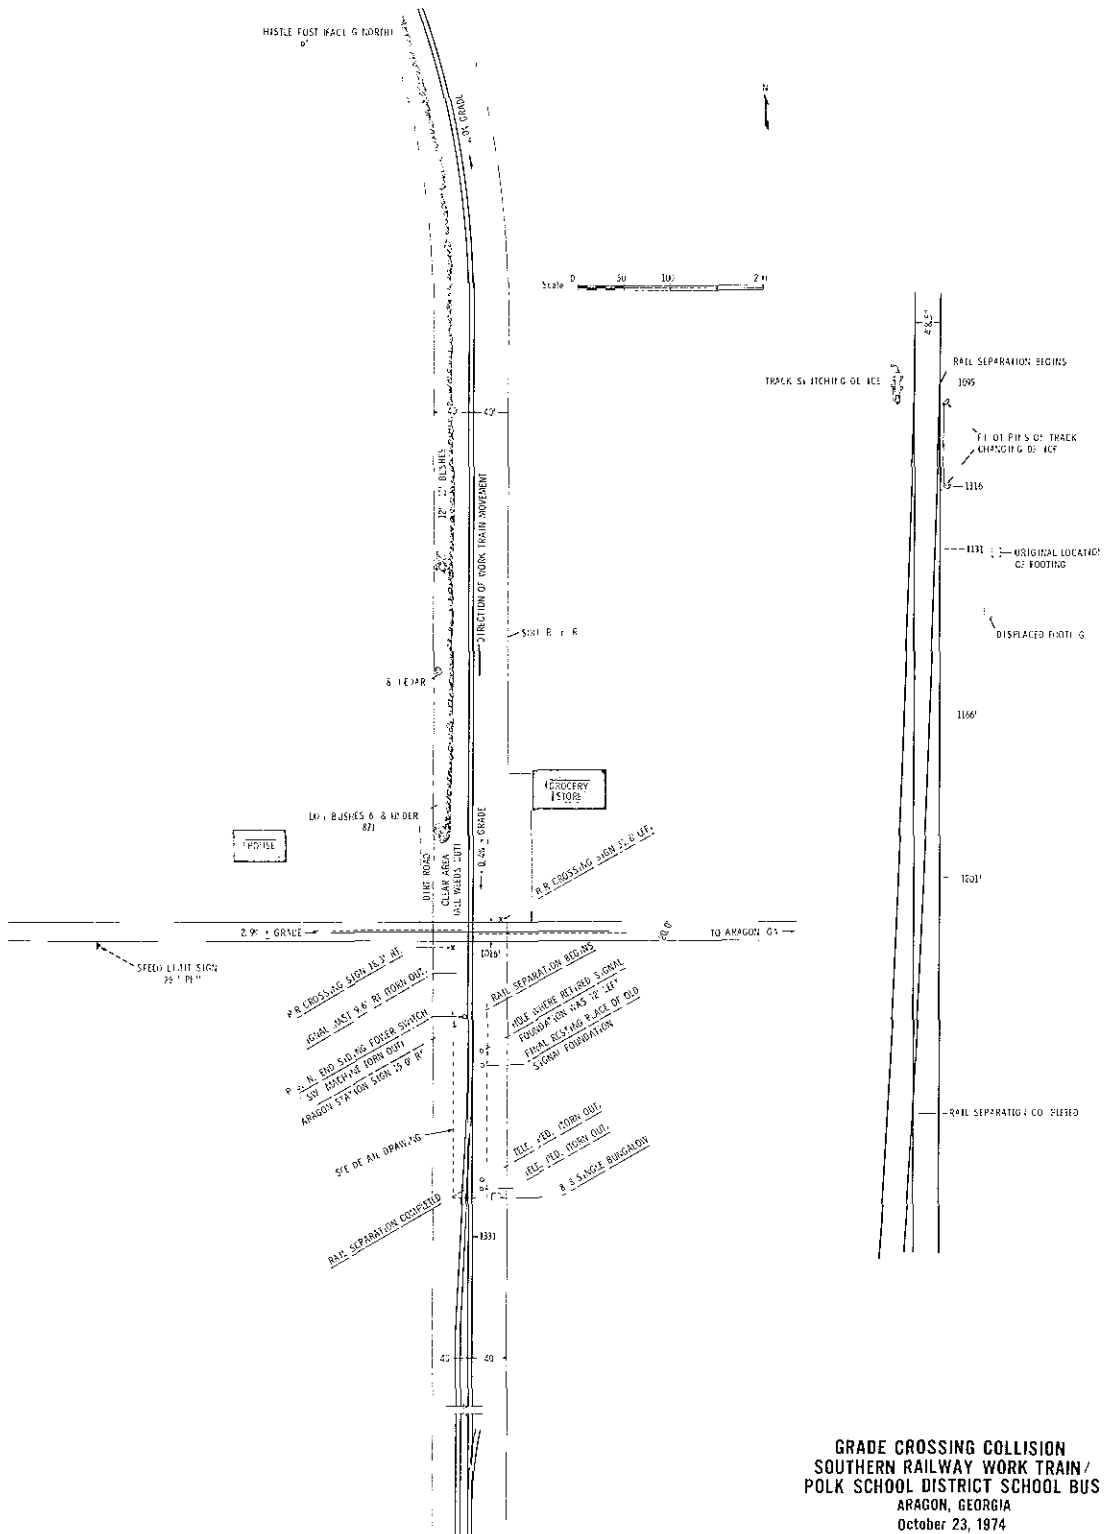
A speed limit sign of 25 mph is posted approximately 400 feet west of the crossing, and a standard railroad crossbuck warning sign is located on the shoulder of the road adjacent to and on both sides of the track. At the time of the accident, there were no other traffic control signs, signals, or warning devices on either approach. 5/ (See Figure 4.)

Figure 4. Accident site.

5/ Subsequent to the accident, the crossing was equipped with active protection: automatic gates, flashing lights, and bells.

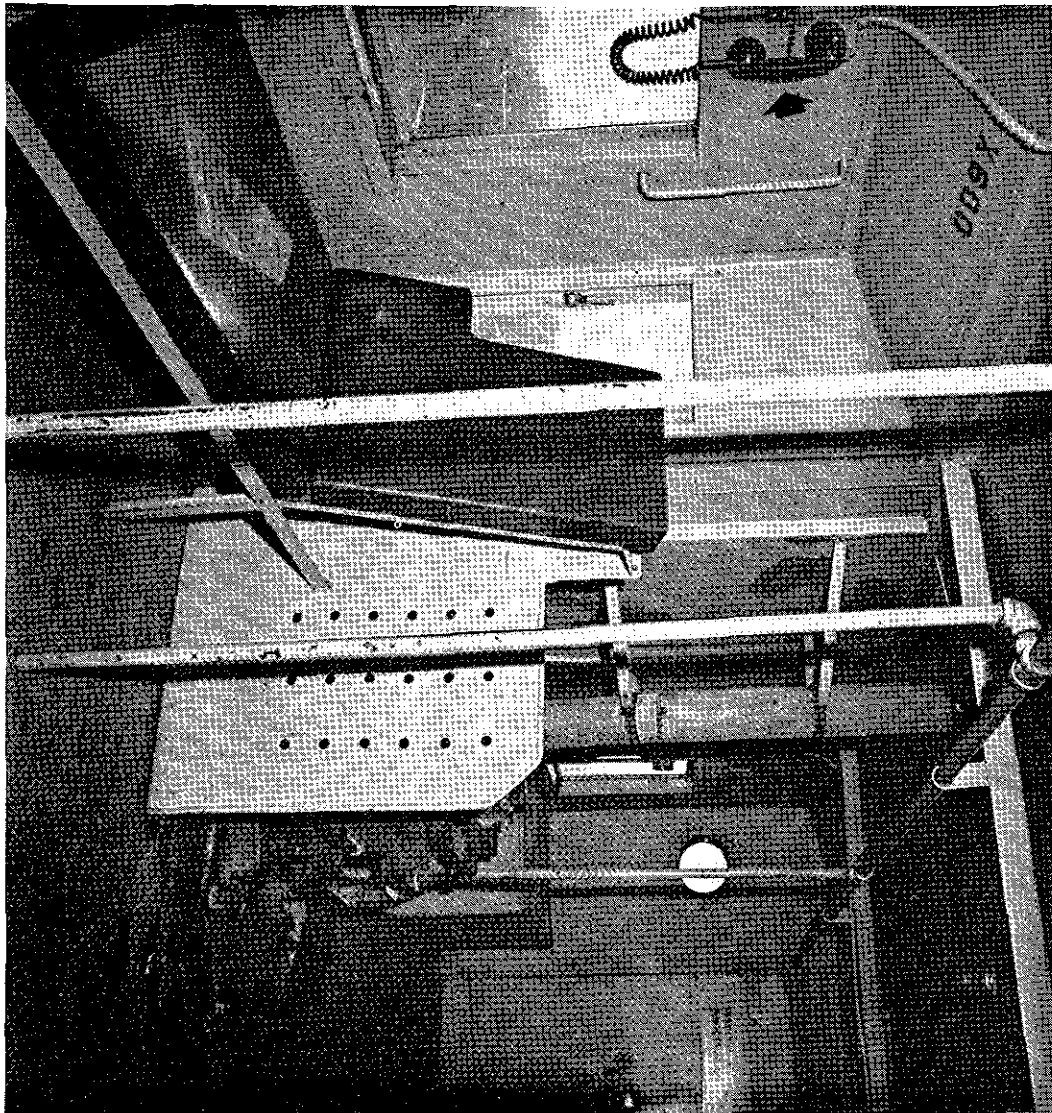
Figure 5. Interior of the caboose. Arrow indicates the handset of the radio-telephone which was affixed to the east wall (picture taken facing end of caboose which struck bus).

The position of the caboose radio set required that the flagman be in the center of the caboose to use the radio. Standing in this position, he could look eastward through the bay windows or southward through the opened end-door to observe the track. However, this provided a line-of-sight restricted to immediate conditions on the east side of the track and the line of travel directly in front of the backing caboose. It follows then that for the flagman to report actual traffic conditions at or near the crossing, he would have had to go out and make his visual observations from the platform of the caboose and then return about 19 feet to the radio to transmit those observations to the locomotive engineer. The Georgia State Patrol, in its report of this accident, stated that a person uses 4.5 seconds to run back to the radio from the door of the caboose and remove the handset from its mounting for use.

1. The Federal Railroad Administration (FRA) promulgate regulations governing railroad operating rules for the use of radio communications and flagging when trains are being pushed (shoved) across grade crossings. (Recommendation R-75-31)
2. The FRA promulgate regulations to require that if radios are to be utilized for directing rearward movement of trains, the radios must be installed so that they can be used by an employee from the leading platform. (Recommendation R-75-32)

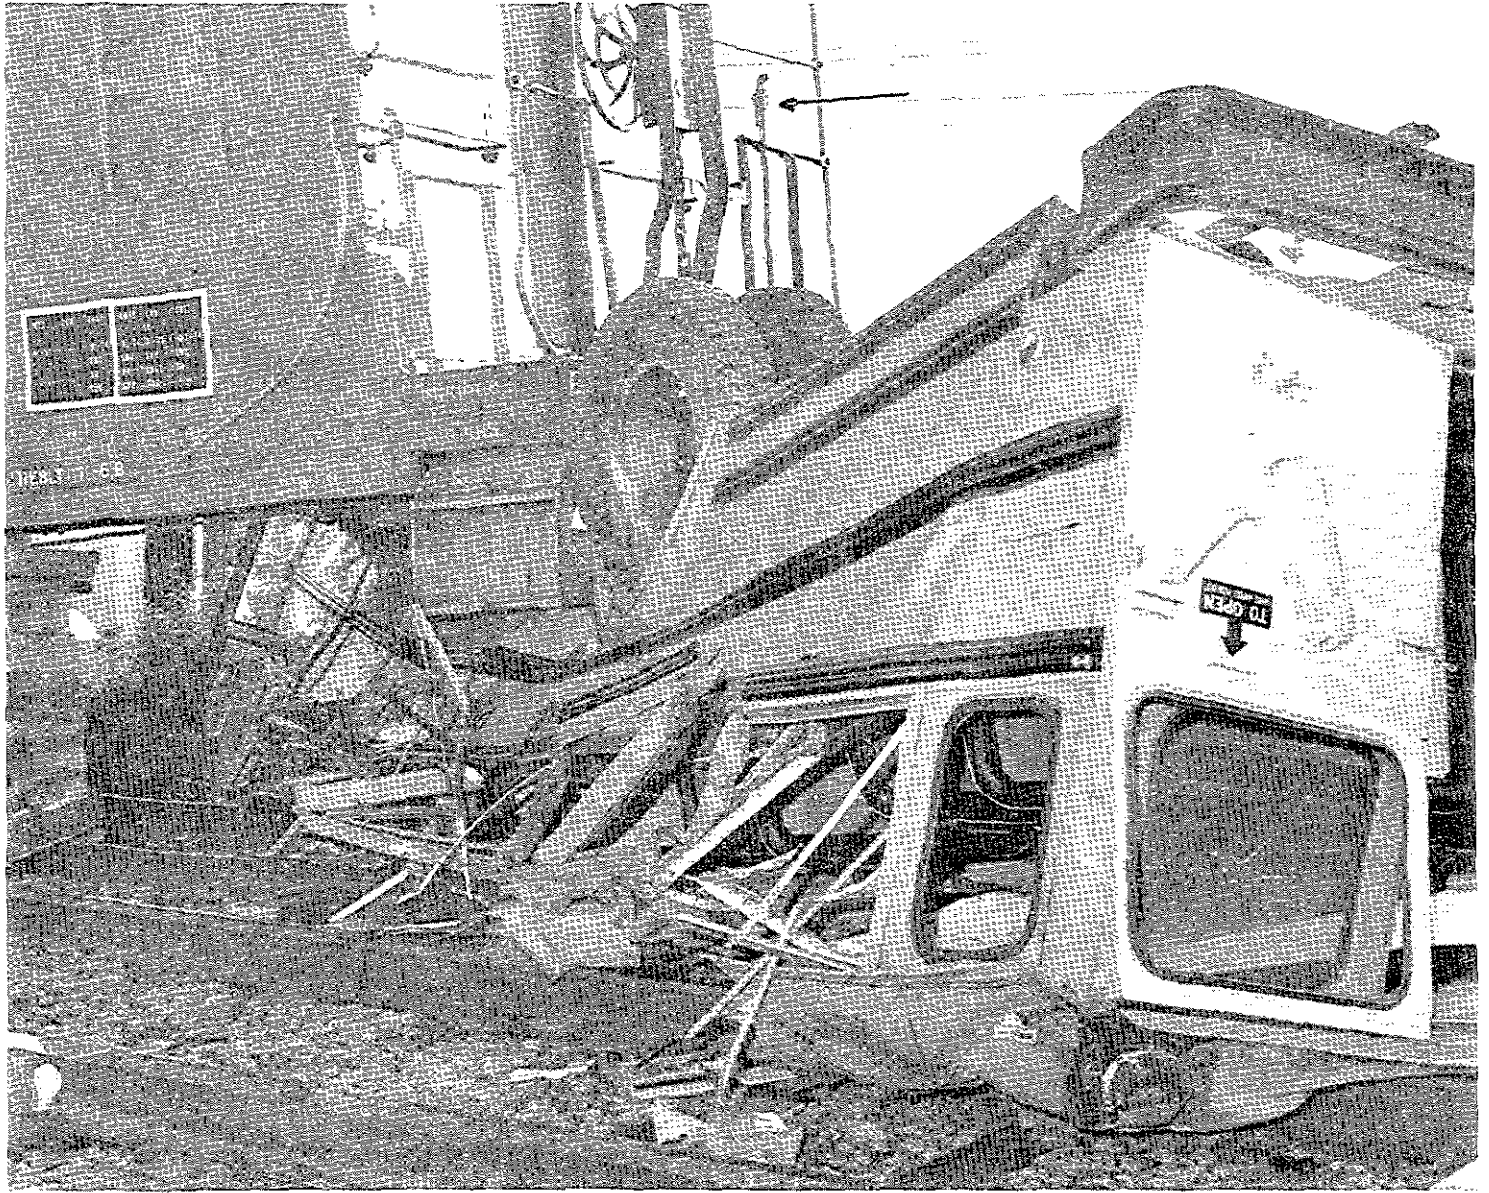
Appendix A, page 2, under "Crash Damage", as reads (Figure 6) on the first two lines: Change to read (Figure A-1).

A-1 The type of failure of window columns noted in this accident (Figure 4) has been called a "critical localized failure" in other cases. It served to permit the collapse of the roof structure onto the seats below. This indicates that the window column did not maintain its maximum strength because of the localized failure at either end. This problem has been found in other accidents involving schoolbuses 2/ and interstate buses. 3/ It cannot be determined whether a differently designed bus column would have been able to resist the weight of the caboose; however, some schoolbuses have been redesigned voluntarily to provide reinforcement at the top and bottom of window columns since the Monarch Pass accident of 1971.

Figure A-1. Bus and caboose in final position. Note (arrow) airbrake valve.
