INTERSTATE COMMERCE COMMISSION

REPORT OF THE DIRECTOR OF THE BUREAU OF SAFETY CONCERNING AN
ACCIDENT ON THE SOUTHERN RAILWAY AT CHARLOTTE, N. C.,
ON JANUARY 13, 1935.

February 12, 1935

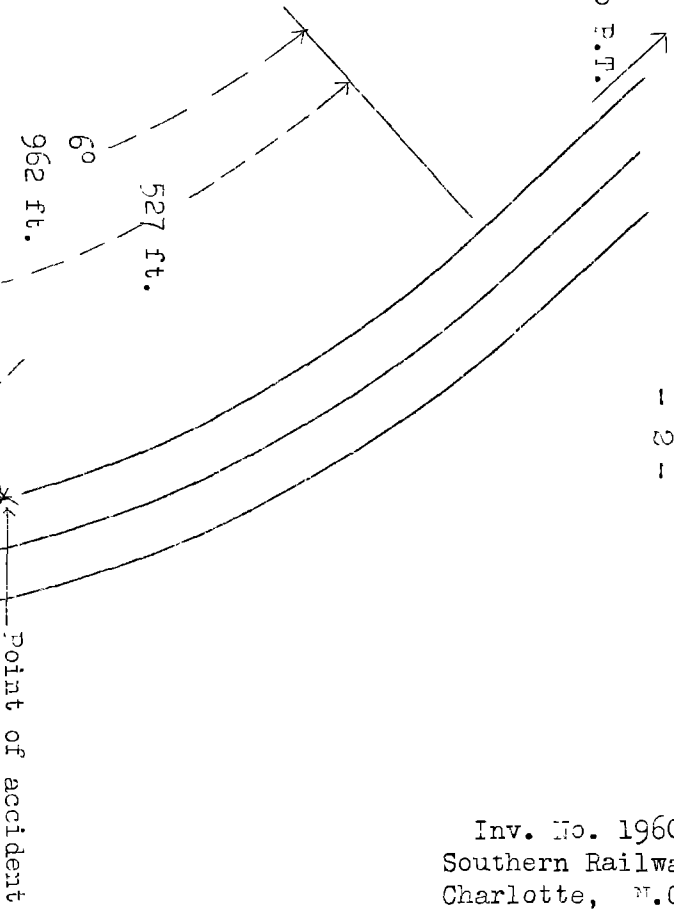
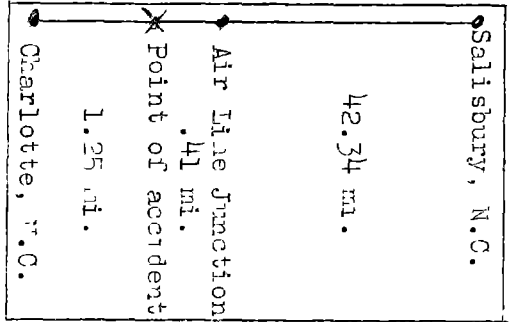
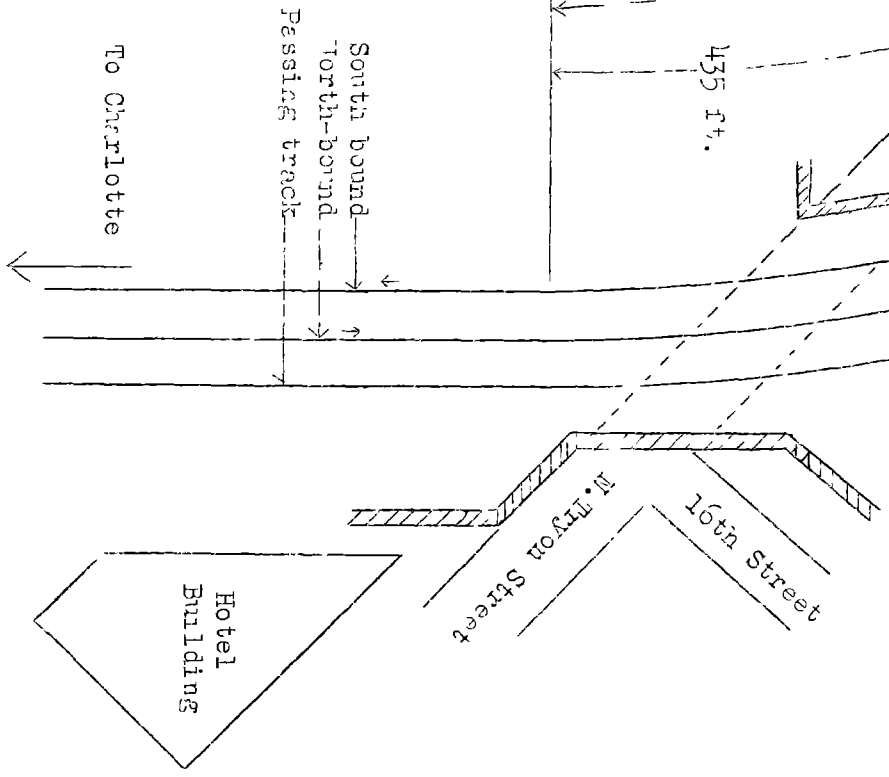
Inv. No. 1960
Southern Railway,
Charlotte, N.C.,
Jan. 13, 1935

5,280 ft. to P.T.
