ACCIDENT ON THE
SOUTHERN RAILWAY

EFLAND, N. C.

JUNE 11, 1936

INVESTIGATION NO. 2069

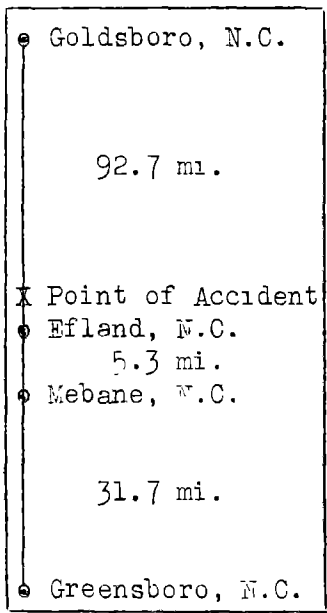
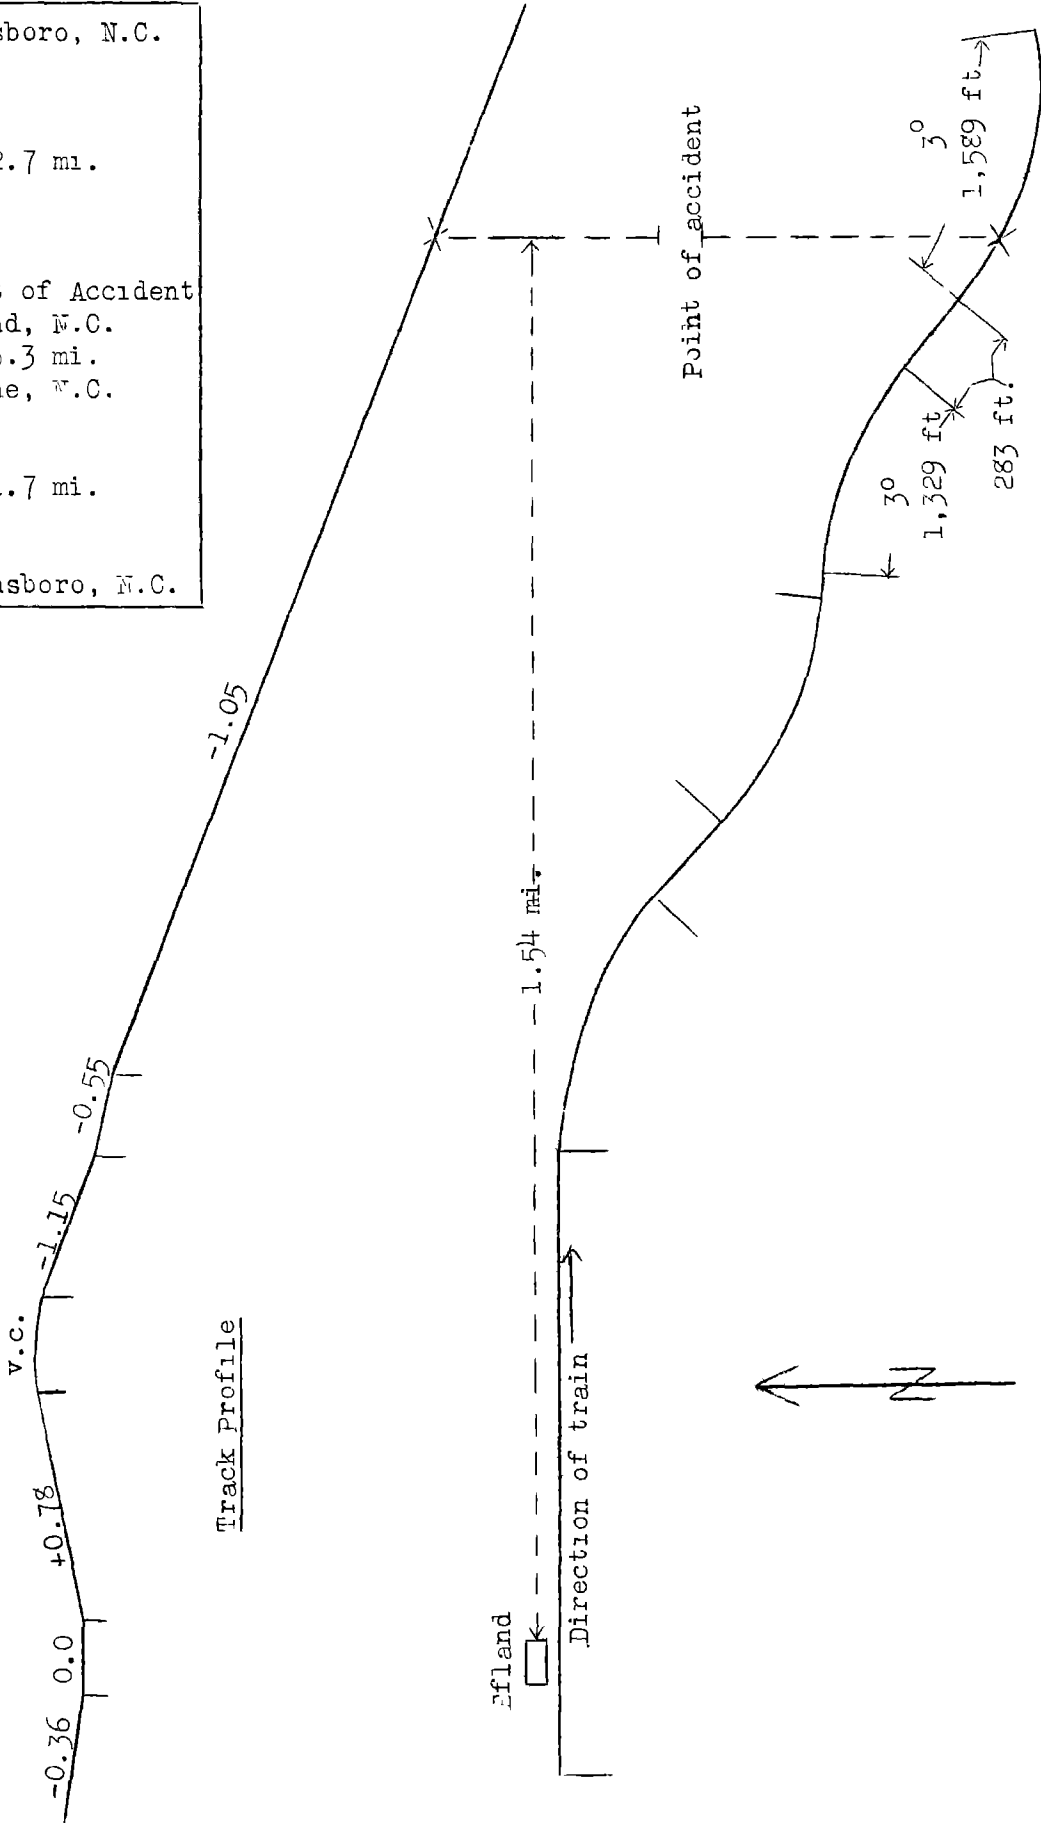
Inv. No. 2069
 Southern Railway
 Efland, N.C.
 June 11, 1936

The engine and first six cars were not derailed and continued about 10 or 15 car lengths before stopping. The lead pair of wheels of the front truck of the seventh car, Norfolk & Western hopper 72411, was derailed to the right and straddled the south rail for a distance of 54 feet, beyond which point the track was practically demolished for a distance of 430 feet; this car stopped on its right side 648 feet east of the initial point of derailment, south of the track, with the front truck near its original location under the car; the next car was a short distance behind it and upright. Approximately 75 feet west of these cars there were two cars that stopped on their sides north of the track and behind them 16 cars were piled in a heap on and near the roadbed, while the next two cars were derailed but remained upright; 14 of the derailed cars were destroyed.

General Car Foreman Fulk, who arrived at the scene about 5 p.m., said that on inspecting the track he saw the flange marks of one pair of wheels on top of the south or high rail of the curve and this mark also showed plainly on the ties, leading immediately off the ends of the ties. He ascertained that these marks were made by the front pair of wheels in the lead truck at the east or B-end of hopper 72411, loaded with coal, which was the first car to be derailed; this car was lying on its side with the damaged lead truck against the underframe, while the truck at the west or A-end was undamaged. He examined
