INVESTIGATION NO. 2463  
THE SOUTHERN RAILWAY COMPANY  
REPORT IN RE ACCIDENT  
AT PINE GROVE, GA., ON  
NOVEMBER 17, 1940

Accident at Pine Grove, Ga., on November 17, 1940, caused by left switch of turnout to left being in position for entry to siding and right point being in position for movement on main line, because of broken switch rod.

Inv. No. 2463  
Southern Railway  
Pine Grove, Ga.  
November 17, 1940

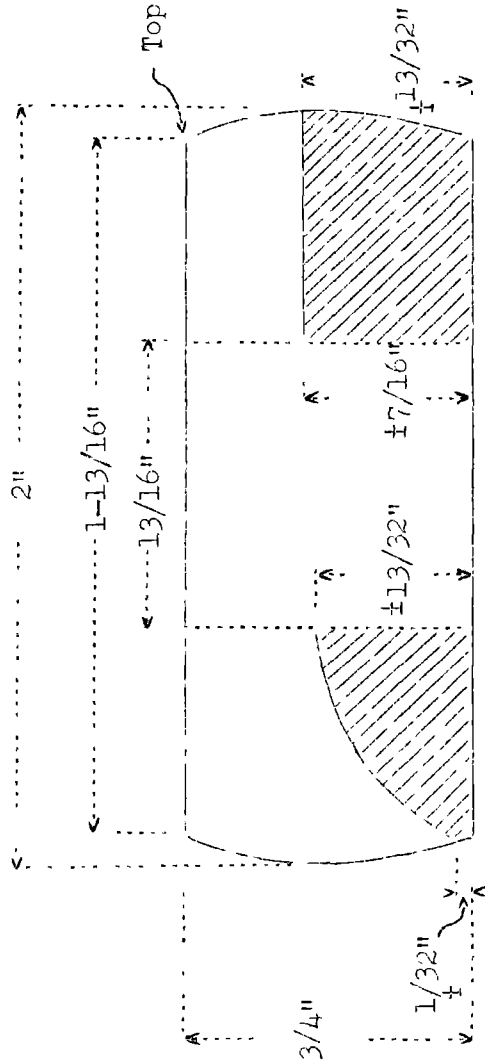
Cross section of No. 1 switch rod.  
Shaded area shows extent of old break.

According to data furnished by the railroad, about 33 percent of the fracture of the switch rod involved was an old break.

The Commission's inspectors observed that the end of the No. 1 switch rod was broken through the center of the left bolt-hole. About 1/4 of the fracture was corroded and worn, indicating that it was an old flaw. The bolt hole showed practically no wear and the other portion of the switch rod was of sound metal. There was a well defined flange mark on the outside portion of the base of the lead rail of the turnout at a point 23 feet 3 inches south of the switch point.

Subsequent to the accident, examination disclosed that the throwing lever of the switch was latched in position for movement on the main track. The target was turned in such manner that it displayed almost all its red aspect toward the north. The right switch-point was against the stock rail and the left point was open about 5 inches. The No. 1 switch rod was broken through the bolt hole where the left clip is joined; a considerable portion of this fracture was an old break.
