REPORT OF THE DIRECTOR

ACCIDENT ON THE
SOUTHERN RAILWAY

JACKSON, GA.

INVESTIGATION NO. 2021

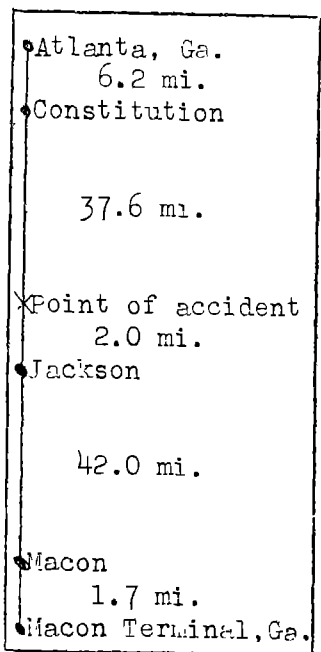
Inv. No. 2021
Southern Railway
Jackson, Ga.
Nov. 20, 1935

This accident occurred on that part of the Atlanta Division extending between Constitution and Macon Terminal, Ga., a distance of 83.3 miles, this being a single-track line over which trains are operated by time table, train orders, an automatic block-signal system, and an automatic train-stop system of the intermittent-inductive type. The accident occurred approximately 2 miles north of Jackson; approaching this point from the south, there is a 6°24' curve to the right 533 feet in length and then tangent track for a distance of 1,028 feet, followed by a 6°24' curve to the left 783 feet in length, the accident occurring on this latter curve at a point 64 feet from its northern end. Approaching from the north, there is a 5° curve to the left 532 feet in length, tangent track for a distance of 777 feet, and then the curve on which the accident occurred. The grade is level at the point of accident.

Due to trees on the inside of the curve, and the fact that the track is laid in a short cut at and north of the point of accident the view was very much restricted; the view had by the crew of the motor car at the point of accident of an approaching north-bound train was restricted to approximately 915 feet. Under the rules, operators of motor cars are required to obtain written line-ups issued by the dispatcher, and to provide flag

This accident was caused by the operation of a motor car and trailer on the time of an opposing overdue train without protection.
