ACCIDENT ON THE
SOUTHERN RAILWAY

LAKE, ILL.

JANUARY 22, 1936

INVESTIGATION NO. 2035

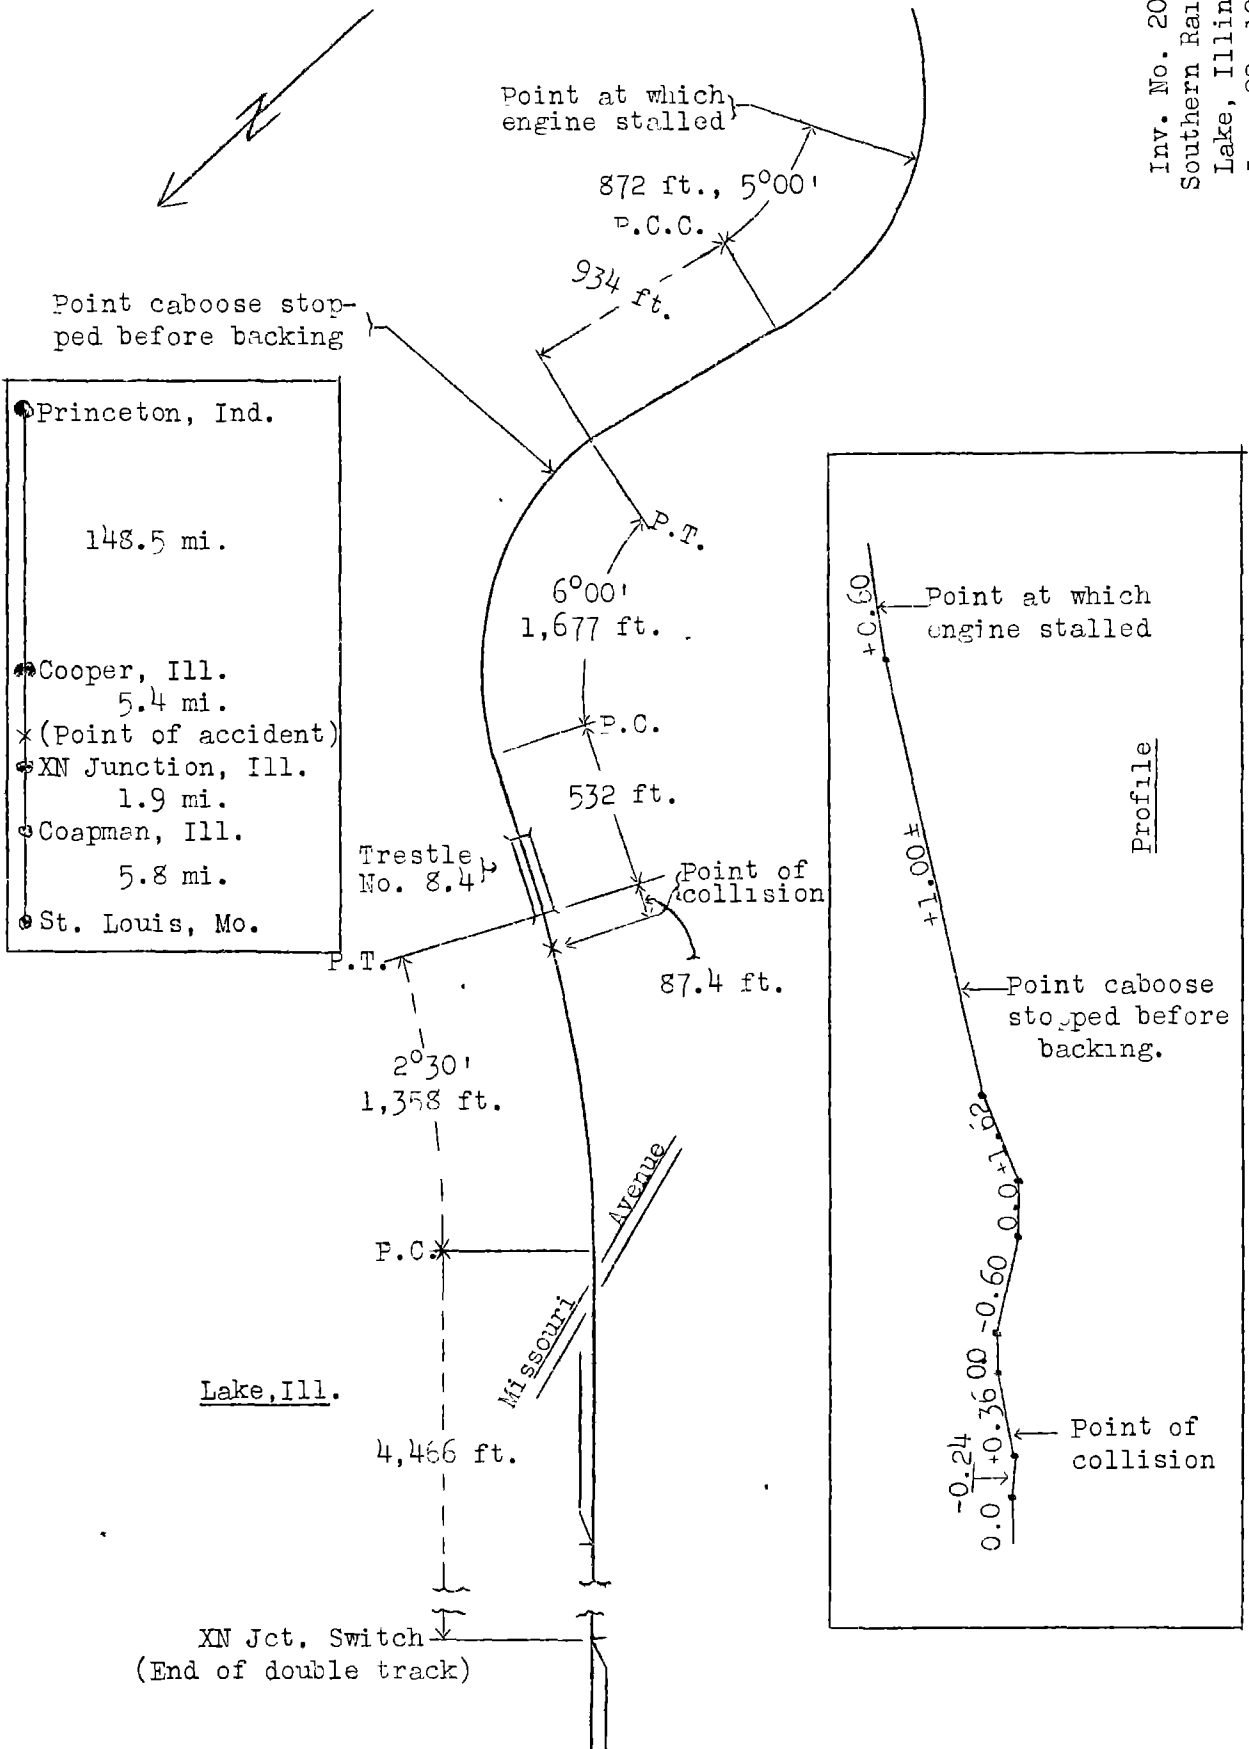
Inv. No. 2035
Southern Railway
Lake, Illinois
Jan. 22, 1936

Train No. 61 left XN Junction about 8:52 a.m., and while ascending the grade east thereof the driving wheels slipped causing the engine to stall on the 5° portion of a compound curve to the left, when it had reached a point about 3,100 feet up the grade, at which time the caboose was on a 6° curve to the right and about 1,100 feet up the hill, and the cars in the middle of the train were on tangent track. After making several unsuccessful attempts to start the train the engineman decided to back up until the engine was off the curve, and to then make another attempt to start, which he did, without arranging with the conductor, assuming that the flagman had been left behind at XN Junction to afford protection against the following first-class train. He permitted the train to back down the hill about 2,000 feet, or until the engine had reached a point in the immediate vicinity of where the caboose had originally stood when the engine stalled. This back-up movement placed the caboose at a point about 950 feet west of the bottom of the hill. While endeavoring to start the train forward again, from this point, the caboose was struck by Train No. 23.
