INTERSTATE COMMERCE COMMISSION

REPORT OF THE DIRECTOR OF THE BUREAU OF SAFETY IN RE
INVESTIGATION OF AN ACCIDENT WHICH OCCURRED ON THE
SOUTHERN RAILWAY NEAR NEW MARKET, TENN., ON APRIL
26, 1931.

June 11, 1931.

INV. NO. 1732
SOUTHERN RAILWAY.
NEW MARKET, TENN.
APRIL 26, 1931.

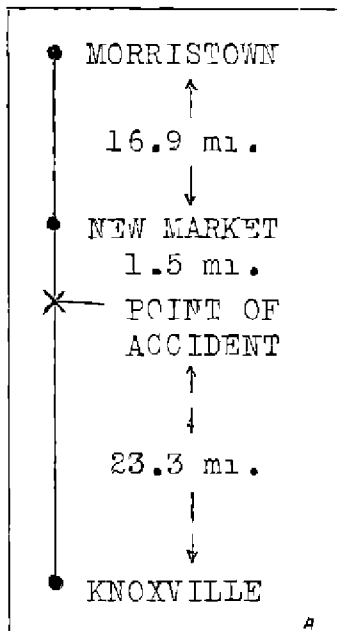
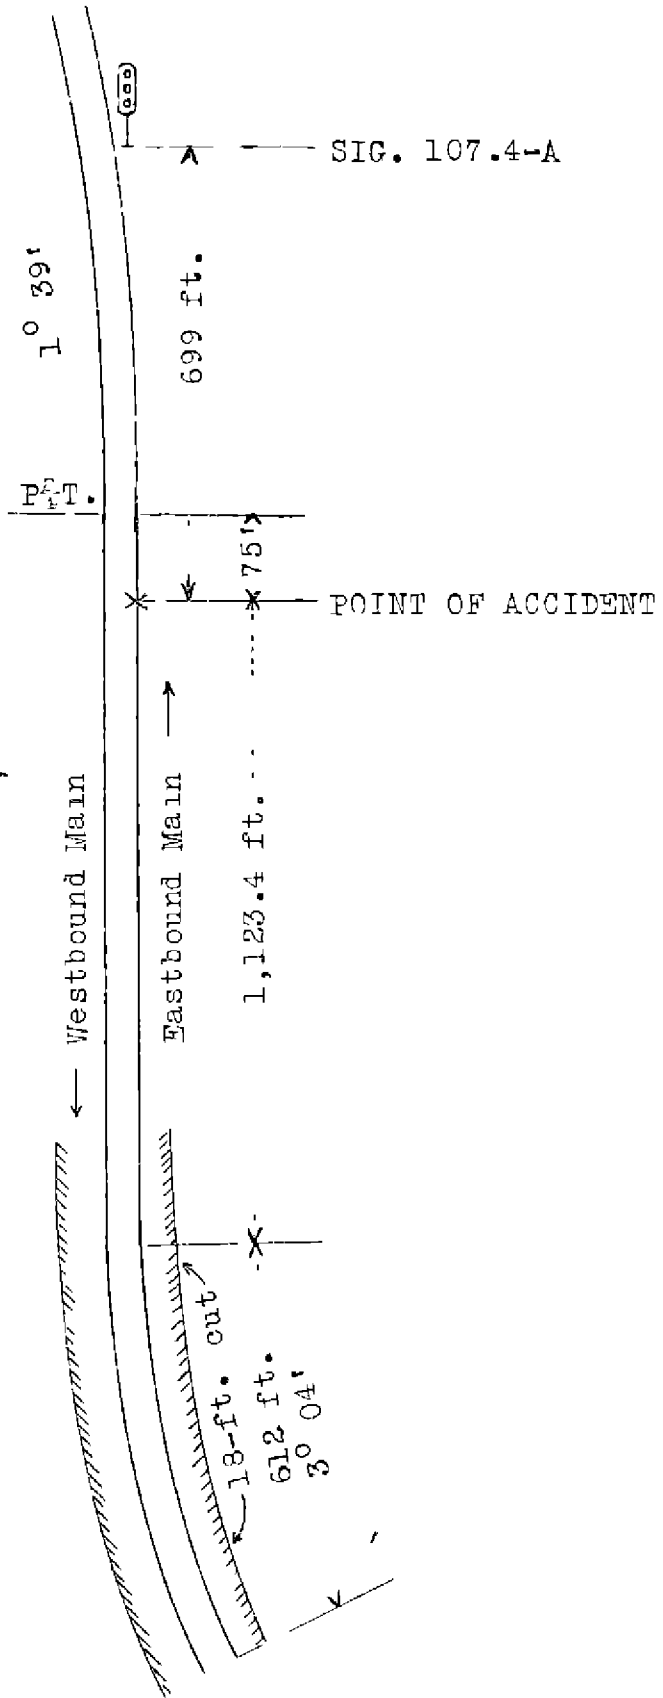
Due to a rock cut 18 feet in height, located on the curve west of the tangent track on which the accident occurred, the view had by an engineman of the rear of an eastbound train standing at the point of accident was restricted to 1,181.5 feet.

SIG. 107.4-A
