INVESTIGATION NO. 3119
SOUTHERN RAILWAY COMPANY
REPORT IN RE ACCIDENT
NEAR ROVER, GA., ON
AUGUST 2, 1947

Kind of accident: Head-end collision

September 22, 1947

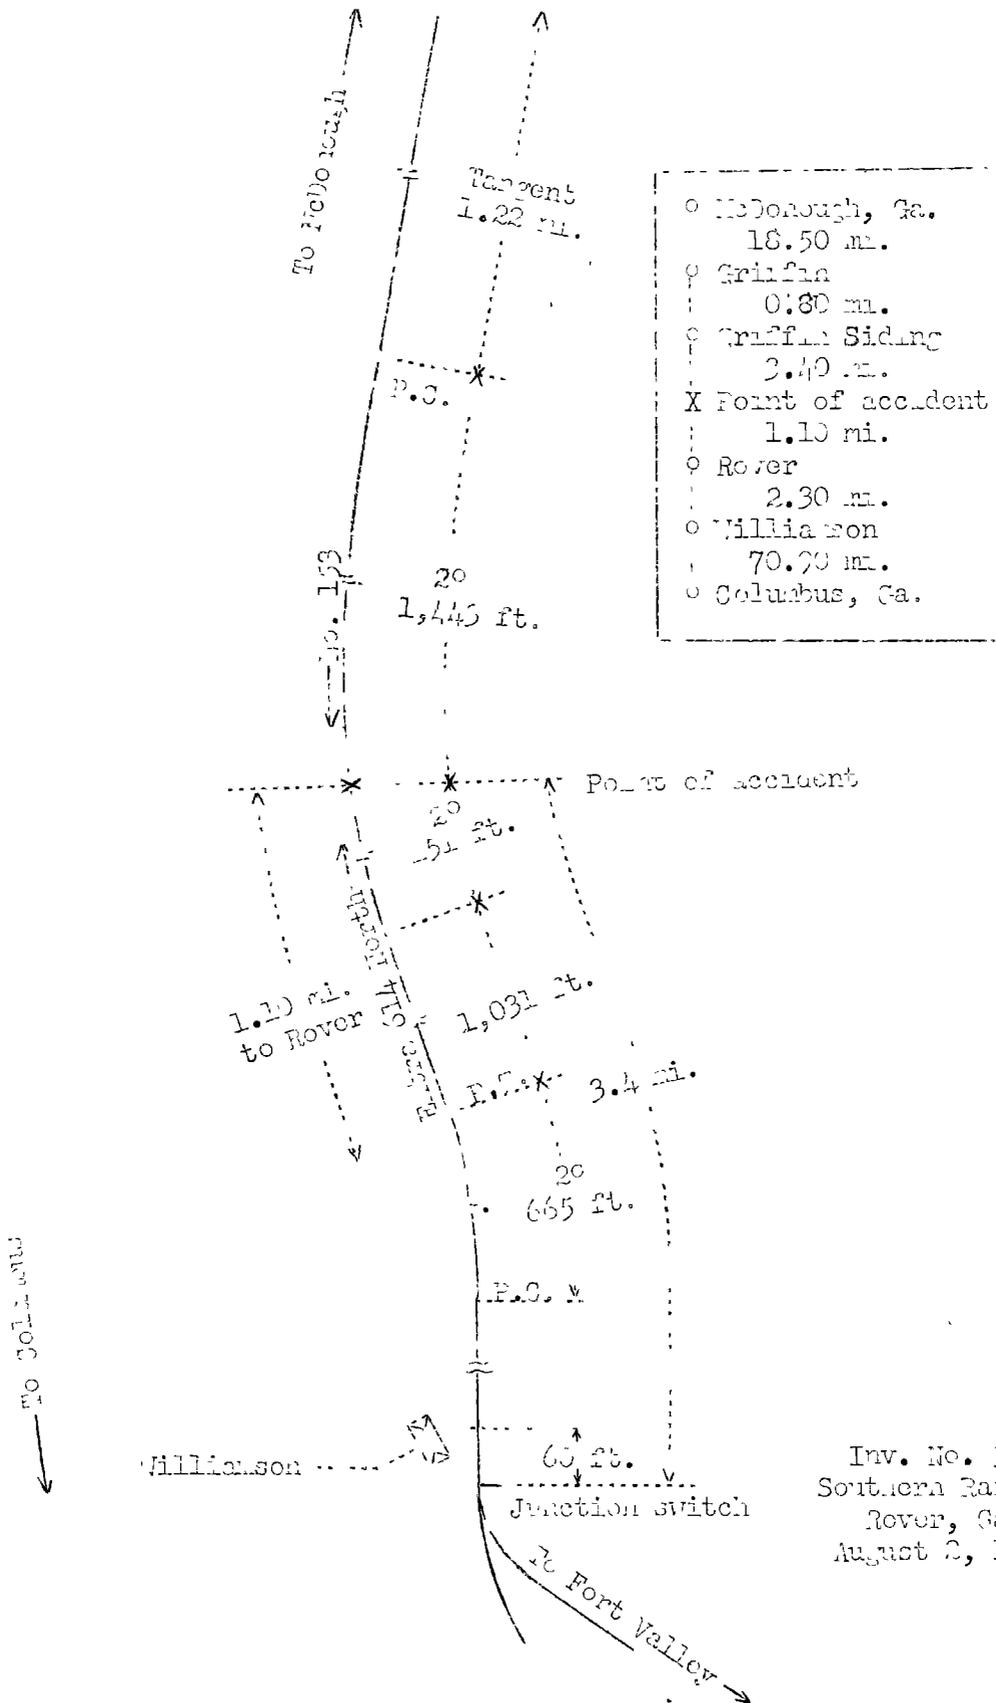
Inv. No. 3119
 Southern Railway
 Rover, Ga.
 August 2, 1947

This accident occurred on that part of the Atlanta Division extending between McDonough and Columbus, Ga., 97 miles, a single-track line, over which trains are operated by timetable and train orders. There is no block system in use. The accident occurred on the main track 22.70 miles south of McDonough and 1.10 miles north of the station at Rover. From the north there is a tangent 1.22 miles in length, and then a 2° curve to the left 1,443 feet to the point of accident and 151 feet southward. From the south there is a 2° curve to the left 665 feet in length, a tangent 1,031 feet, and then the curve on which the accident occurred. The grade is 1.26 percent descending southward.

At Williamson, 2.3 miles south of Rover, a single-track line extending southeastwardly to Fort Valley, Ga., 60.3 miles, converges with the line on which the accident occurred. The junction switch is 60 feet south of the station.
