INTERSTATE COMMERCE COMMISSION

-----  
ACCIDENT ON THE  
SOUTHERN RAILWAY

-----  
SALUDA, N. C.

-----  
INVESTIGATION NO. 2448

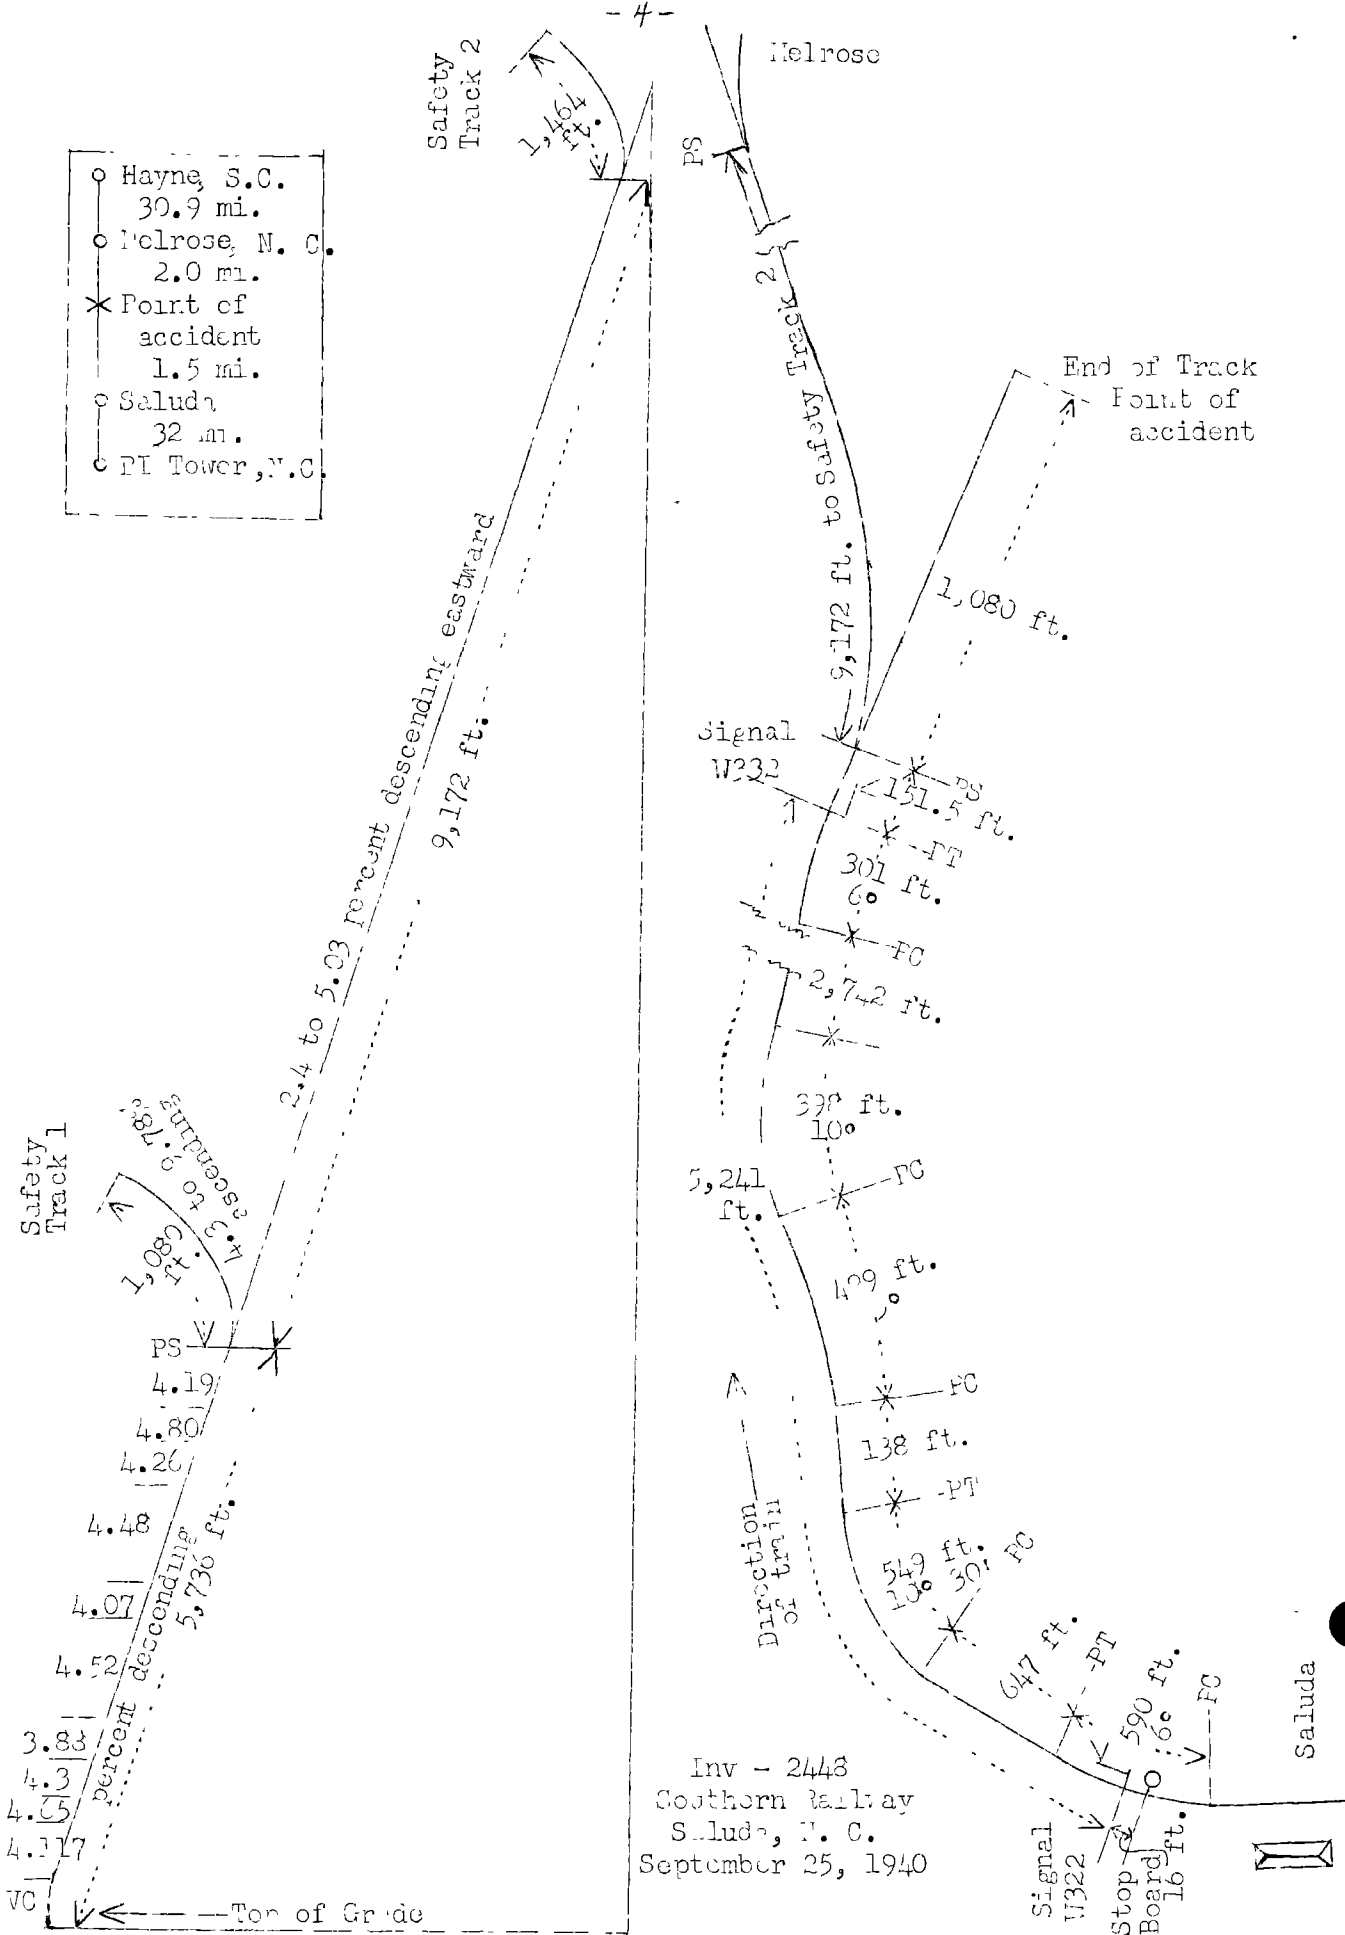
Inv - 2448  
 Southern Railway  
 Saluda, N. C.  
 September 25, 1940

End of Track Point of accident

2.4 to 5.03 percent descending eastward  
 9,172 ft.

1,080 ft.  
 4.3 to 5.78 percent ascending

5,736 ft.  
 4.07 percent descending
