RAILROAD ACCIDENT INVESTIGATION

Report No 3776

SOUTHERN RAILWAY COMPANY

AUGUST 26, 1957

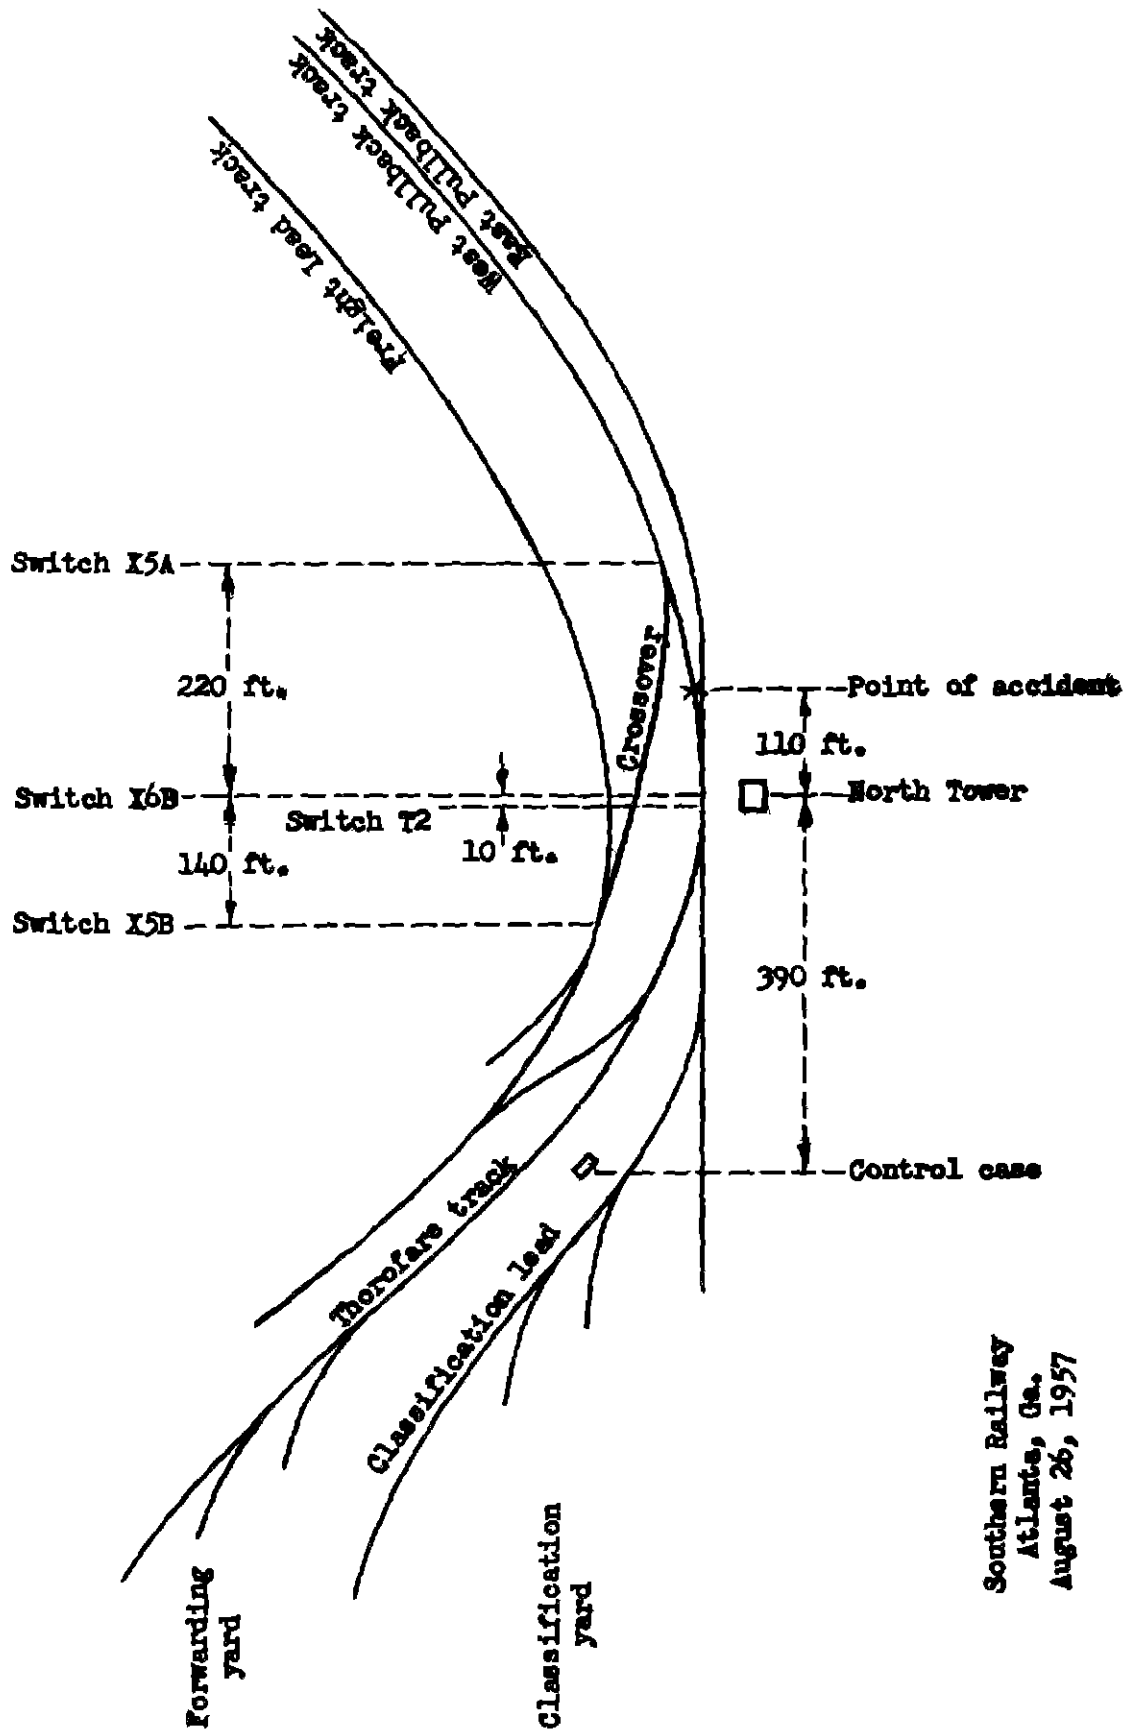
Location of Accident and Method of Operation

Switches X6B, X5A, X5B, and T2 are so arranged that they can be operated either manually or electrically. A control case is provided for the electrical operation of these switches. It is located between the classification lead track and the Thorofare track at a point approximately 390 feet south of North Tower. The control case is approximately 2 feet wide and 3 feet high and is mounted on a mast. The panel is hooded and contains six switch levers which are numbered from left to right, consecutively, 1 to 6. The levers are approximately 5 feet 10 inches above ground level. Normal position for each lever is down and reverse position is up. Each lever is provided with three lights. When a lever and the switch or switches it controls are in normal position a green light becomes lighted, and when in reverse position a red light becomes lighted. Track occupancy is indicated by a white light. A detector track circuit is provided for each power-operated switch and is so arranged that when an approaching movement is approximately 3 feet from the switch points of the switch involved the track-occupancy light becomes extinguished and the switch cannot be operated electrically until after the movement passes the switch.

Levers 1 and 3 control the operation of switches X6B and T2, respectively. When these levers are in reverse position the route is lined for a northbound movement from the Thorofare track to the East Pullback track. Lever 2 controls the operation of switches X5A and X5B. When this lever is in reverse position the route is lined for a southbound movement from the West Pullback track over the crossover to the Freight Lead track. When this lever is in normal position the route is lined for continued movement on the West Pullback track.

During the investigation the switchman said that he did not move any of the levers, however, it is evident that lever 2 was moved from reverse position to normal position as the south-bound movement on the West Pullback track was closely approaching switch X5A diverting the movement from the crossover track, the intended route, to the junction of the West Pullback track and the East Pullback track which was occupied by another movement

The power-operated switches involved in this accident are remotely controlled and the control circuits so arranged that they can be operated immediately in front of an approaching movement without any warning to the members of the crew. Such switches are not provided with all the protective features which usually surround the use of interlocked power-operated switches, nor do they appear to have the degree of safety associated with the use of hand-operated switches, since after a hand operated switch is properly lined for a movement it is improbable that the switch could be reversed without some member of the crew being aware of it. Consideration should be given to such measures as are necessary to prevent improper operation of power-operated switches in installations of the type involved in this accident
