INTERSTATE COMMERCE COMMISSION,
WASHINGTON

REPORT NO. 3601
SOUTHERN RAILWAY COMPANY
IN RE ACCIDENT
NEAR MARION JCT., ALA., ON
NOVEMBER 24, 1954

Accident near Marion Jct., Ala., on November 24, 1954,
caused by a motor-truck occupying a rail-highway
grade crossing immediately in front of an approach-
ing train.

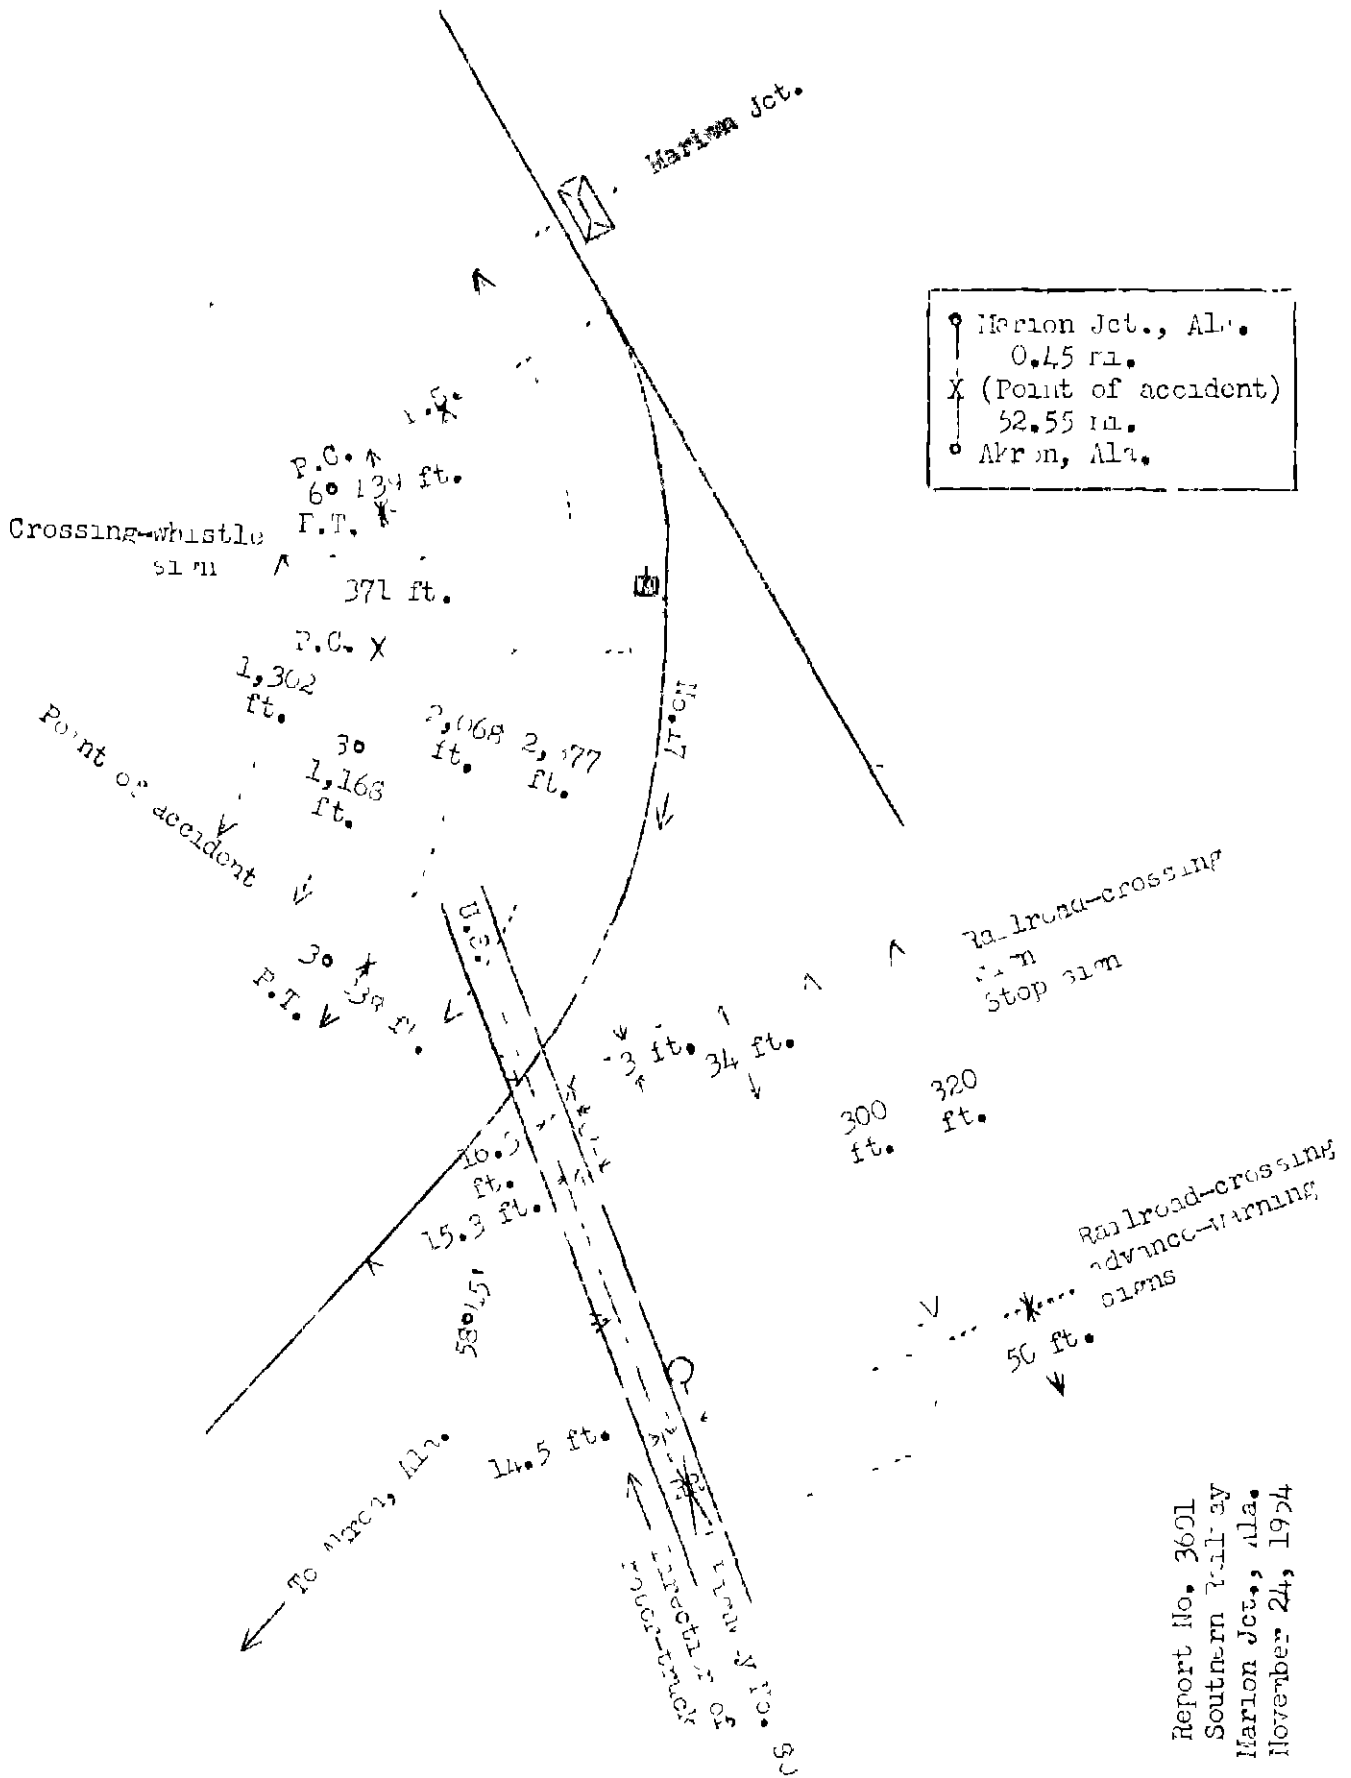
Report No. 3691
 Southern Railway
 Marion Jct., Ala.
 November 24, 1924

In the immediate vicinity of the crossing U. S. Highway No. 80 is tangent and is surfaced with bituminous material. The southeast angle of the intersection of the highway and the railroad is 58°45'. The crossing is 24 feet in width. Planking is provided on each side of each rail, and the remaining area of the crossing is surfaced with bituminous material to the level of the tops of the rails. The grade for west-bound vehicles averages 3.1 percent ascending throughout a distance of 400 feet immediately east of the crossing, and it is 0.9 percent ascending at the crossing. A railroad-crossing advance-warning sign in the west-bound traffic lane extends between points 370 feet and 320 feet east of the crossing. This sign, which is painted with reflecting paint, consists of two diagonal stripes with the letter "R" in the angle at each side and a transverse stripe at each end. A circular railroad-crossing advance-warning sign 30 inches in diameter is located 14.5 feet north of the center-line of the highway and 500 feet east of the track. This sign is mounted on a mast and is 2 feet 8 inches above the level of the highway. It bears two diagonal lines intersecting at right angles and the letters "RP" in black on a yellow background. The lines and letters are equipped with reflector buttons. An octagonal sign is located 15.3 feet north of the center-line of the highway and 34 feet east of the track. This sign is mounted on a mast and is 5 feet 7 inches above the level of the highway. It bears the word

"STOP" in black letters on a yellow background with a black border. The letters are equipped with reflector buttons. A standard cross-buck railroad-crossing sign is located in the northeast angle of the intersection, 16.3 feet north of the center-line of the highway and 13 feet east of the center-line of the track. This sign is mounted on a mast and is 10 feet 2 inches above the surface of the highway. It bears the words "RAILROAD CROSSING" in black on a white background. A crossing-whistle sign for south-bound trains is located 1,302 feet north of the crossing.

After the accident occurred, skid marks were found on the surface of the highway between points approximately 150 feet and 20 feet east of the crossing. These marks indicated that the truck had turned toward the left at a point approximately 30 feet east of the crossing. The accident occurred at a point 12 feet south of the center-line of the highway.

As a vehicle approaches the crossing from the east, the driver's view of an approaching south-bound train is somewhat restricted by two small houses located north of the highway and about 600 feet east of the crossing. After a vehicle passes these houses, the driver has an unobstructed view of an approaching south-bound train throughout a distance of several hundred feet immediately north of the crossing.
