REPORT NO. 3608
SOUTHERN RAILWAY COMPANY
IN RE ACCIDENT
NEAR STROTHER, S. C., ON
JANUARY 13, 1955

Date: January 13, 1955
Railroad: Southern
Location: Strother, S. C.
Kind of accident: Derailment
Train involved: Passenger
Train number: 28
Engine number: Diesel-electric units 6702 and 6705
Consist: 9 cars
Speed: 50 m. p. h.
Operation: Timetable and train orders
Track: Single, 3° curve; 0.29 percent descending grade eastward
Weather: Cloudy
Time: 3:50 p. m.
Casualties: 11 injured
Cause: Broken rail

Accident near Strother, S. C., on January 13, 1955, caused
by a broken rail.

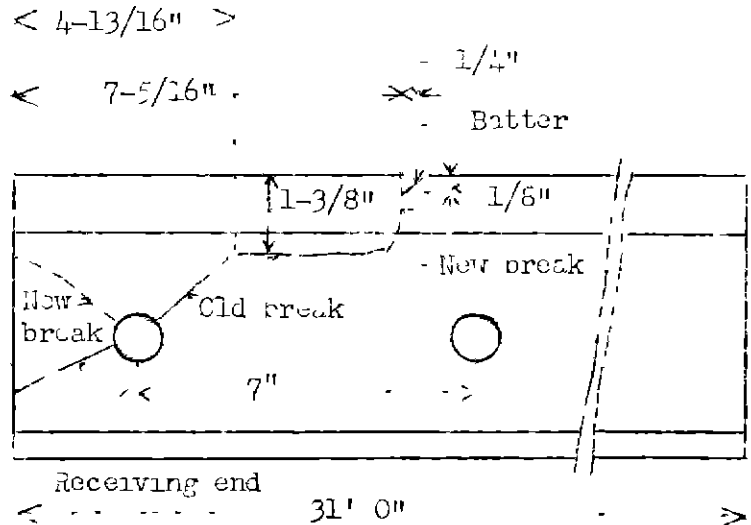
Sketch showing broken rail-north side of track

After the accident occurred a broken rail was found in the north side of the track. This rail was manufactured by the Maryland Steel Company in 1924 and bore heat number 73D03. An old fracture through the web extended diagonally upward from a point $4\text{-}9/16$ inches below the head at the receiving end of the rail, through the first bolt hole to a point immediately under the head and $4\text{-}13/16$ inches east of the end of the rail,

then parallel to the head to a point 7-5/16 inches from the end of the rail. From the latter point a new break extended upward through the head. A new break through the web extended diagonally upward from the first bolt hole to the end of the rail at a point 1-13/16 inches below the head. The 7-5/16-inch section of the head had become dislodged, and the head of the rail east of the break was battered 1/8 inch vertically and 1/4 inch horizontally. The joint bars remained in place.

According to the report of the engineer of tests of the carrier, the failure of the rail at the initial point of derailment was the result of a progressive fatigue type of fracture which originated in the web at the bolt hole. Examination of the rail disclosed no excessive wear or battering which would indicate looseness of the joint. The chemical composition of the rail was normal.

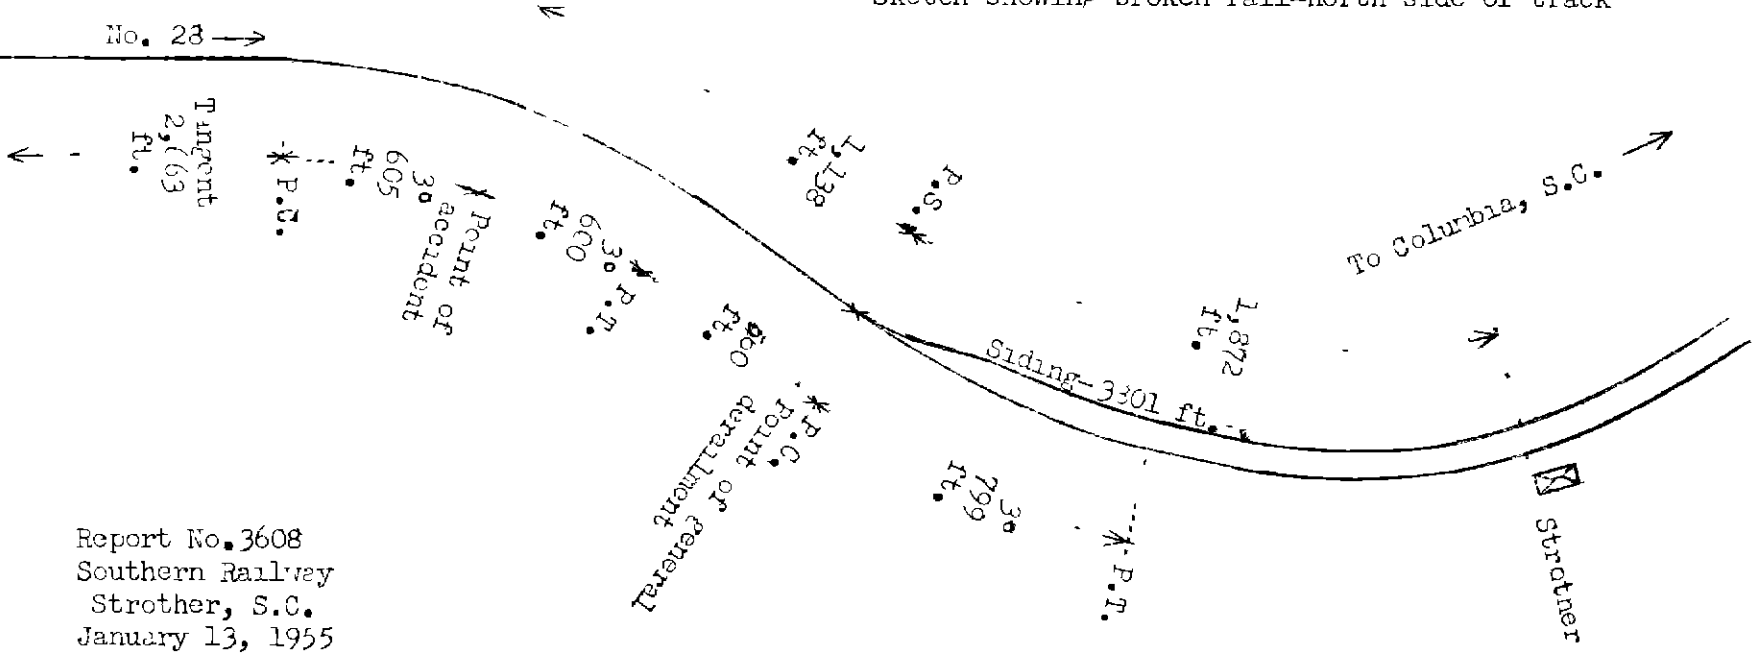
Report No. 3608
 Southern Railway
 Strother, S.C.
 January 13, 1955

Immediately east of the point at which the section of rail was dislodged there was a flange mark on the head of the north rail. This mark extended diagonally outward throughout a distance of 37 feet, and east of this mark the ties bore marks which indicated that a pair of wheels had become derailed to the north. These wheels had continued in line with the track to the west siding-switch. Rail braces on the north side of each rail at the switch were marked, and the right hand switch rail bore marks indicating that it had been struck by a wheel. The derailed wheels had been deflected toward the north at the switch, and marks on the ties indicated that a second pair of wheels had become derailed at a point 30 feet 6 inches east of the switch point. East of this point the track was torn up throughout a distance of approximately 450 feet.

The third car of No. 20 was equipped with six-wheel trucks. Marks on the treads and flanges of the middle pair of wheels of the rear truck indicated that this pair of wheels had become derailed at the initial point of derailment and had come in contact with the rail braces and the right hand switch rail at the west siding-switch. Apparently the other wheels of this truck became derailed when the middle wheels were deflected toward the north at the switch, and the front truck of this car and both trucks of the second car became derailed when the rear end of the third car was deflected to the left. The following equipment was then derailed as a result of the ensuing damage to the track.
