INVESTIGATION NO. 2864
THE SPOKANE, PORTLAND & SEATTLE RAILWAY COMPANY
REPORT IN RE ACCIDENT
AT PORTLAND, OREG., ON
JANUARY 29, 1945

Railroad: Spokane, Portland & Seattle
Date: January 29, 1945
Location: Portland, Oreg.
Kind of accident: Side collision
Trains involved: S. P. & S. freight : N. P. T. yard
engine and cars
Train numbers: Extra 335 East :
Engine numbers: 335 : 10
Consist: Caboose : 10 cars
Estimated speed: 3 m. p. h. : 3 m. p. h.
Operation: Timetable and train orders;
yard limits
Track: Double; tangent; 0.2 percent
ascending grade eastward
Weather: Clear
Time: 7:14 a. m.
Casualties: 1 killed; 1 injured
Cause: Failure properly to control
speed of yard engine moving
within yard limits

Accident at Portland, Oreg., on January 29, 1945, caused
by failure properly to control the speed of a yard
engine moving within yard limits

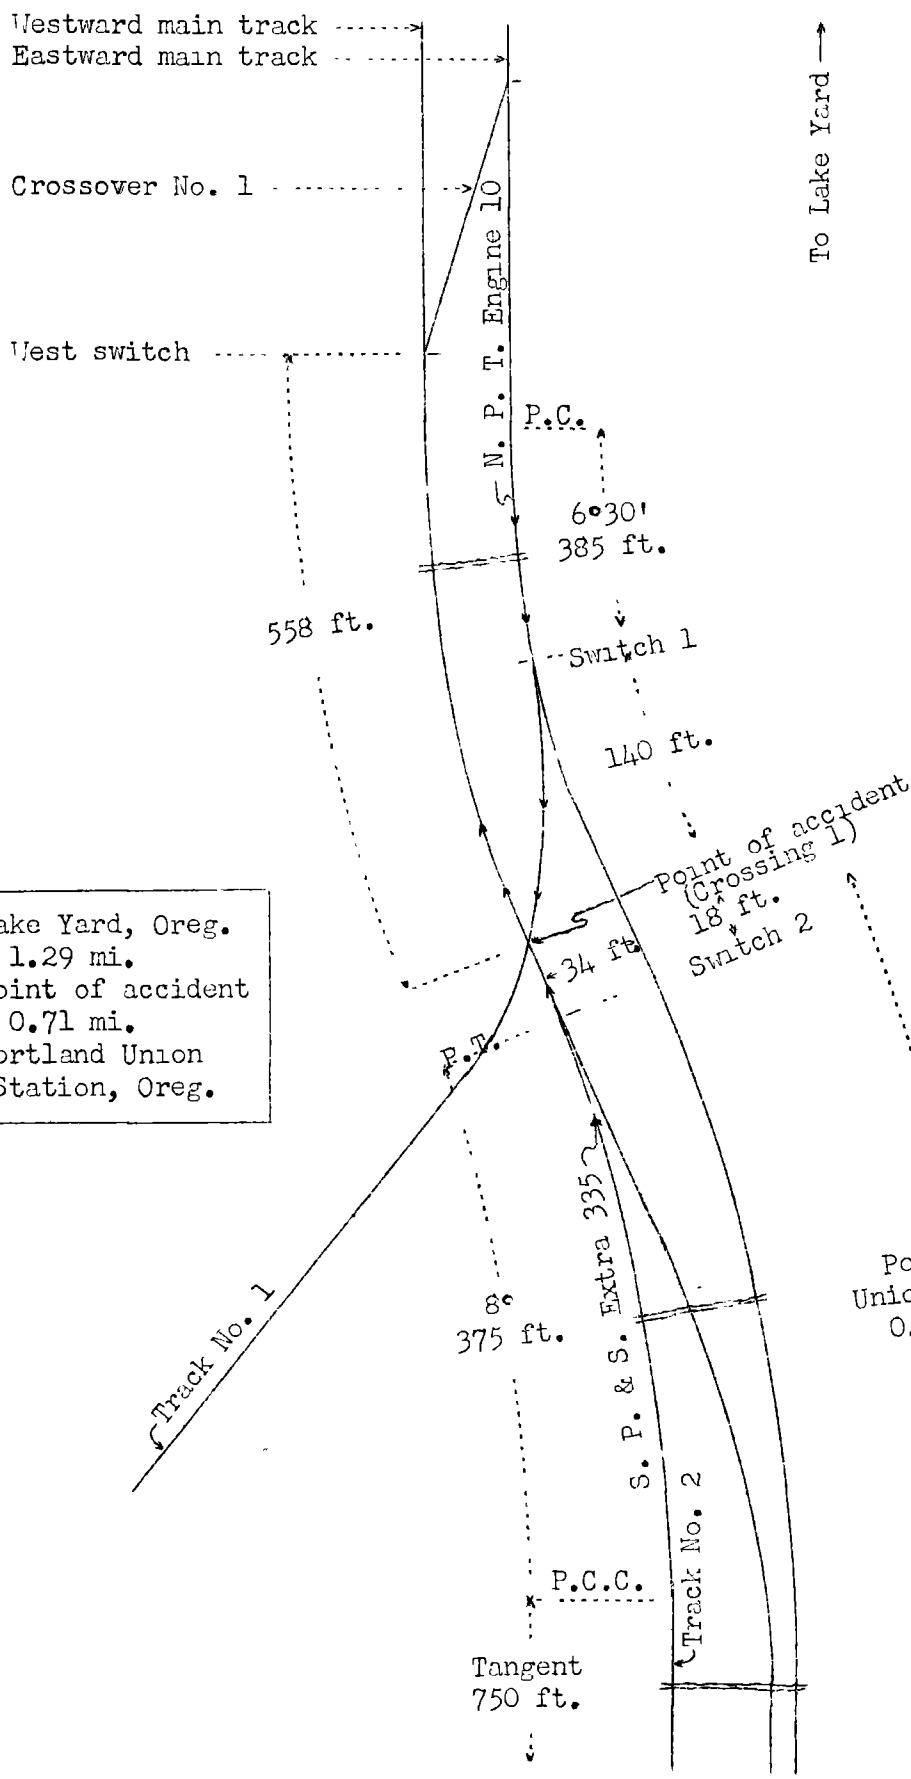
Inv. No. 2864
 Spokane, Portland & Seattle Railway
 Portland, Oreg.
 January 29, 1945

o Lake Yard, Oreg.
 1.29 mi.
 X Point of accident
 0.71 mi.
 o Portland Union
 Station, Oreg.

This accident occurred on that part of the Terminals Sub-Division extending eastward from Portland Union Station to Lake Yard, Oreg., 2 miles. This was a double-track line, within yard limits, over which trains moving with the current of traffic were operated by timetable and train orders. There was no block system in use. Yard engines of the Northern Pacific Terminal Company of Oregon, hereinafter referred to as the N. P. T., were regularly operated in this territory. At a point 0.71 mile east of Union Station a spur track, hereinafter referred to as track No. 1, extended northwestward from the eastward main track and intersected the westward main track at an angle of 31 degrees. At the crossing, hereinafter referred to as crossing 1, the distance between the track centers of the main tracks was 34 feet. The switch which connected the eastward main track and track No. 1 was 140 feet east of crossing 1, and was trailing-point for east-bound movements on the eastward main track. This switch is hereinafter referred to as switch 1. In this vicinity a lead track, hereinafter referred to as track No. 2, which connected the westward main track and several yard tracks, practically paralleled the main tracks on the north. The east switch of the lead track was 18 feet west of crossing 1, and was facing point for west-bound movements on the westward main track. This switch is hereinafter referred to as switch 2. The west switch of a trailing-point crossover about 450 feet long, hereinafter referred to as crossover No. 1, which connected the main tracks, was 558 feet east of crossing 1. East-bound trains en route from track No. 2 to the eastward main track were authorized by special instructions to operate against the current of traffic on the westward main track from switch 2 to the west switch of crossover No. 1. The accident occurred at the fouling point of crossing 1 and track No. 1. From the west on track No. 2 to switch 2 and thence eastward on the westward main track there were, in succession, a tangent 750 feet, a compound curve to the left 375 feet, the maximum curvature of which was 8° , and a tangent 18 feet to crossing 1 and a short distance eastward. From the east on the eastward main track there was a $6^{\circ}30'$ curve to the left 385 feet to switch 1, and beyond this switch on track No. 1 there was a 20° curve to the right 140 feet to crossing 1. The grade was 0.2 percent ascending eastward.

Extra 335 East, an east-bound S. P. & S. freight train, consisting of engine 335, headed westward, and a caboose, in the order named, was en route eastward from track No. 2 to the westward main track, and thence through crossover No. 1 to the eastward main track. While this train was moving over crossing 1 at a speed of about 3 miles per hour the engine was struck by the first car of a cut of cars being pushed by N. P. T. yard engine 10.

N. P. T. yard engine 10, headed westward, pushing 10 cars, moved westward on the eastward main track and entered track No. 1 at switch 1. While moving at an estimated speed of about 3 miles per hour it struck Extra 335 East.

The engine foreman of yard engine 10 was the only member of the crew of this engine who was in the immediate vicinity of crossing 1. The view of the crossing had by other members of the crew was materially restricted because of track curvature. The foreman said that he lined switch 2 for Extra 335 to proceed from track No. 2 to the westward main track, but he
