INVESTIGATION NO. 2897

SPOKANE, PORTLAND AND SEATTLE RAILWAY COMPANY

REPORT IN RE ACCIDENT

JUNE 10. 1945

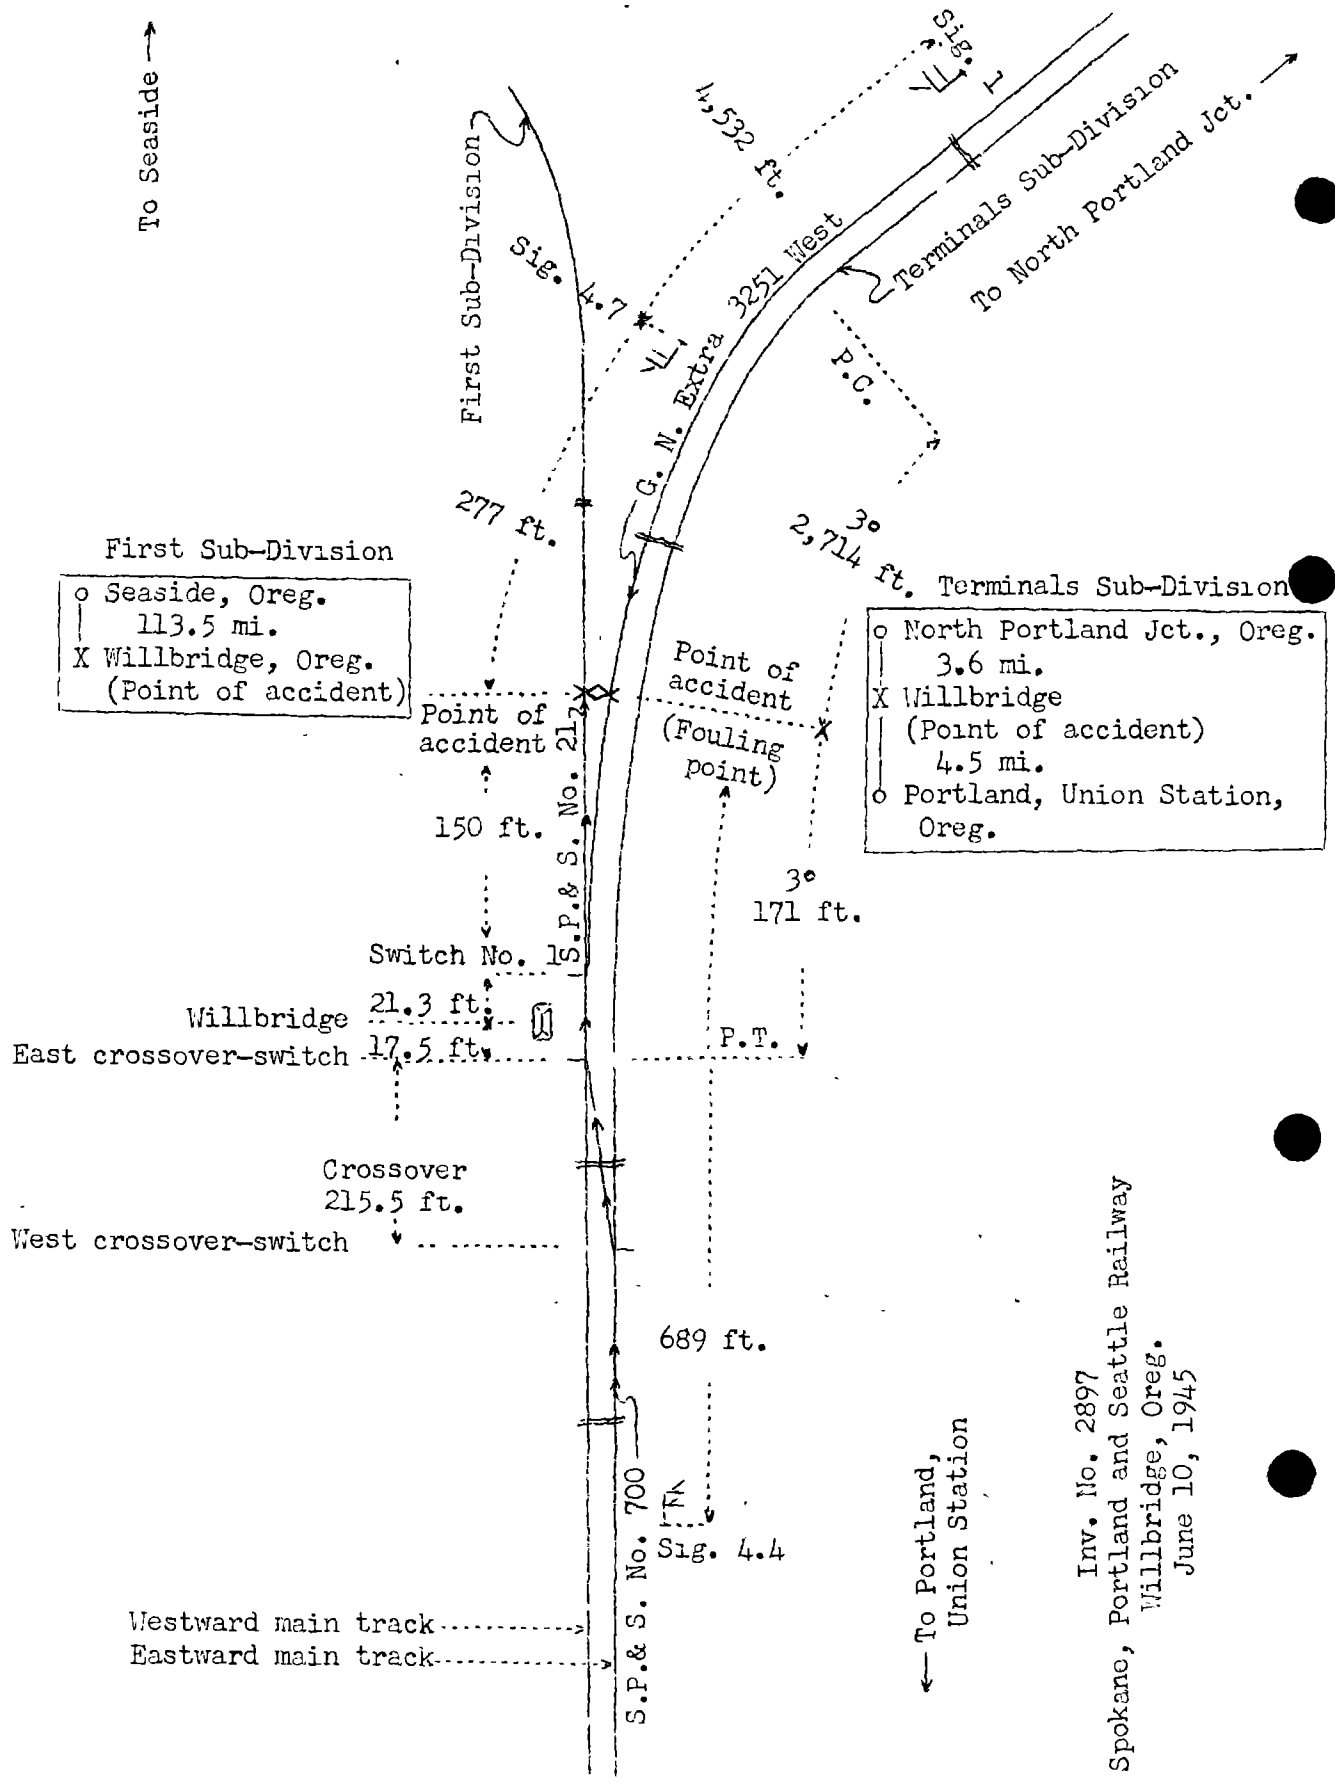
Inv. No. 2897  
 Spokane, Portland and Seattle Railway  
 Willbridge, Oreg.  
 June 10, 1945

This accident occurred on the First Sub-Division, which extends northwestward from Willbridge to Seaside, Oreg., 113.5 miles, a single-track line, and on that part of the Terminals Sub-Division extending southwestward from North Portland Jct. to Portland Union Station, Oreg., 8.1 miles, a double-track line. Trains of the Great Northern Railway are regularly operated over the Terminals Sub-Division. According to time-table directions, trains moving from Willbridge to Seaside are west-bound, and trains moving from North Portland Jct. to Portland Union Station are west-bound. Hereinafter, time-table directions will be used in this report. Within interlocking limits at Willbridge the line of the First Sub-Division converges with the westward main track of the Terminals Sub-Division. The switch which connects these tracks is 21.3 feet east of the tower, and is hereinafter referred to as switch No. 1. A facing-point crossover 215.5 feet long connects the eastward and westward main tracks of the Terminals Sub-Division. The east switch of the crossover is 17.5 feet west of the tower. Switch No. 1 and both switches of the crossover are hand-operated, and are in the charge of the operator at Willbridge. The accident occurred within interlocking limits 188.8 feet east of the tower, at the fouling point of the westward main track and the turnout of switch No. 1. On the First Sub-Division the main track is tangent 150 feet from switch No. 1 to the point of accident and some distance westward. The grade is 0.5 percent ascending westward. From the east on the Terminals Sub-Division there is a 3° curve to the left 2,714 feet to the point of accident and 171 feet westward. The grade on this line is 0.5 percent descending westward.

Interlocking home signal 4.4, governing movements from the eastward to the westward main tracks through the crossover and thence through switch No. 1 to the First Sub-Division, is 689 feet west of the point of accident. Semiautomatic signal 1 and interlocking home signal 4.7, governing west-bound movements on the westward main track of the Terminals Sub-Division, are respectively, 4,809 feet and 277 feet east of the point of accident. These signals are of the two-arm, upper-quadrant, semaphore type. The involved day aspects and corresponding indications and names of these signals are as follows:
