RAILROAD ACCIDENT INVESTIGATION

Report No 3782

SPOKANE, PORTLAND AND SEATTLE RAILWAY COMPANY

LEVEY WASH

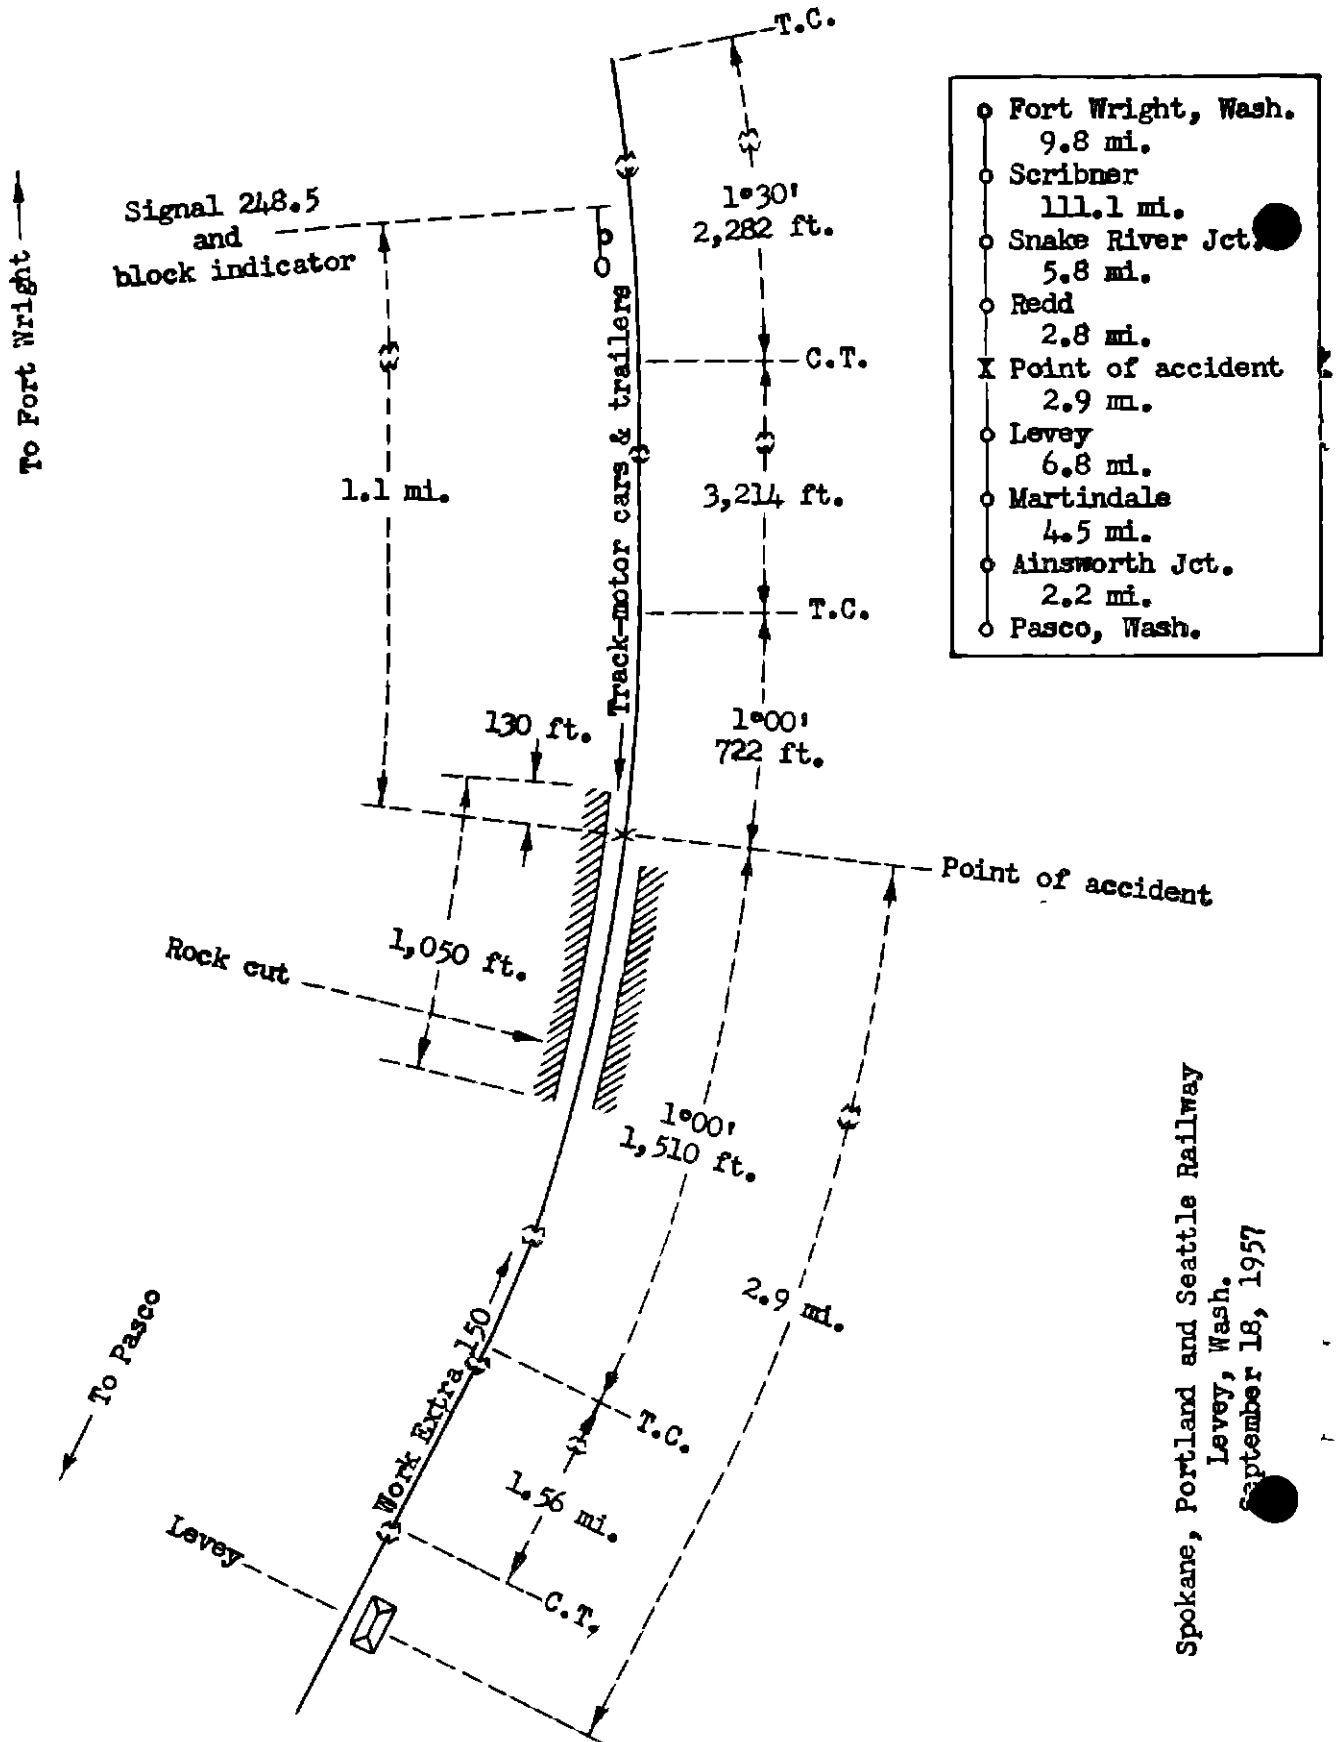
Spokane, Portland and Seattle Railway
 Levey, Wash.
 September 18, 1957

This accident occurred on that part of the Vancouver Division extending between Fort Wright and Pasco, Wash., 145.9 miles, a single-track line over which trains are operated by timetable, train orders, and an automatic block-signal system. The accident occurred on the main track at a point 129.5 miles west of Fort Wright and 2.9 miles east of the station at Levey. From the east there are, in succession, a 1°30' curve to the right 2,282 feet in length, a tangent 3,214 feet, a 1° curve to the right 722 feet to the point of accident and 1,510 feet westward. From the west there is a tangent 1.56 miles in length and the curve on which the accident occurred. The grade is level in the vicinity of the point of accident.

In the vicinity of the point of accident the track is laid in a rock cut extending westward from a point 130 feet east of the point of accident throughout a distance of 1,050 feet. The north wall of the cut is 13 feet north of the centerline of the track and rises to a height of about 16 feet. The range of vision is materially restricted in the vicinity of the point of accident because of the rock cut and curvature of the track.
