BUREAU OF SAFETY

REPORT NO. 1939

Railroad: St. Louis & Southwestern and
Louisiana & Arkansas

Kind of accident: Side collision

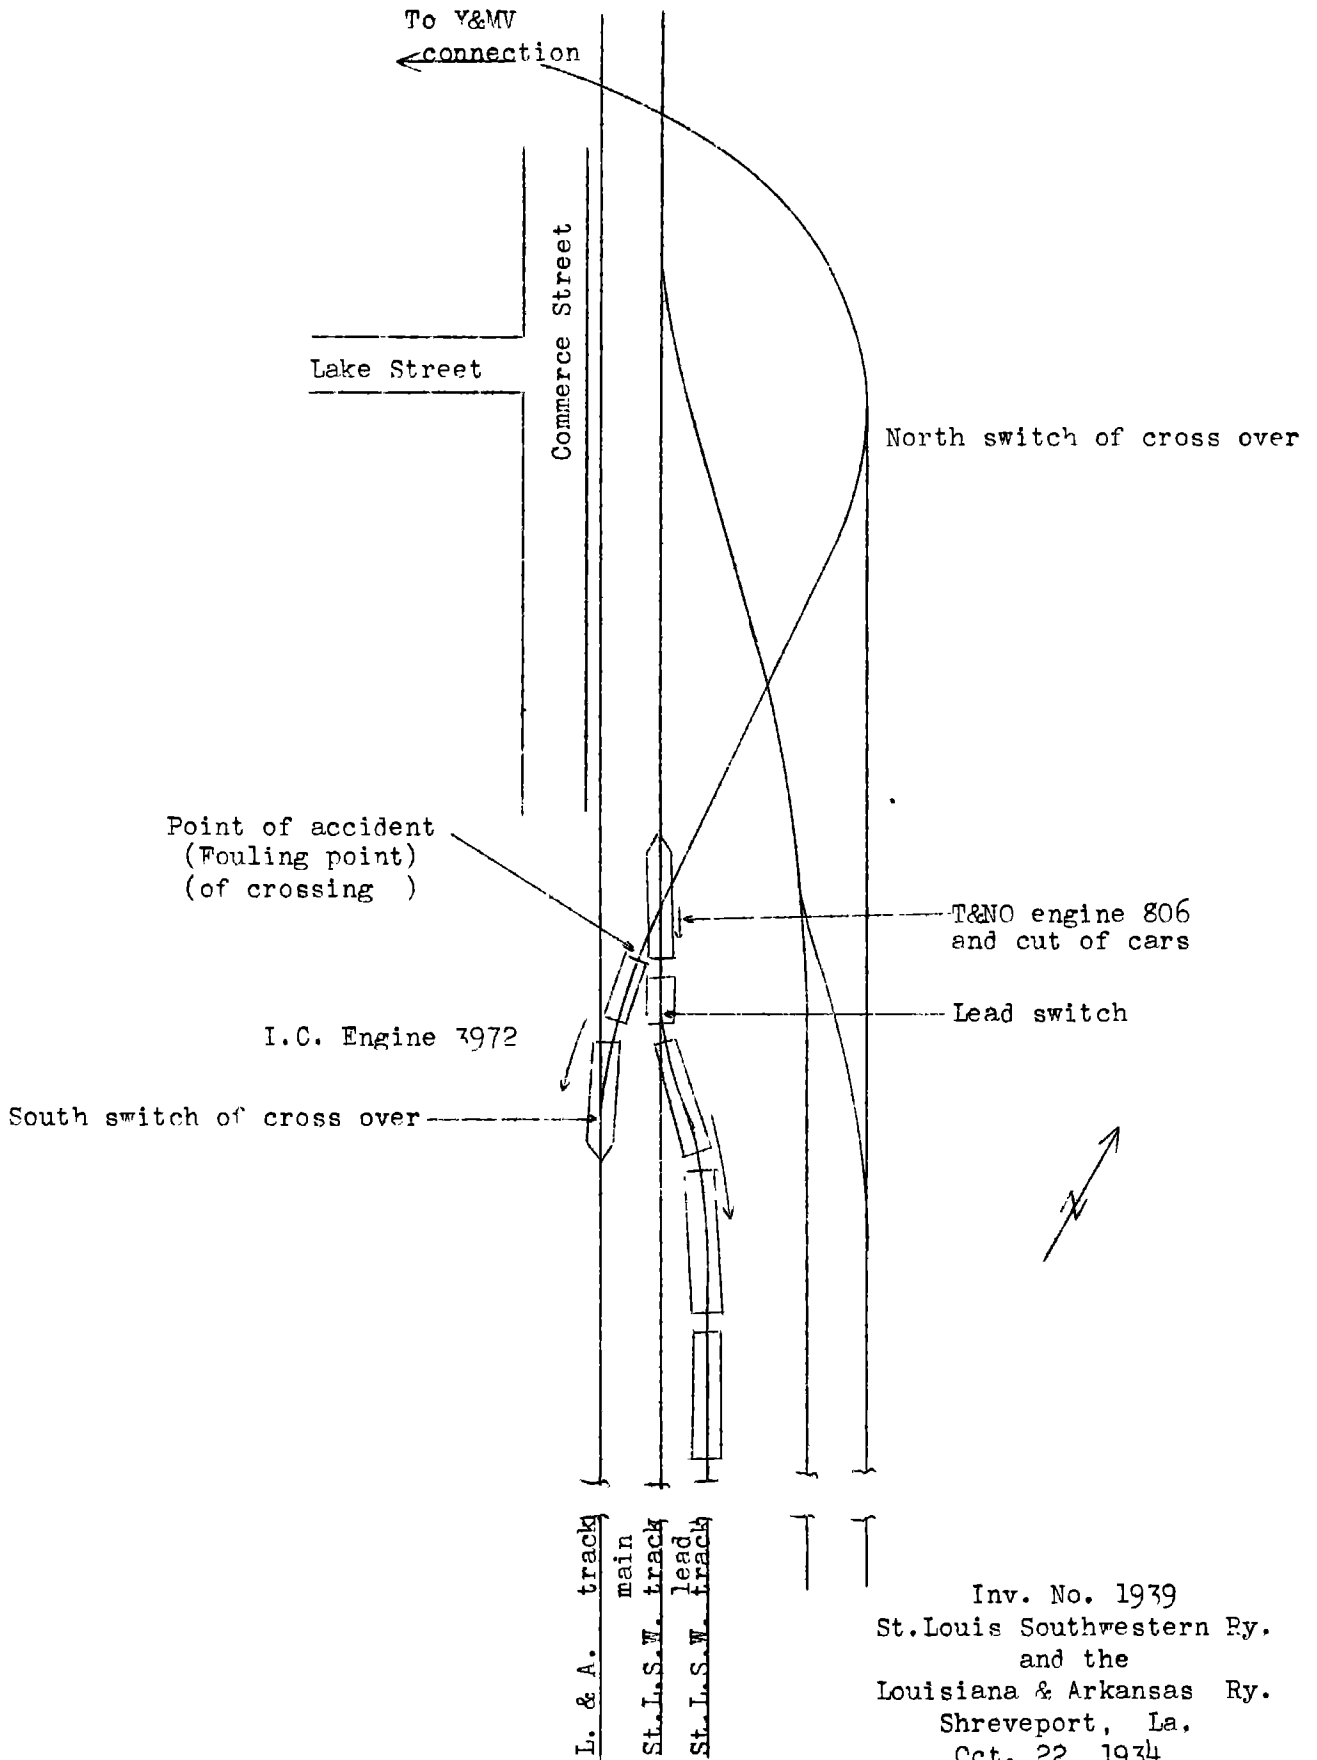
Inv. No. 1939
 St. Louis Southwestern Ry.
 and the
 Louisiana & Arkansas Ry.
 Shreveport, La.
 Oct. 22, 1974

This accident occurred within yard limits at a crossing of the tracks of the StLSW and L&A; in this vicinity movements over both railways are governed primarily by the book of rules and special instructions. In the immediate vicinity of the point of accident the StLSW main track extends northwest and southeast and parallels the L&A on the east, and the intersection is formed by a long cross-over, 362 feet in length, which extends north and south across the StLSW main track and joins the L&A with the Y&MV connection. The south switch of the cross-over is a facing-point switch for northward movements and leads off the L&A to the east, with a low switch stand located on the east side of the track which displays a red indication when the switch is open; the accident occurred just north of the south switch of this cross-over, at its fouling point with the crossing over the StLSW track.

At a point 44 feet south of the center line of the crossing the StLSW lead track connects with its main track, the lead-track switch being a trailing-point switch for northward movements and the lead track paralleling the main track on the east. Shreveport yard is located south of the intersection involved; approaching the crossing from that direction on either railway, the track is tangent for a considerable distance.
