INVESTIGATION NO. 2859
THE ST. LOUIS SOUTHWESTERN RAILWAY COMPANY
AND
THE CHICAGO, ROCK ISLAND & PACIFIC RAILWAY COMPANY
REPORT IN RE ACCIDENT
AT BRINKLEY, ARK., ON
JANUARY 13, 1945

Kind of accident: Side collision

Accident at Brinkley, Ark., on January 13, 1945, caused by
failure of the Chicago, Rock Island & Pacific Railway
Company to enforce its rules governing the movement
of trains approaching a railroad crossing at grade.

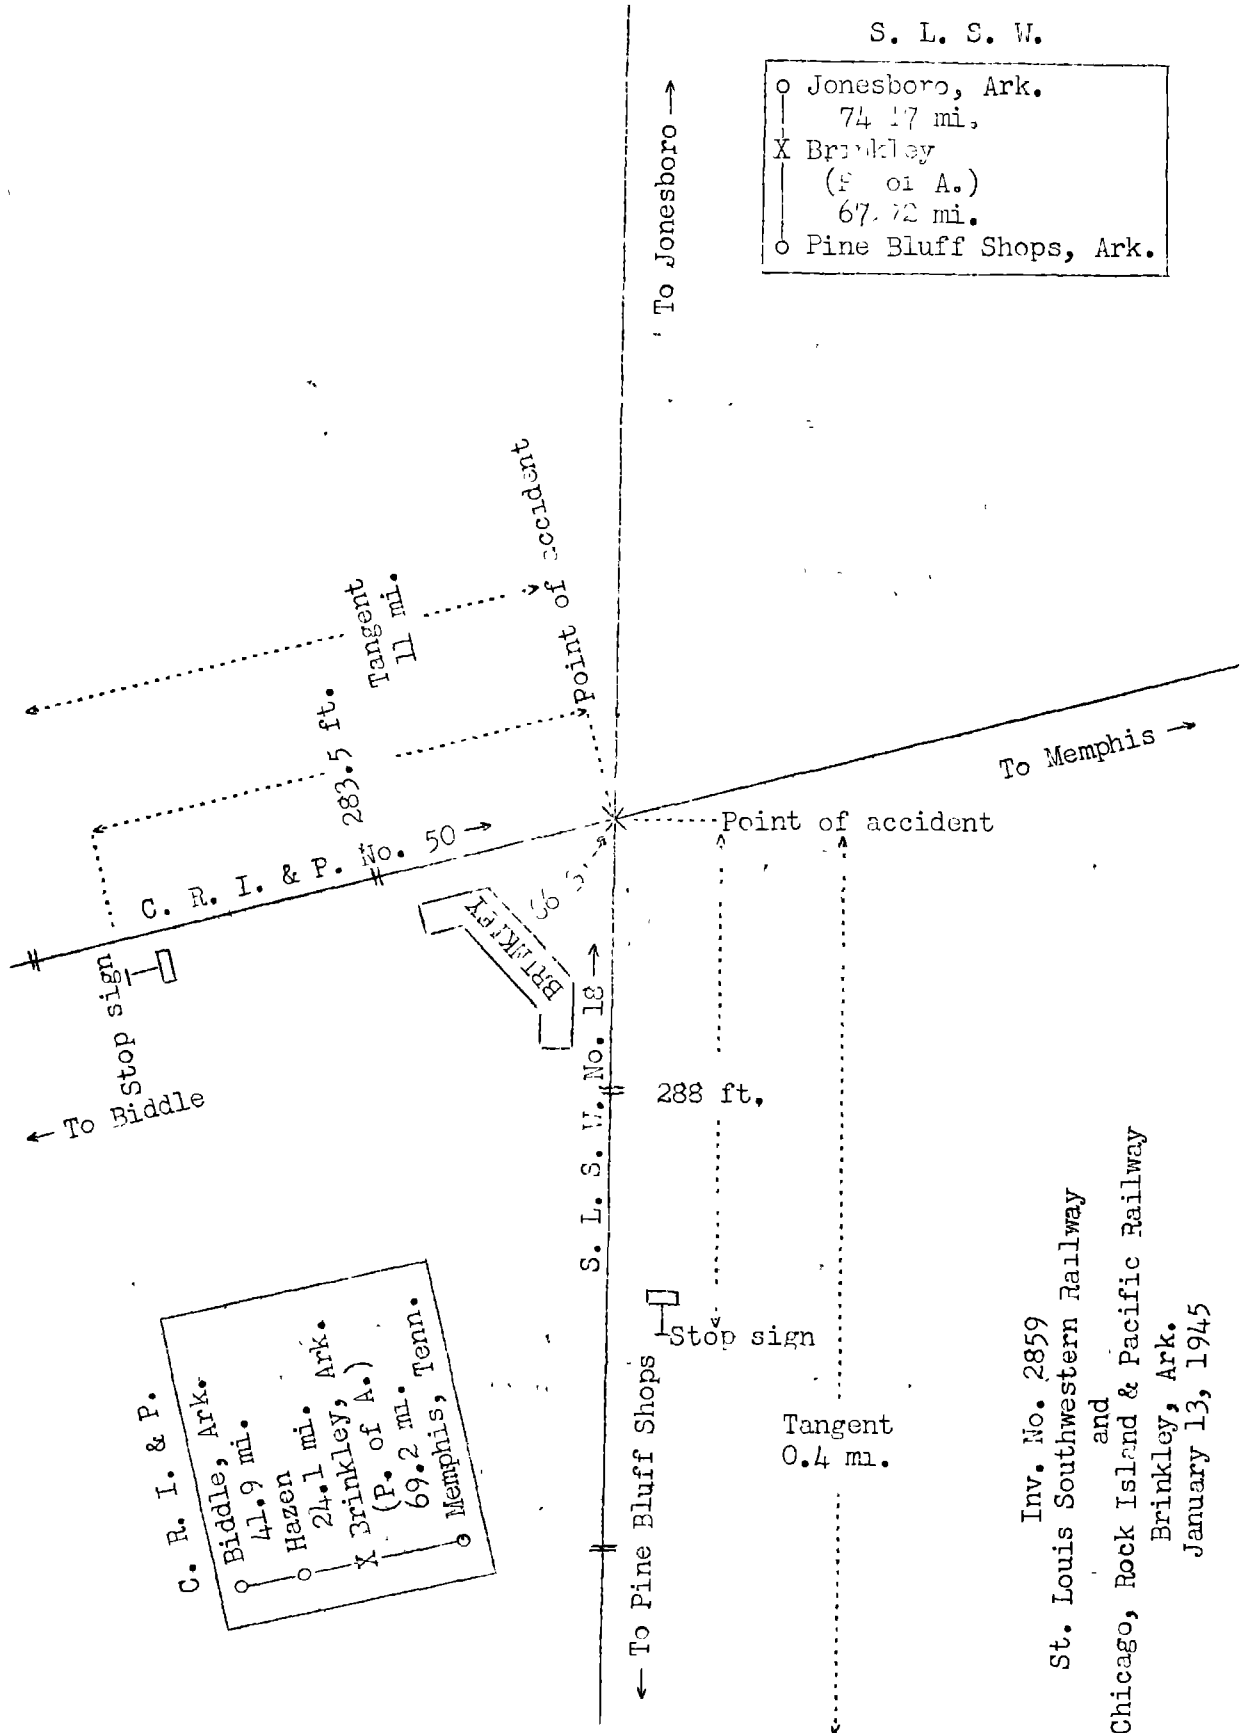
Inv. No. 2859
 St. Louis Southwestern Railway
 and
 Chicago, Rock Island & Pacific Railway
 Brinkley, Ark.
 January 13, 1945

This accident occurred at an intersection of the St. Louis Southwestern Railway, hereinafter referred to as the S. L. S. W., and the Chicago, Rock Island & Pacific Railway, hereinafter referred to as the C. R. I. & P. Brinkley was located on that part of the Northern Division of the S. L. S. W. designated as the Jonesboro Subdivision and extending northward from Pine Bluff Shops to Jonesboro, Ark., 141.89 miles, and on that part of the Arkansas Division of the C. R. I. & P. designated as Subdivision 52 and extending eastward from Biddle, Ark., to Memphis, Tenn., 135.2 miles. Brinkley was 67.72 miles north of Pine Bluff Shops and 66 miles east of Biddle. In the vicinity of Brinkley both were single-track lines over which trains were operated by timetable and train orders. There was no block system in use on either line, and no interlocking at this intersection. The main tracks intersected at an angle of 69°34' at a point 66.3 feet east of the station, which was used by both lines and located in the southwest angle of the intersection. On the S. L. S. W. the main track was tangent throughout a distance of 0.4 mile south of the crossing and a considerable distance northward. The grade was practically level. On the C. R. I. & P. the main track was tangent throughout a distance of 11 miles west of the crossing and a considerable distance eastward. The grade was 0.2 percent descending eastward.

Stop signs governing movement of north-bound trains on the S. L. S. W. and east-bound trains on the C. R. I. & P. were located, respectively, 288 feet south and 283.5 feet west of the crossing.
