NATIONAL TRANSPORTATION SAFETY BOARD

RAILROAD ACCIDENT REPORT

ST. LOUIS SOUTHWESTERN RAILWAY COMPANY
FREIGHT TRAIN DERAILMENT AND
RUPTURE OF VINYL CHLORIDE TANK CAR
LEWISVILLE, ARKANSAS
MARCH 29, 1978

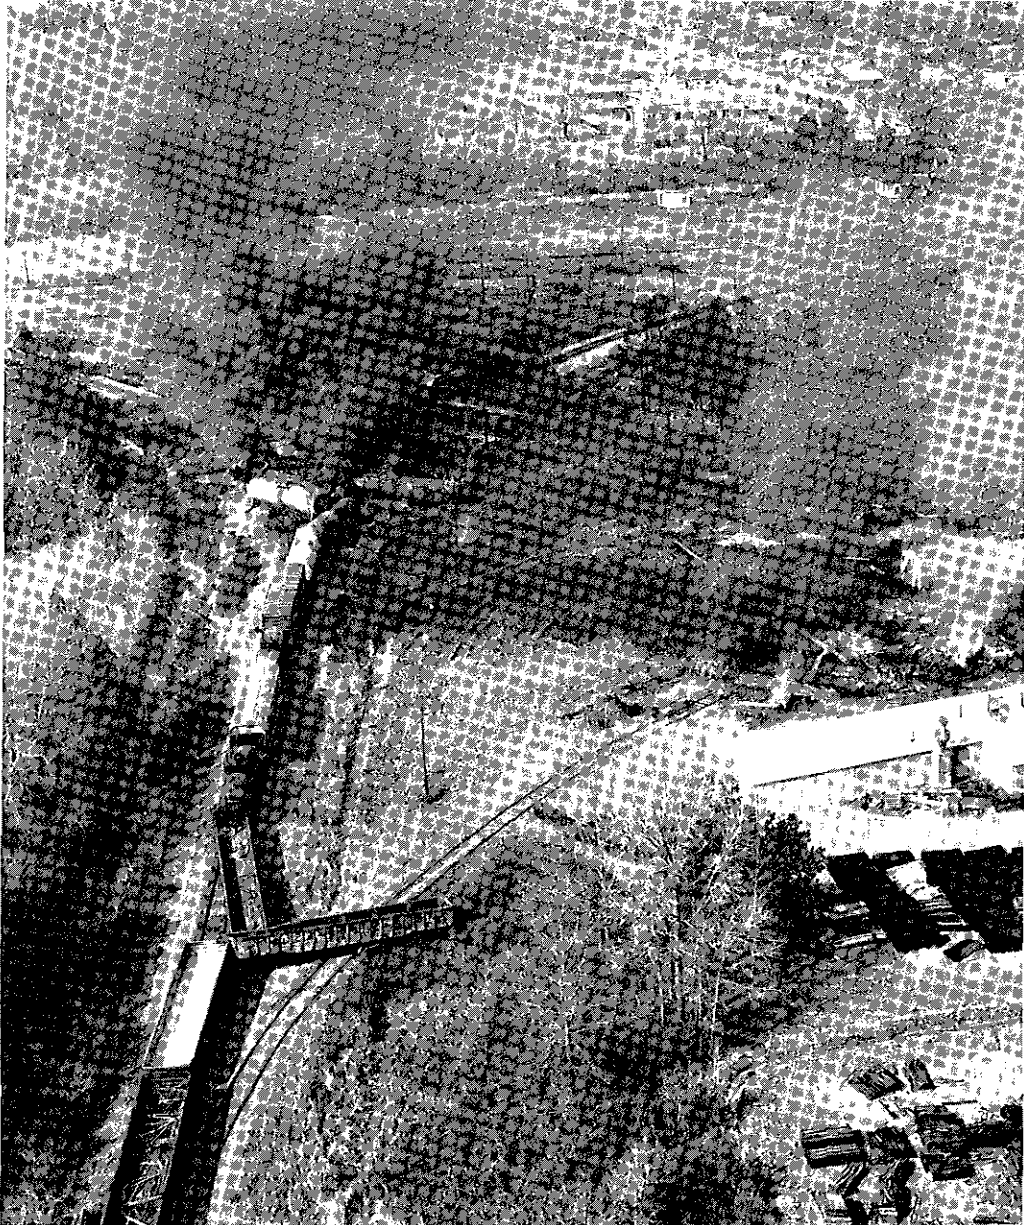
The initial derailment occurred about 100 feet into the wye curve near the southwest edge of the city. (See figure 2.) The J&P Petroleum Products, Inc., Company (J&P) was adjacent to the wye on the east side of the track. The business district and main residential areas began about 1,000 feet northwest of the wye.

As the lead locomotive unit turned over, the following 3 locomotive units and 16 cars derailed. The 20th to 23rd, 26th to 42nd, and 86th to 94th cars also derailed. The body of the 13th car struck and ruptured the head of the 12th car, a tank car containing vinyl chloride. Escaping vinyl chloride ignited with an explosive force, engulfing the locomotive, the 1st through 16th cars, and a J&P shed and storage area. The 29th car, a tank car containing tetrahydrofuran, was also leaking at an underbody valve. Its contents poured into an adjacent swampy area without igniting.

Figure 2. Aerial view of accident site.

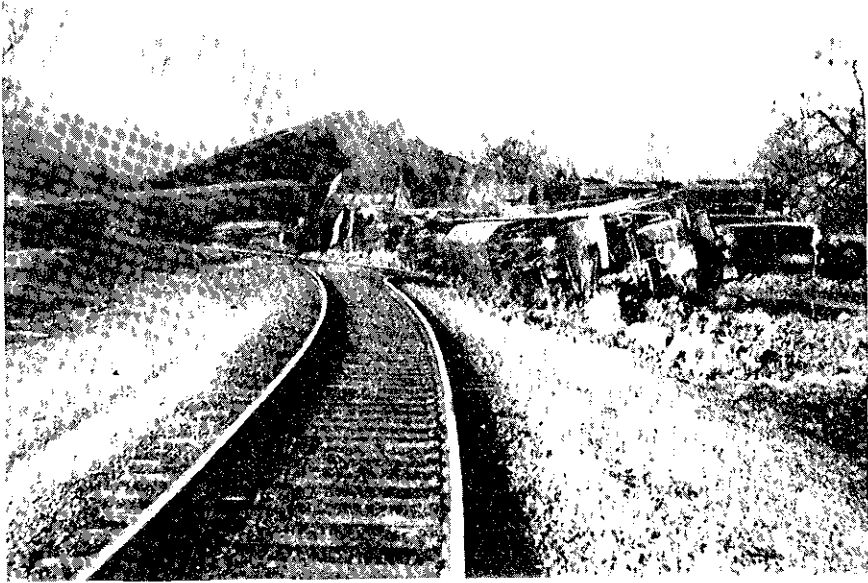
Two of the four locomotive units were destroyed, and two were heavily damaged. (See figure 3.) Twenty-two of the 43 derailed cars were destroyed and the others were damaged. The 12th car's trailing head was dented and its tank torn on the left side at the junction of the trailing head and shell. The tear was 82 inches long at the weld line between the 7 and 10 o'clock positions. (See figure 4.) About 500 feet of track, including one switch, were destroyed. An additional 1,070 feet of track were damaged.

Figure 3. Track and lead locomotive unit.

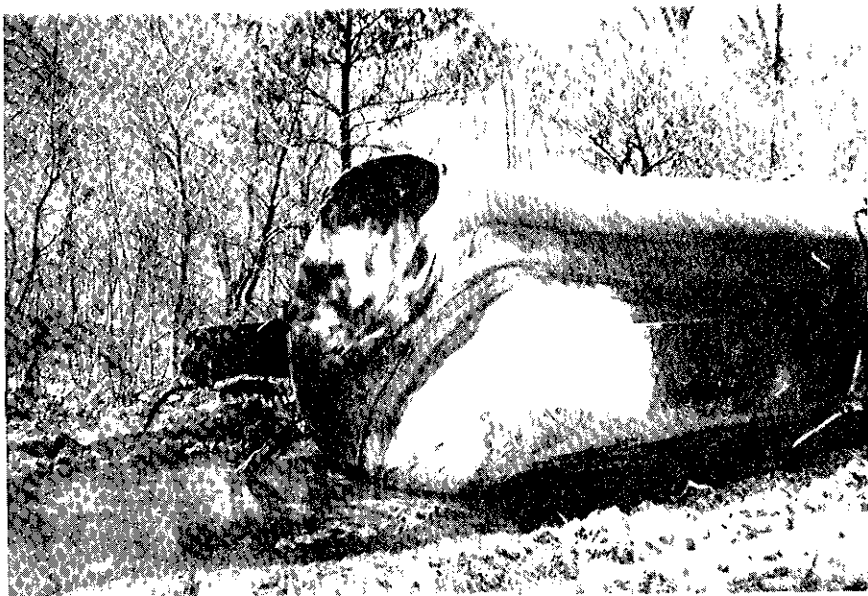
Figure 4. Ruptured end of tank car.

When the body of the 13th car struck the unprotected tank head of the 12th car, the flammable, compressed vinyl chloride quickly pressure-vented through the 82-inch tear in the tank. A head shield may have

prevented the tear by reducing the impact on the tank made by the following car. If the cars had been equipped with top and bottom shelf couplers, they might have stayed in line, further reducing the probability of collision. The Safety Board discussed these safety corrections--head shields and top and bottom shelf couplers--in its report entitled "Analysis of Proceedings of the National Transportation Safety Board Into Derailment and Hazardous Materials, April 4-6, 1978" issued June 23, 1978. This accident further substantiates the need for expeditious completion of the retrofit for DOT 112A and 114A tank cars under the deadlines imposed by the Materials Transportation Bureau's Docket HM-144 published July 13, 1978.
