NATIONAL TRANSPORTATION SAFETY BOARD

RAILROAD ACCIDENT REPORT

**DERAILMENT OF ST. LOUIS
SOUTHWESTERN RAILWAY COMPANY
(COTTON BELT) FREIGHT TRAIN
EXTRA 4835 NORTH AND
RELEASE OF HAZARDOUS MATERIALS
NEAR PINE BLUFF, ARKANSAS
JUNE 9, 1985**

NTSB/RAR-86/04

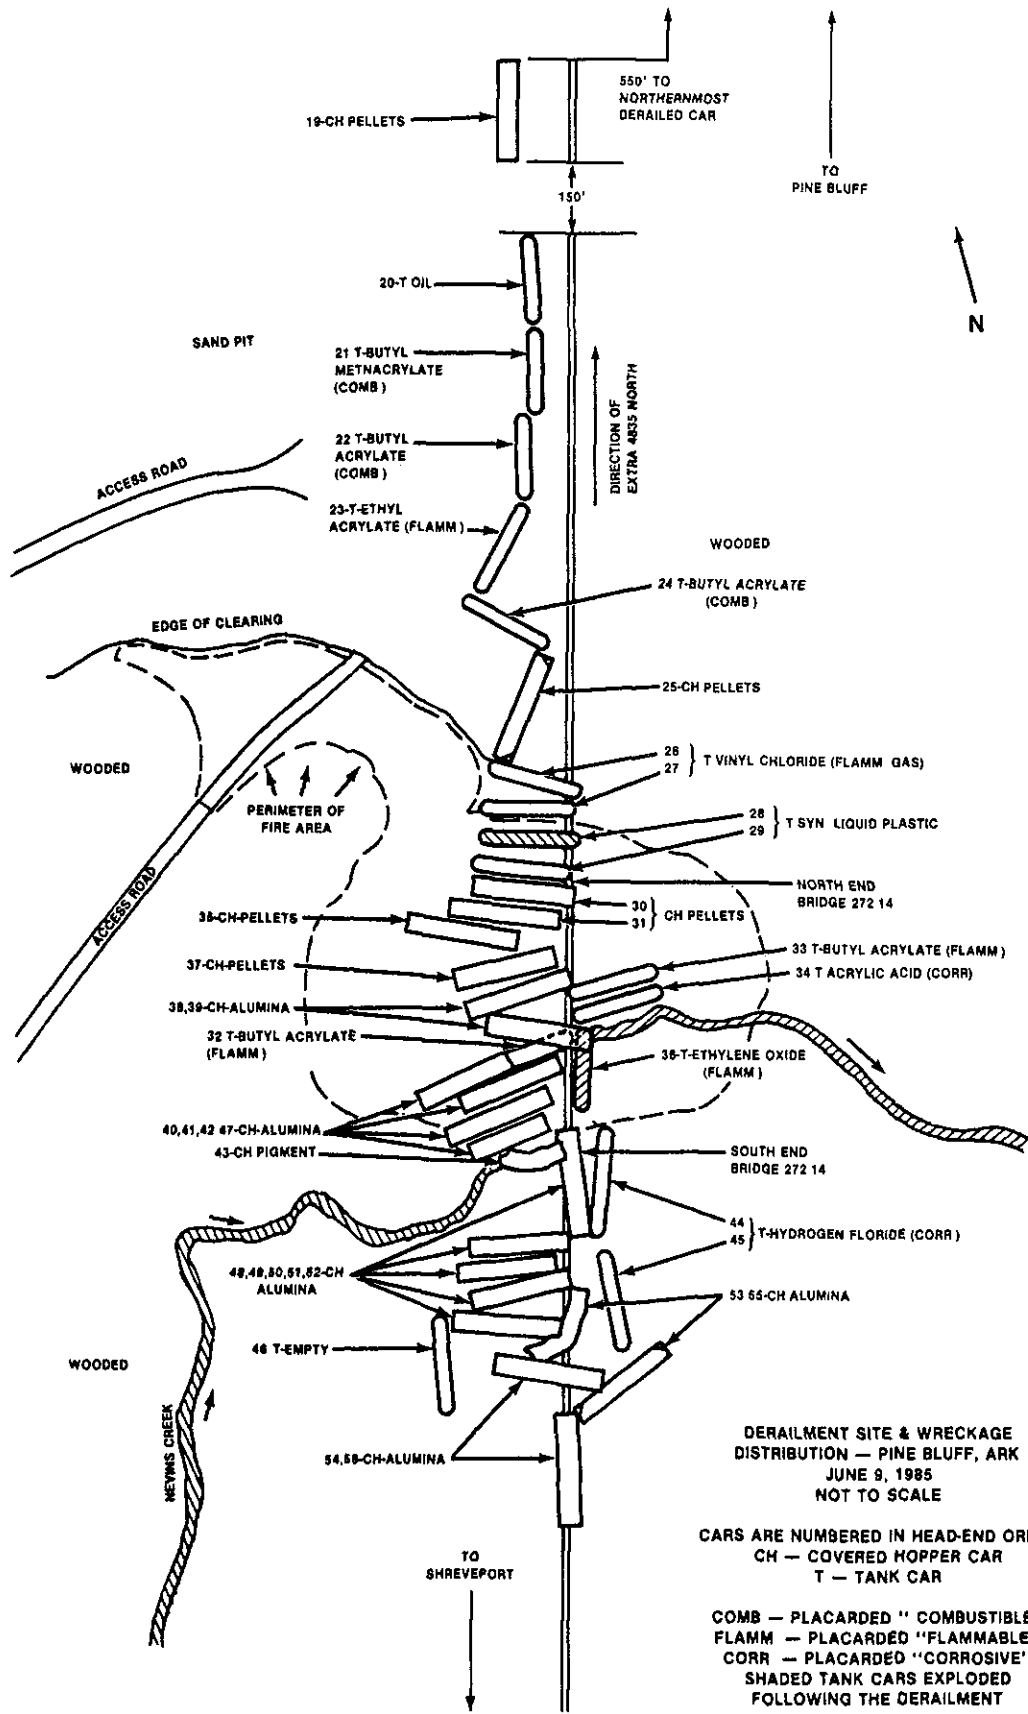
Figure 1.--Plan view of accident site and wreckage distribution.

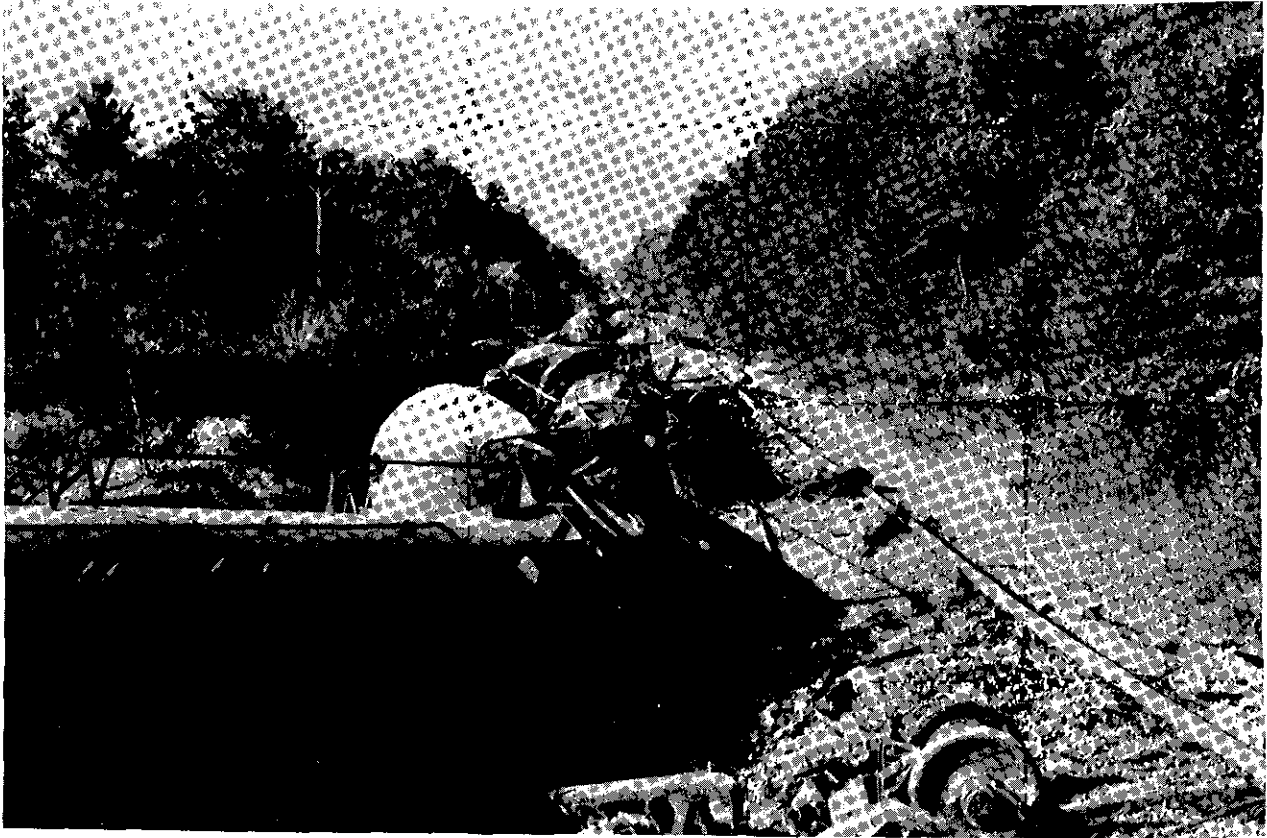
As the locomotive units of Extra 4835 North passed over the kink, they rocked laterally but did not derail. The first 25 cars in the train also passed safely over the kink. However, when the locomotive was about 1/4-mile north of Bridge 272.14 and moving at about 41 mph, the train brakes went into emergency and cars began derailling at the bridge. The 26th through the 56th cars from the train's head end derailed at and immediately south of the bridge. As a result of the derailment, the west rail was turned over north of Bridge 272.14, and this caused the derailment of the 15th through the 25th head cars which had passed safely over the kink in the track. (See figure 1.) These 11 cars included 8 loaded tank cars, all but 2 of which were placarded and contained hazardous chemical commodities. None of these tank cars was punctured or ruptured, and although a tank car lost some of its cargo of hydrogen peroxide solution through a dome leak, there was no outbreak of fire with any of these cars. (See figure 2.)

Figure 2.--View facing north showing derailed tank cars that remained in line with the track north of the general derailment area at Bridge 272.14. All of these cars had top-and-bottom shelf couplers, and none of them was ruptured or breached.

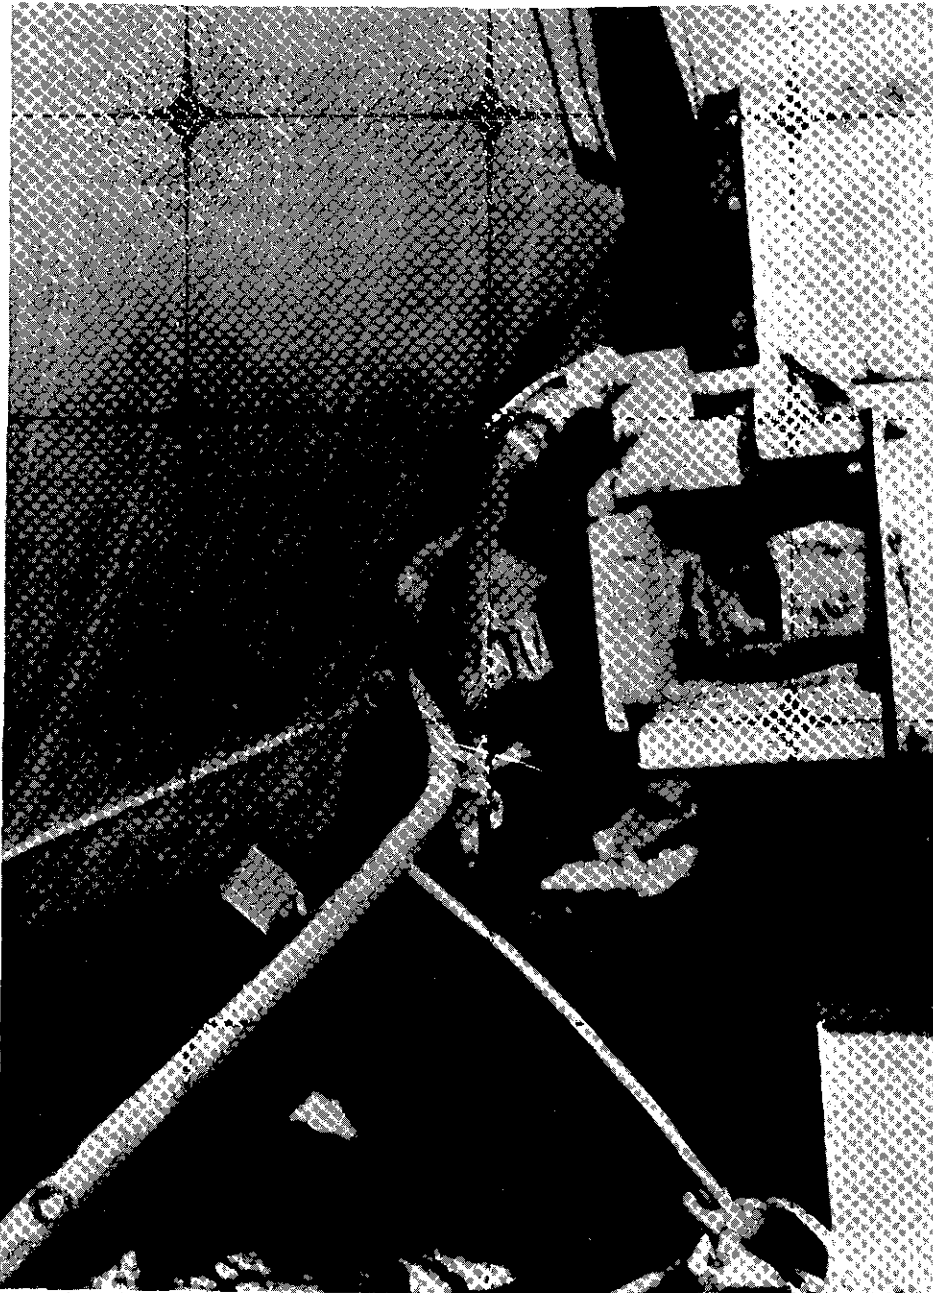
Figure 3.--Conventional Type E coupler of a covered hopper car imbedded in the side of a vinyl chloride tank car. The strike was absorbed by the outer jacket and insulation, and there was no damage to the tank shell.

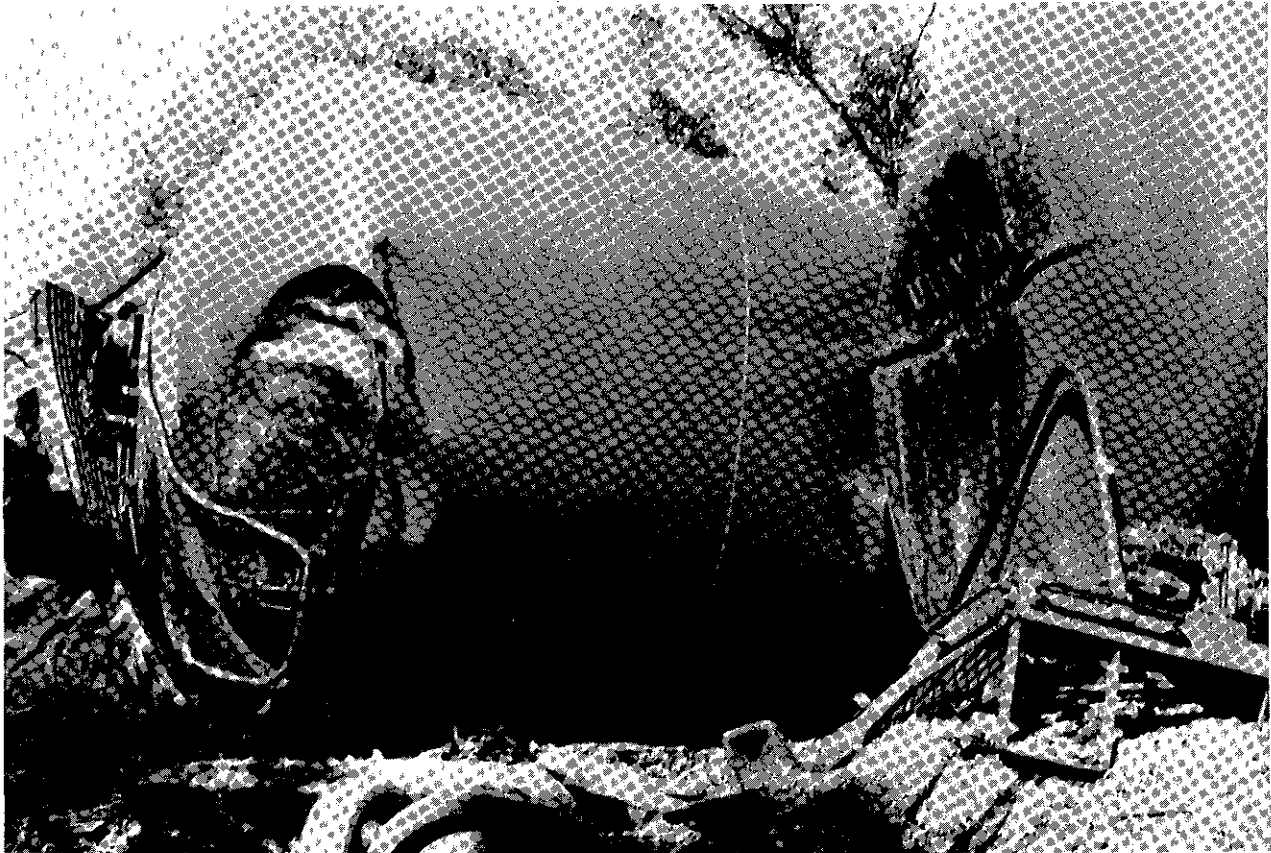
Figure 4.--Heads of the two jacket-insulated tank cars loaded with vinyl chloride showing damage from impacts that was absorbed by the outer jacket and insulation material.

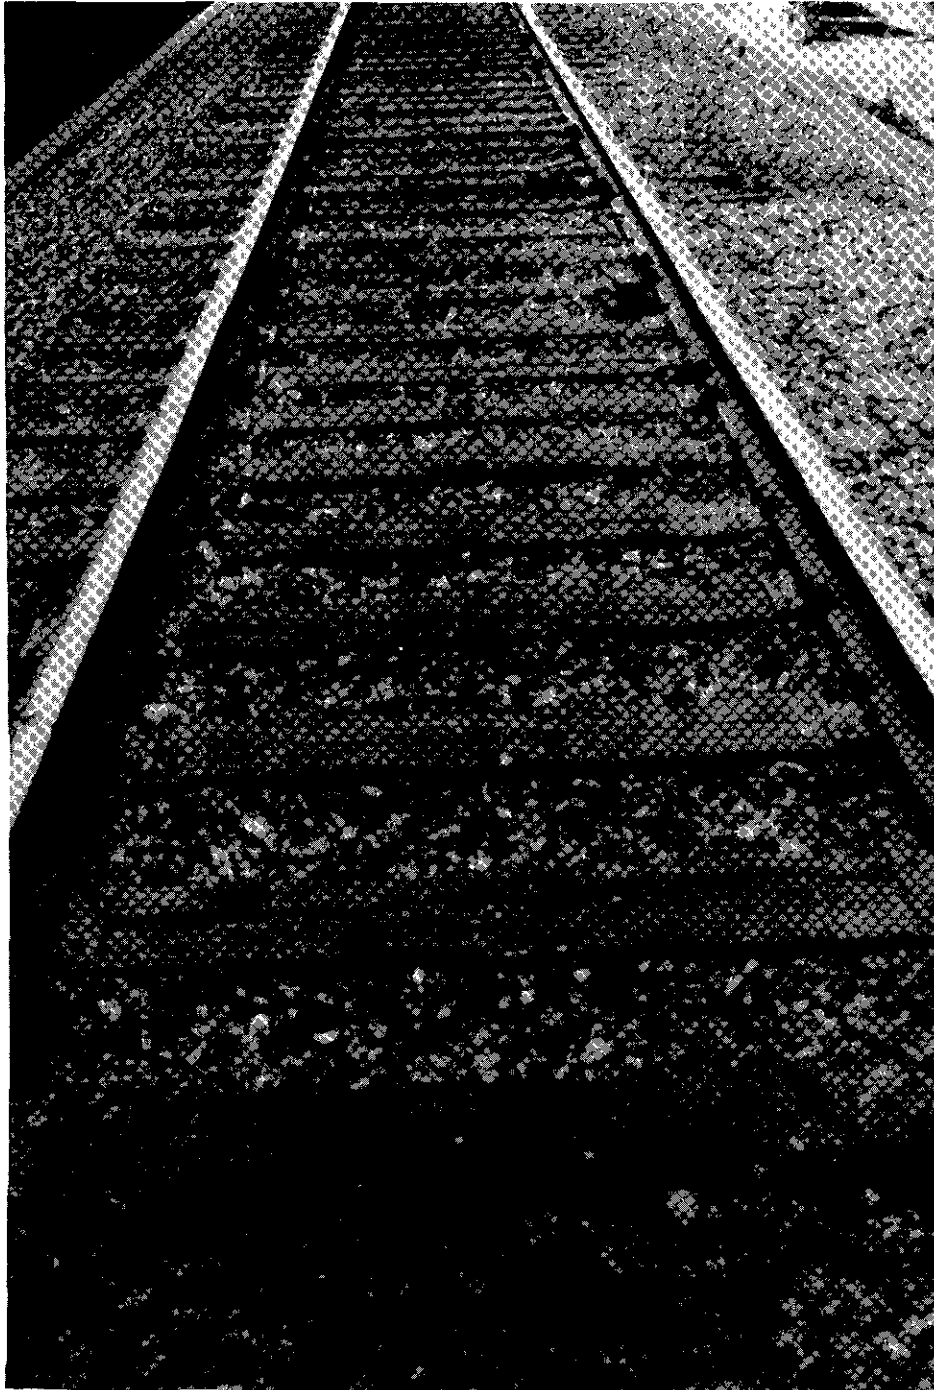
Figure 5.--The main track at Bridge 272.29 facing north toward the derailment area. Note the irregular distribution of rail anchors that was typical of the 112-pound CWR section approaching the accident location from the south.

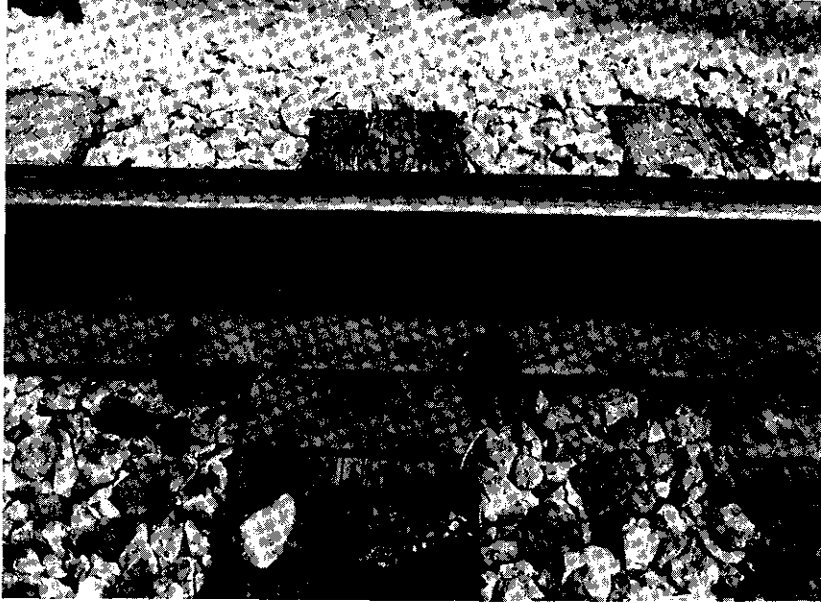
Figure 6.--East rail of the 112-pound CWR section south of the derailment site showing the lack of a rail-holding spike on the gauge side of the tieplate. Only one anchor is bearing against the tie and there is a rub mark on the base of the rail where it moved to the left (north) under this anchor. Positions of the anchors in relation to the tie may have been reversed before the accident.

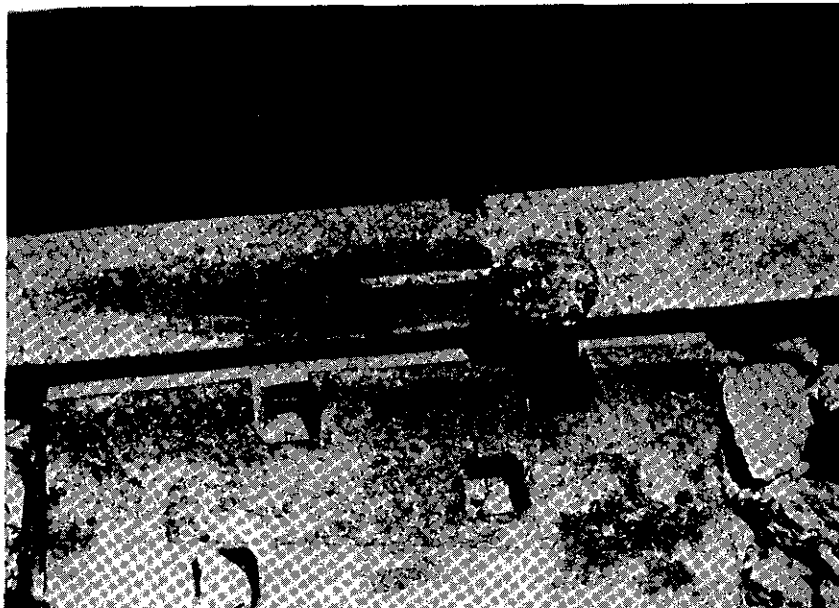
In the undamaged section of tangent track south of the derailment area, there appeared to be no set spiking pattern, although most tieplates had two rail-holding spikes. Some tieplates had one or two plate-holding spikes, but many had none. Two tieplates were missing in the 400 feet of track immediately south of the derailment area. In this section ties were spaced on 19-inch centers, and there were 47 rail anchors to retard northward rail movement per 100 ties; 25 were applied to the west rail and 22 were applied to the east rail. (See figure 5.) About 40 percent of these anchors were not bearing against ties. (See figure 6.) Fresh rub marks made by spike heads on the base of the rail indicated the rails had moved 3 to 4 inches northward. (See figure 7.)

Figure 7.--Fresh rub mark on the base of the east rail 330 feet south of the derailment site caused by the rail moving to the left (north) under the spike head.

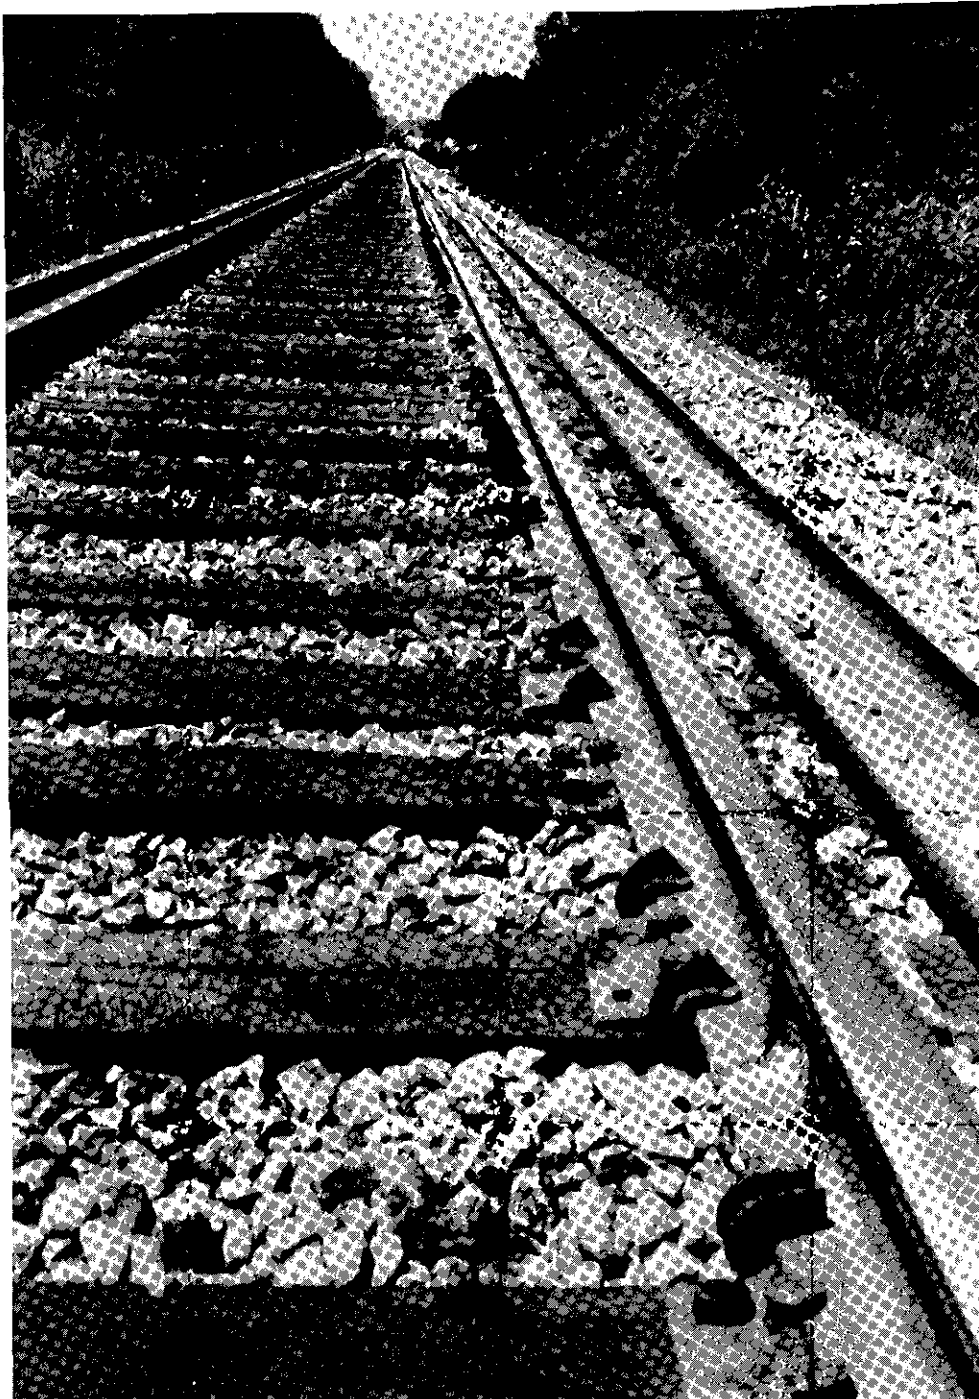
Figure 8.--The main track viewed facing south toward the derailment site at milepost 271.8 showing the field weld marking the location where the west rail was cut on May 7, 1985. Every second tie has been box anchored. New 136-pound rail to replace the existing 112-pound CWR is laying on the tie ends ready to be installed.
