REPORT OF THE DIRECTOR
BUREAU OF SAFETY

ACCIDENT ON THE
ST. LOUIS, BROWNSVILLE & MEXICO RY.

BROWNSVILLE, TEX.

INVESTIGATION NO. 2062

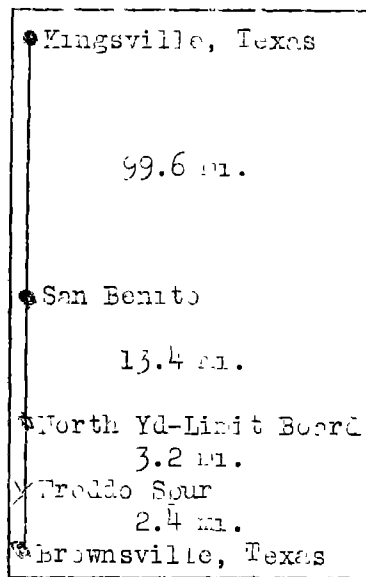
Inv. No. 2062
St. Louis, Brownsville & Mexico Ry.
Brownsville, Texas
April 28, 1936

Switch engine 9582, headed north, with four cars coupled behind, was in charge of Engine Foreman Hill and Engineman Wagner. It backed in at the switch leading to Freddo spur and stopped on track 3, the main-line switch being left open and unattended. While standing at this point, arranging to perform switching, it was struck by Extra 1024.

Point of accident
