REPORT NO 3542
ST. LOUIS-SAN FRANCISCO RAILWAY COMPANY
IN RE ACCIDENT
NEAR EDWARD, KANS , ON
OCTOBER 24, 1953

Date. October 24, 1953

Kind of accident: Derailment

Accident near Edward, Kans., on October 24, 1953, caused
by a broken rail.

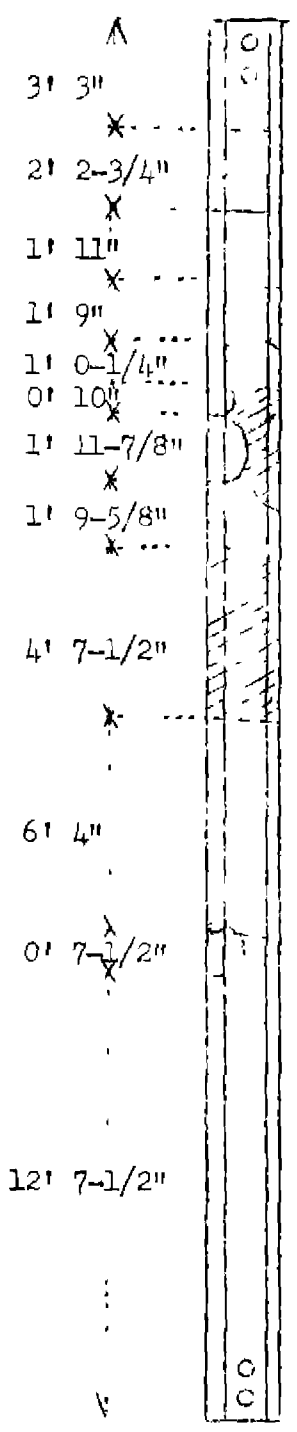
Sketch showing broken rail-east side of track

Shaded portions not recovered

After the accident occurred a broken rail was found in the east side of the track. This rail was rolled by the Tennessee Coal and Iron Division of the United States Steel Company in August, 1930. It was broken into many pieces, 12 of which were recovered. The first three breaks occurred at points, respectively, 3 feet 3 inches, 5 feet 5-3/4 inches, and 7 feet 4-3/4 inches south of the receiving end of the rail. Each of these breaks occurred between ties. Examination of the rail disclosed that prior to the time of the accident transverse fissures had existed in the head of the rail at the first break and at the third break. The fissure at the first break covered 10 to 12 percent of the area of the head, and the fissure at the third break covered 18 to 20 percent of the area of the head. Neither fissure extended to the surface of the rail, and neither could be detected by visual inspection. Apparently the rail was broken under the front portion of No. 105. After the first break occurred, evidently the broken end was struck with sufficient force to cause the second and third breaks, and a broken piece of rail was dislodged.
