INVESTIGATION NO. 2576  
THE ST. LOUIS-SAN FRANCISCO RAILWAY COMPANY  
REPORT IN RE ACCIDENT  
AT GRANBY, MO., ON  
MARCH 7, 1942

Kind of accident: Head-end collision

Accident at Granby, Mo., on March 7, 1942, caused by an inferior train occupying the main track on the time of an opposing superior train, and by an inadequate block-signal system.

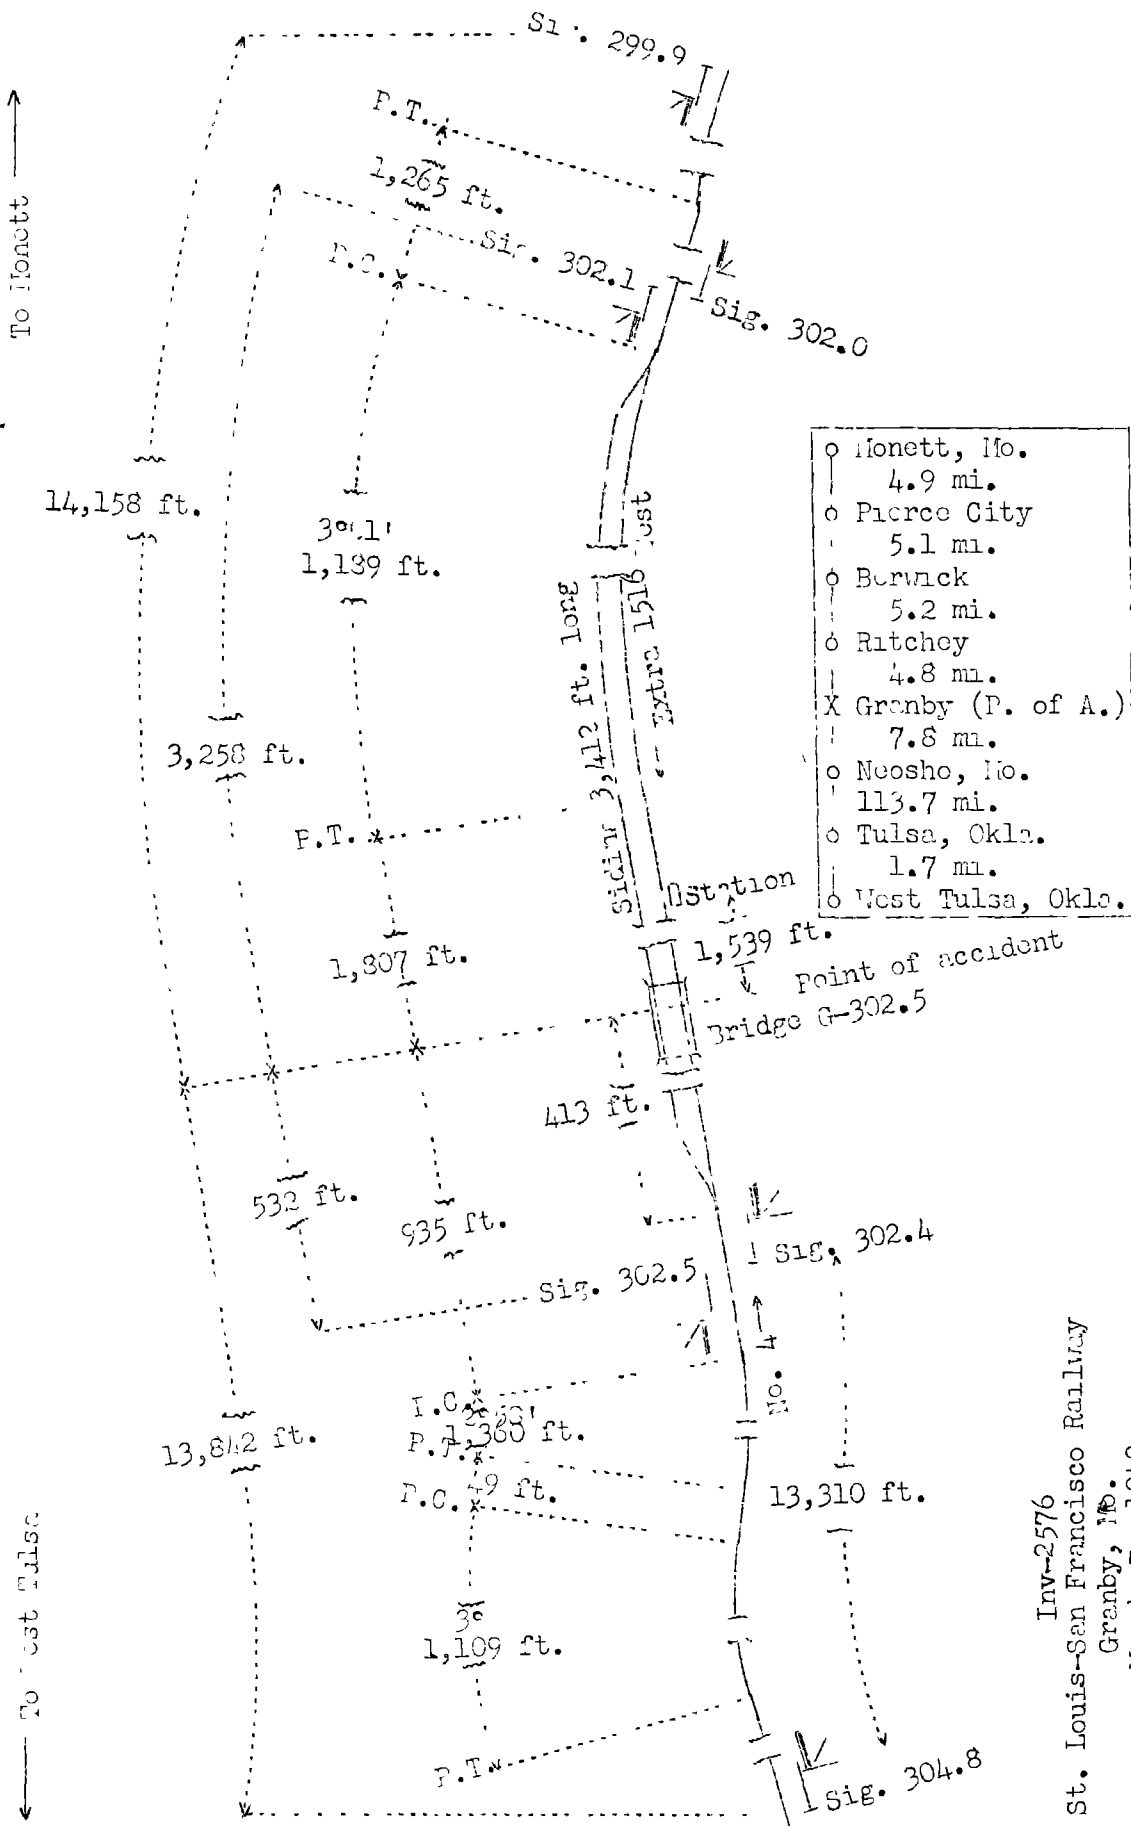
Inv-2576  
 St. Louis-San Francisco Railway  
 Granby, Mo.  
 March 7, 1942

Bridge G-302.5, which spans a dry wash, is a 14-panel, open-deck, pile trestle, 190 feet in length, and has a maximum height of 8 feet. The accident occurred 41.6 feet west of the eastern end of this bridge.

Signals 299.9, 302.1 and 302.5, governing west-bound movements, are located, respectively, 14,158 and 3,258 feet east and 532 feet west of the point of accident. Signals 304.8, 302.4 and 302.0, governing east-bound movements, are located, respectively, 13,842 and 532 feet west and 3,258 feet east of the point of accident. The controls of these signals are so arranged that when an east-bound train reaches a point 26,110 feet west of signal 302.5, signals 302.5 and 302.1 display yellow, and signal 299.9 displays green; when the train reaches a point 16,560 feet west of signal 302.5, signals 302.5, 302.1 and 299.9, respectively, display red, yellow and green; and when the train reaches a point 3,860 feet west of signal 302.5, signals 302.5 and 302.1
