INTERSTATE COMMERCE COMMISSION

REPORT OF THE DIRECTOR OF THE BUREAU OF SAFETY CONCERNING
AN ACCIDENT WHICH OCCURRED ON THE ST. LOUIS-SAN FRANCISCO
RAILWAY AT LOWELL, ARK., ON JUNE 2, 1932.

July 18, 1932.

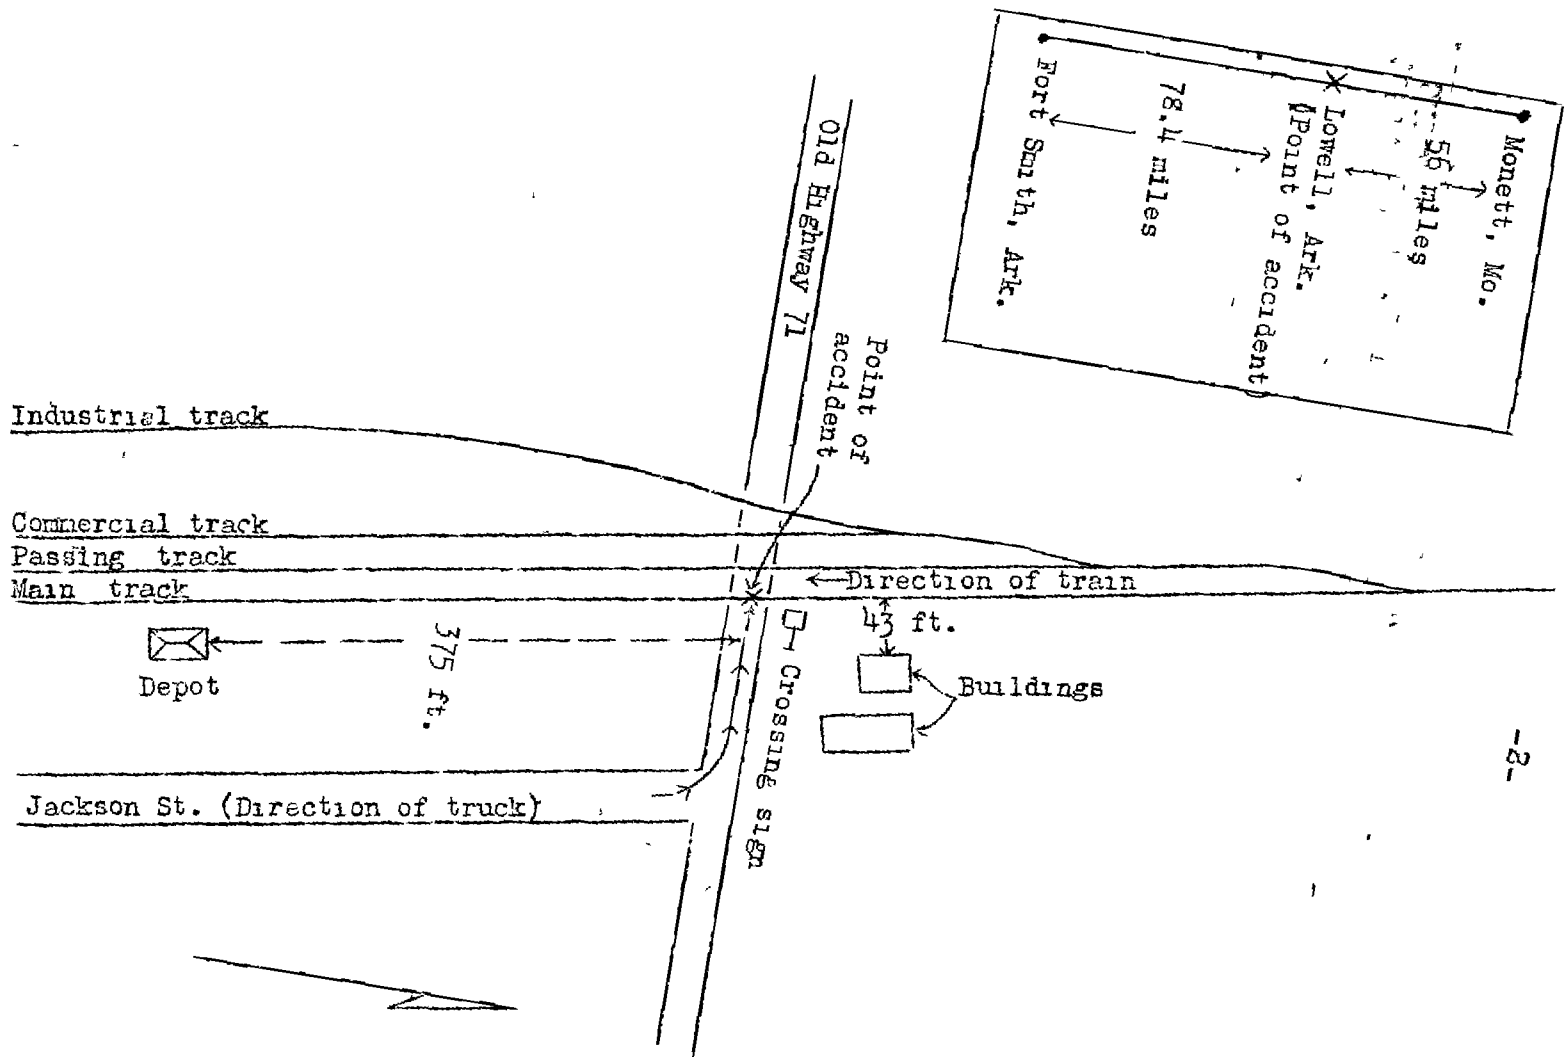
Inv. No. 1765
 St. Louis - San Francisco Ry.
 Lomell, Ark.
 June 2, 1932.

From the driver's seat of a truck a view of an approaching southbound train can be had for a distance of 1,219 feet on reaching a point on the highway 50 feet east of the main track.
