INVESTIGATION NO. 3105
ST. LOUIS-SAN FRANCISCO RAILWAY COMPANY
REPORT IN RE ACCIDENT
NEAR MANSFIELD, MO., ON
MAY 30, 1947

Railroad: St. Louis-San Francisco
Date: May 30, 1947
Location: Mansfield, Mo.
Kind of accident: Derailment
Train involved: Passenger
Train number: 106
Engine number: 4403
Consist: 14 cars
Speed: 45 m. p. h.
Operation: Timetable, train orders and
automatic block-signal system
Track: Single; 6°08' curve; 1 percent
descending grade northward
Weather: Clear
Time: 1:47 a. m.
Casualties: 2 killed; 22 injured
Cause: Broken rail

Accident near Mansfield, Mo., on May 30, 1947, caused
by a broken rail.

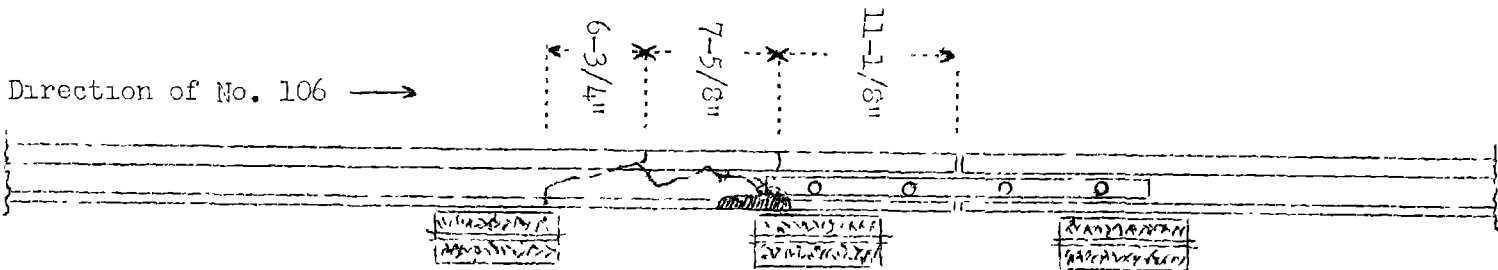
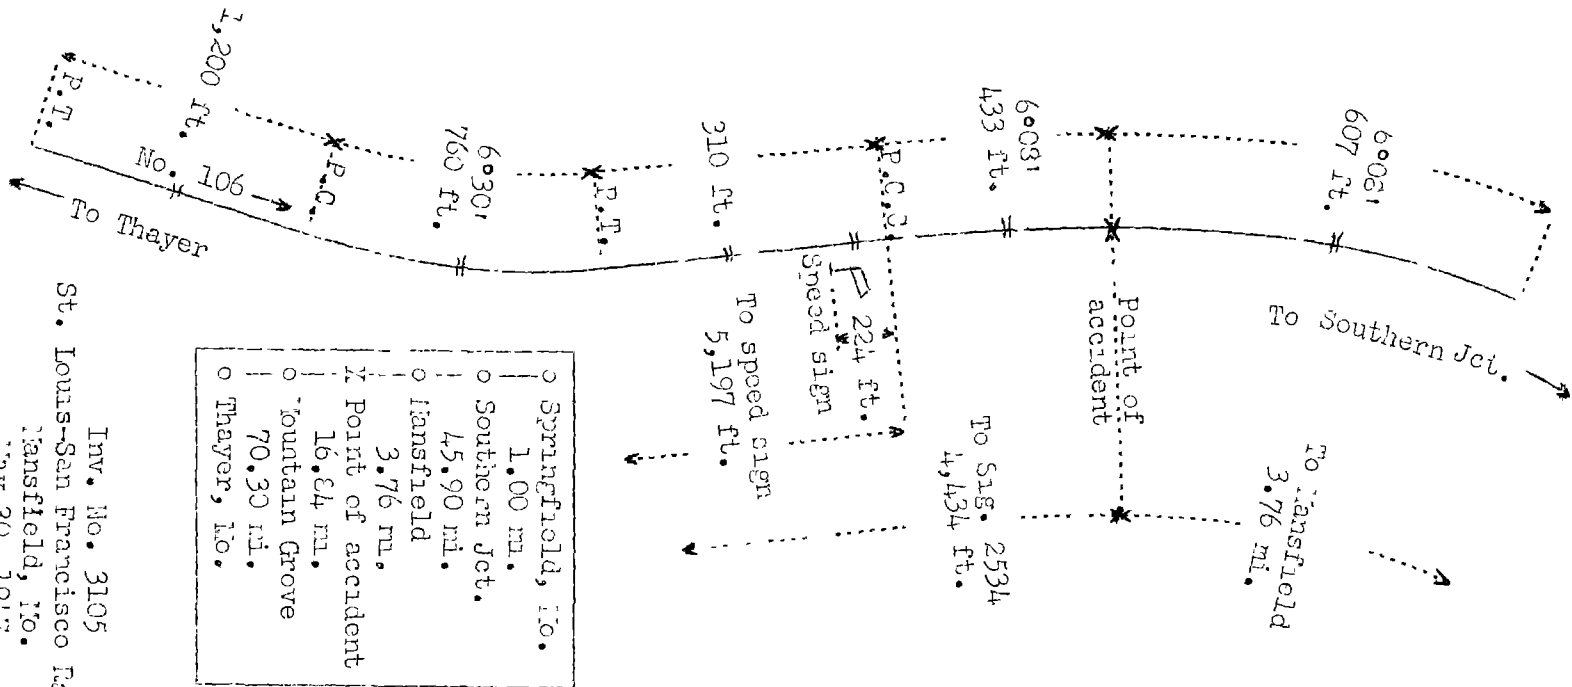
Sketch showing broken rail on west side of track
Shaded portion indicates missing fragment

After the accident a broken rail was found on the high, or west, side of the curve at a point 433 feet north of the south end of the curve. The rail was broken into seven pieces, six of which were recovered. The first break occurred at a point 11-1/8 inches south of the leaving end of the rail, over a tie, about 1 inch north of the south ends of the angle bars and 2-1/2 inches north of the south bond-wire connection. This break extended diagonally upward and southward through the base and about 50 percent of the web, then diagonally northward to a point where it broke out at the head of the rail. The second break extended southward in an irregular line through the web, then upward through the head in a square break at a point 7-5/8 inches from the first break. From this second break through the head the line of break extended diagonally downward through the web and broke through the base at a point 6-3/4 inches southward. The remainder of the breaks were pieces breaking off in this area as a result of the derailment. The first break was a result of a progressive fracture, which started at the juncture of the web and the head of the rail, and was primarily a fillet crack. This developed until it had extended upward into the head of the rail 3/4-inch and downward into the web 1-1/2-inches. In addition, two secondary cracks were found in the immediate region of the first fracture. All of these cracks disclosed discoloration as a result of oxidation. The remainder of the breaks were new. The chief chemist of the railroad said that the first break occurred as the result of a fatigue crack of

considerable size in both fillets of the rail. At the point of break the head was worn about 1/4-inch at the top of the gage side, and the gage side was curve-worn about 1/8-inch at the top and 1/16-inch at the bottom. Analysis indicated that the chemical components of the rail were in accordance with the carrier's specifications. There was a slight segregation of metal, but not sufficient to classify the rail as being defective.

Marks on the rail, the inside angle bar and the top of the flange of the left No. 2 driving-wheel tire indicated that as the engine of No. 106 traversed the curve involved, the flanges of the engine-truck wheels and left No. 1 driving-wheel exerted sufficient lateral force to snap the head of the rail outwardly, then the flange of the left No. 2 driving wheel struck the top of the south end of the inside angle bar, and this wheel was derailed.

A south-bound freight train passed over the rail involved about 1 hour 35 minutes before the derailment occurred, and the crew observed no indication of defective track. However, the first fracture could have existed prior to the passage of No. 106, as it was located within the angle bars. As this fracture was between the bond-wire connections at the rail joint, the automatic block signals gave no indication of defective condition of the rail.

The track involved was last inspected by the section foreman about 17 hours before the accident occurred, and no defective condition of the rail was observed. The fillet crack involved was concealed from detection by ordinary visual inspection by the fit of the head-free angle bars against the fillet. The rail involved was last tested by a detector car on March 29, 1947, and no defective condition was indicated.
