REPORT NO. 3649  
ST. LOUIS-SAN FRANCISCO RAILWAY COMPANY  
IN RE ACCIDENT  
AT MARKED TREE, ARK., ON  
AUGUST 19, 1955

Date: August 19, 1955  
Railroad: St. Louis-San Francisco  
Location: Marked Tree, Ark.  
Kind of accident: Derailment  
Train involved: Passenger  
Train number: 103  
Locomotive number: Diesel-electric units  
2018 and 2015  
Consist: 13 cars  
Speed: 50 m. p. h.  
Operation: Timetable, train orders,  
and automatic block-  
signal system  
Track: Single; spiral; level  
Weather: Clear  
Time: 9:10 a. m.  
Casualties: 5 killed; 21 injured  
Cause: Defective switch stand

Accident at Marked Tree, Ark., on August 19, 1955,  
caused by a defective switch stand.

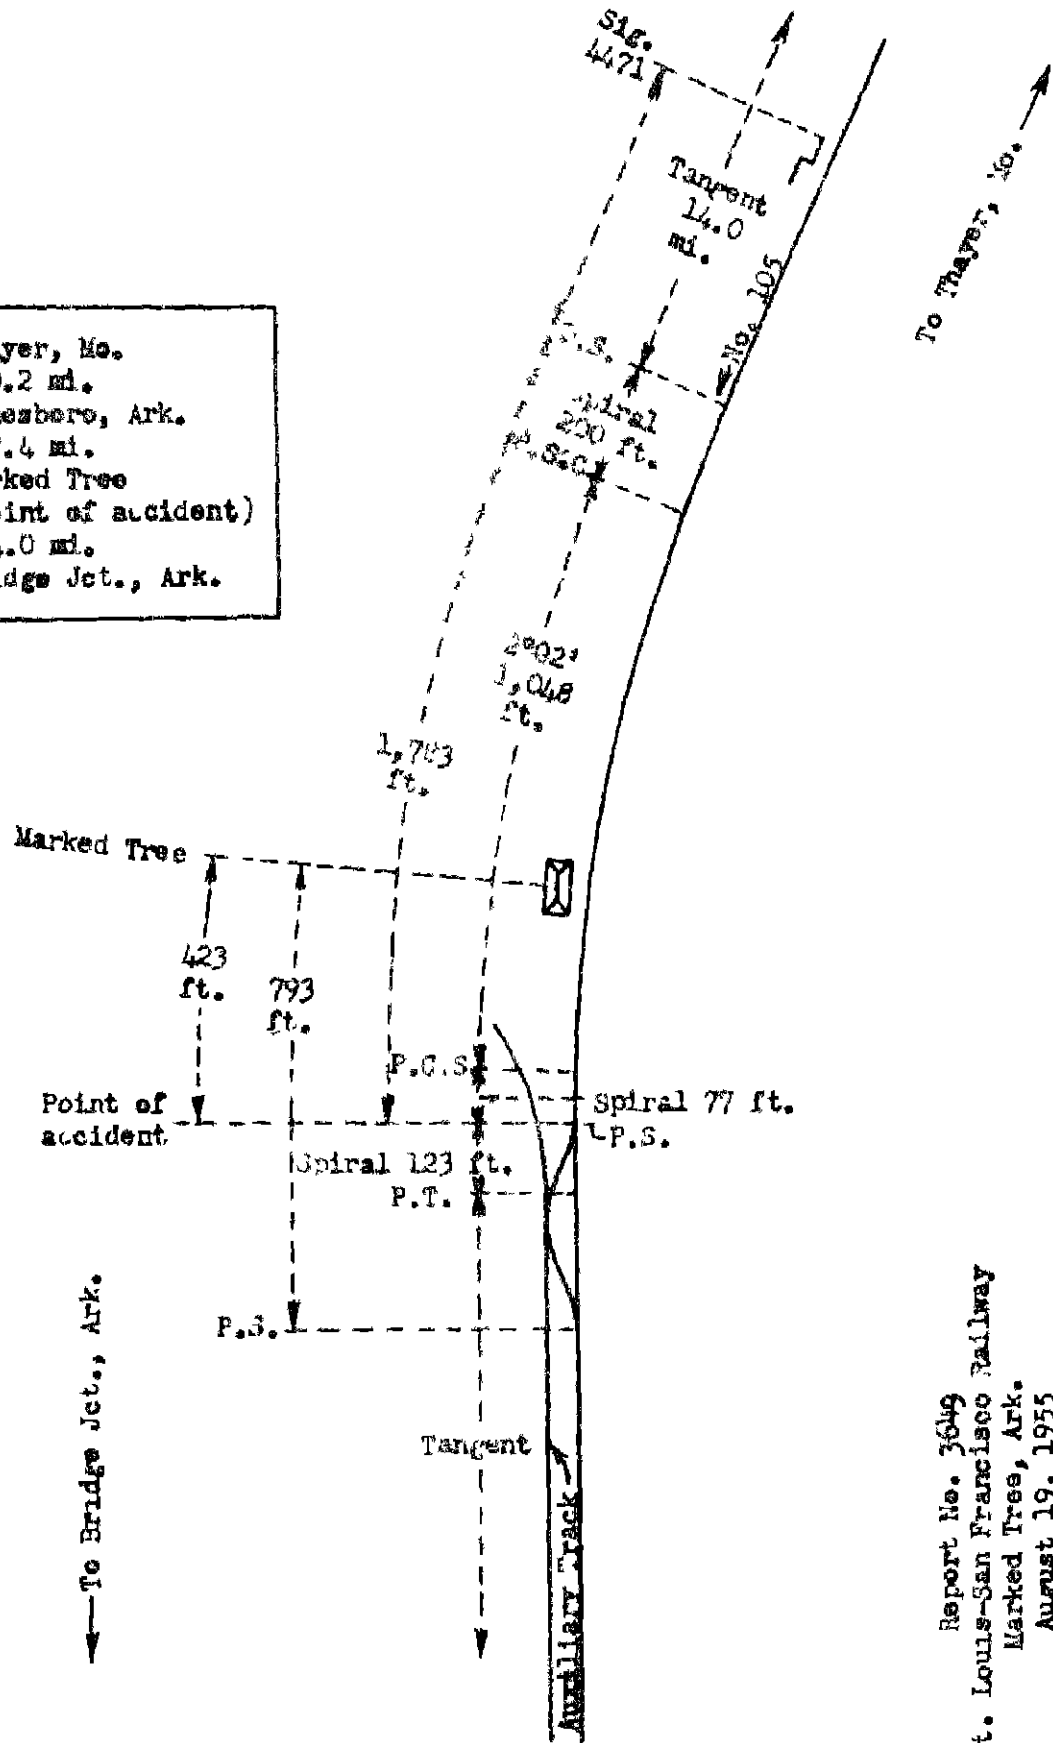
Report No. 3649  
 St. Louis-San Francisco Railway  
 Marked Tree, Ark.  
 August 19, 1955

No. 105, a south-bound first-class passenger train, consisted of Diesel-electric units 2018 and 2015, coupled in multiple-unit control, one express-refrigerator car, three baggage cars, one baggage-mail car, one baggage car, one coach-dormitory car, three chair cars, one cafe-lounge car, and two sleeping cars, in the order named. The first car was of steel underframe construction, the tenth and the thirteenth cars were of lightweight steel construction, and the other cars were of conventional all-steel construction. The ninth, tenth, and thirteenth cars were equipped with tightlock couplers. This train departed from Thayer at 6:45 a. m., on time, passed signal 4471, which indicated Proceed, passed the station at Marked Tree at 9:10 a. m., 6 minutes late, and while moving at a speed of 50 miles per hour the rear truck of the ninth car, the tenth and the eleventh cars, and the front truck of the twelfth car were derailed at the north switch of the north crossover at Marked Tree.

Separations occurred between the eighth and the ninth cars and between the tenth and the eleventh cars. The forward portion of the train stopped with the eighth car about 1,700 feet south of the point of derailment. The rear truck of the ninth car became rerailed at the south switch of the south crossover. This car stopped with the front end 914 feet south of the point of derailment. None of the derailed cars overturned. The side of the tenth car struck the freight cars on the auxiliary track, and the west side of the car was torn off between a point near the center and the rear end. This car stopped approximately in line with the main track. The eleventh car stopped with the front end near the rear end of the tenth car, and the rear end on the track structure of the auxiliary track. The front end of the car was badly damaged. The twelfth car stopped in line with the auxiliary track. The front truck and the appurtenances below the floor level at the front end of the car were considerably damaged. The thirteenth car stopped on the auxiliary track. The two most northerly freight cars on the auxiliary track were demolished.

After the accident occurred it was found that the connecting rod was disengaged from the crank on the switch stand at the north switch of the north crossover. The throwing lever was locked in position for main-track movement and the target indicated that the switch was in this position, but the switch points were lined for entry to the crossover. The switch points were undamaged. Marks on the ties indicated that wheels had dropped inside the east rail of the main track and inside the west rail of the crossover at a point about 24 feet south of the switch points. After becoming derailed several wheels had veered to the west, and the east wheels had crossed the west rail of the main track at a point about 40 feet south of the frog. From the position of the equipment after the accident occurred it appears that these marks were made by the rear truck of the tenth car and the front truck of the eleventh car. The tenth car apparently moved southward with the front end on the track structure of the main track and the rear end on the track structure of the auxiliary track to the point at which it struck the freight cars. The fact that signal 4471 indicated Proceed indicates that the switch points were in normal position when No. 105 passed the signal. From the position of the equipment and the marks on the track structure it appears that the switch points remained in normal position until after the front truck of the ninth car passed over them. The switch points then moved sufficiently to permit flanges to pass between the west switch rail and the stock rail. After the front truck of the twelfth car passed, the east switch point was moved against the stock rail. The following wheels were then diverted to the crossover.

When the housing of the switch stand was removed it was found that the rivet through the spindle and the hub of the segment gear had broken and worked out. The spindle had worked downward through the hub of the segment gear, and the crank at the lower end of the spindle had been lowered to the extent that the lugs underneath the base of the stand were no longer effective in preventing the end of the connecting rod from rising above the top of the lug on the crank. The end of the connecting rod had become disengaged from the lug on the crank, and the switch points were then free to move.
