INTERSTATE COMMERCE COMMISSION

REPORT OF THE DIRECTOR OF THE BUREAU OF SAFETY CONCERNING AN
ACCIDENT ON THE ST. LOUIS-SAN FRANCISCO RAILWAY AT
NEODESHA, KANSAS, ON MAY 16, 1933.

July 22, 1933

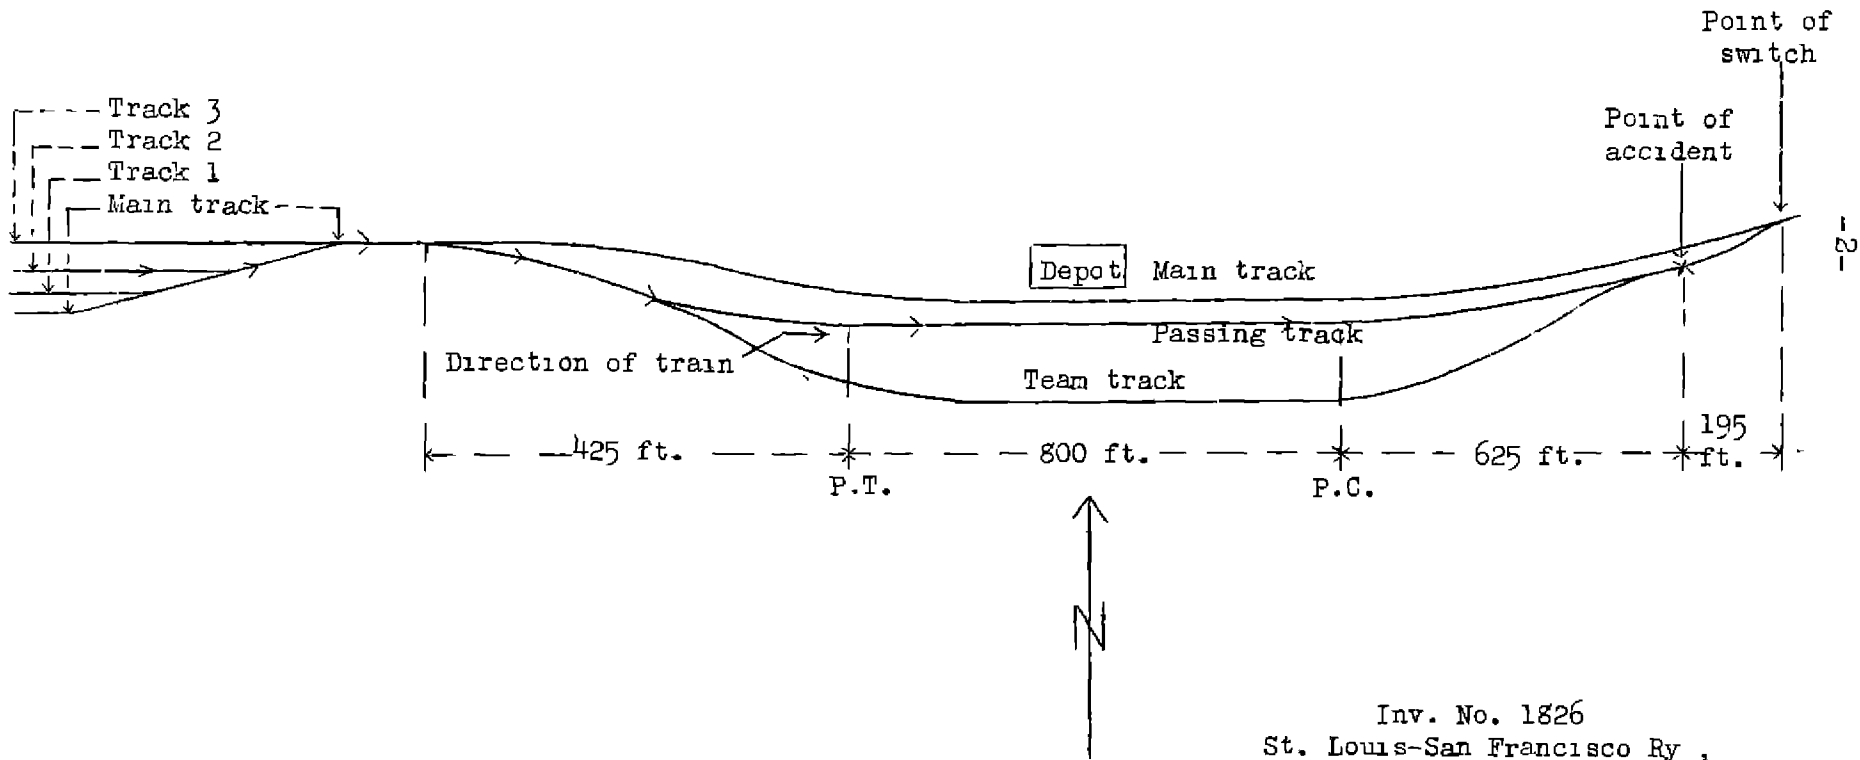
Inv. No. 1826
St. Louis-San Francisco Ry.,
Neodesha, Kansas
May 16, 1933

The engine, tender, and the forward truck of the first car were derailed, the engine stopping on its right side with the forward end 112 feet east of the derail, while the tender and first car remained upright. The engine was badly damaged and the tender sustained slight damage. The employees injured were the fireman and head brakeman.
