INTERSTATE COMMERCE COMMISSION
WASHINGTON

ACCIDENT ON THE
ST. LOUIS-SAN FRANCISCO RAILWAY

QUINCY, MISS.

INVESTIGATION NO. 2332

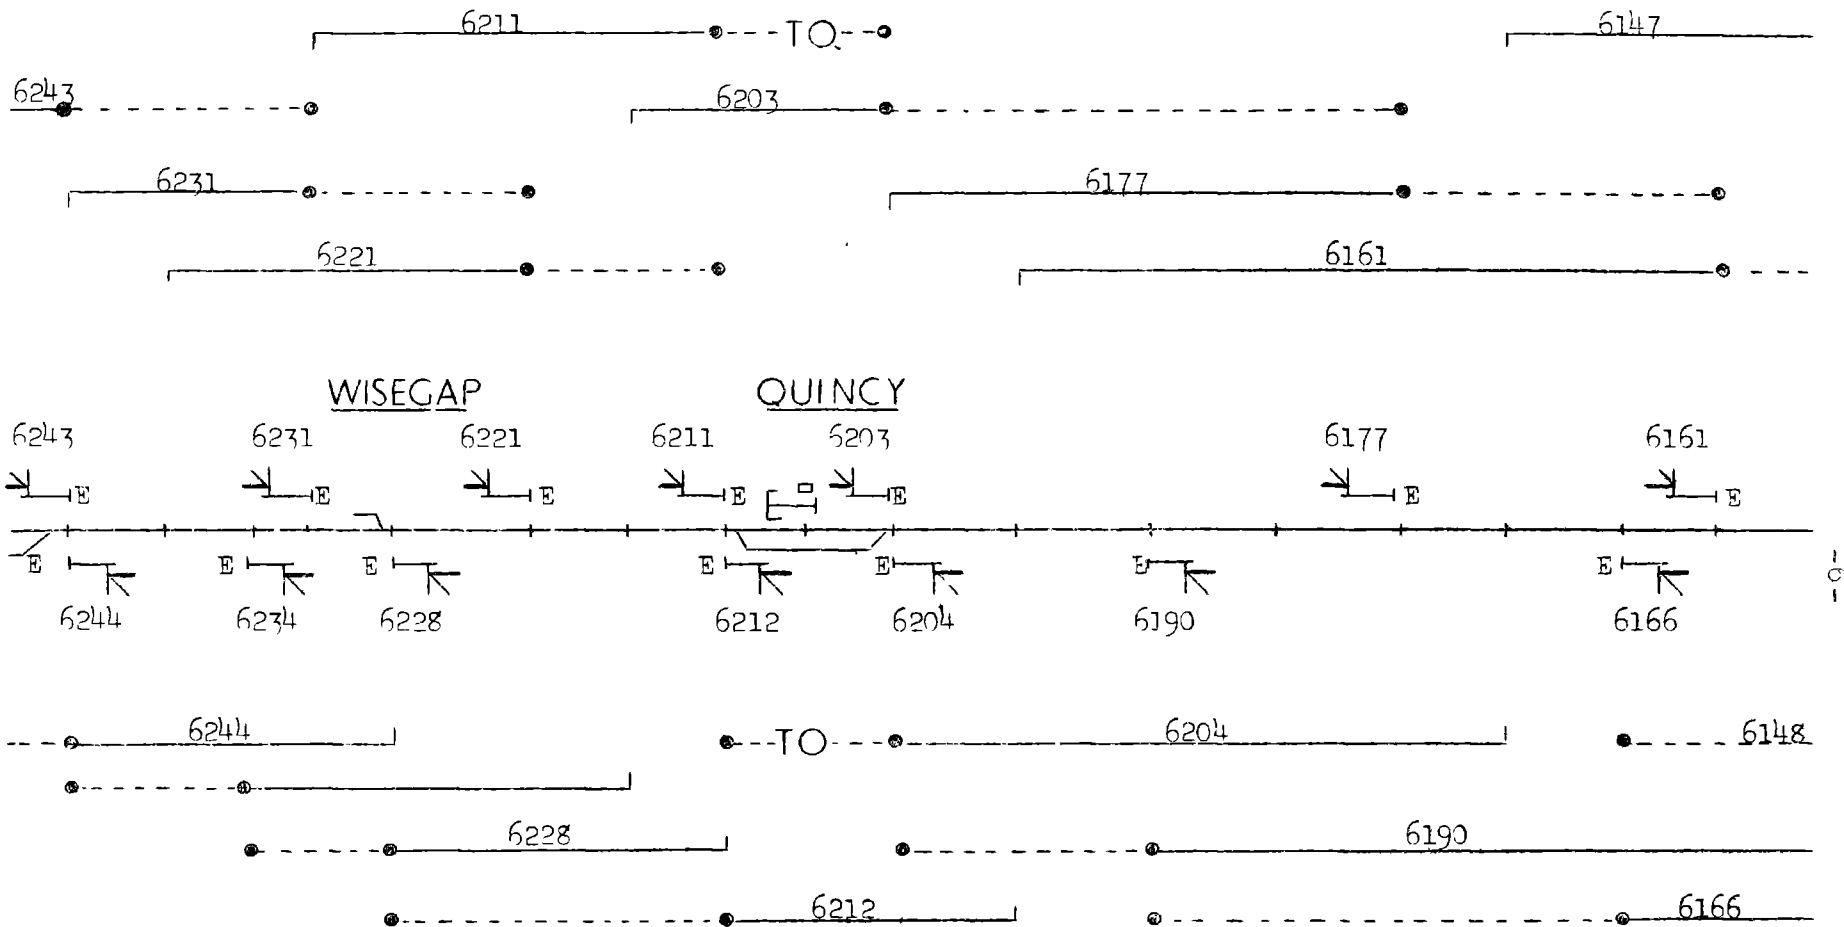
SIGNAL CONTROLS

Signals 6212 and 6204, governing north-bound movements, are located 6,396 and 2,158 feet, respectively, south of the point of accident, and signal 6177, an intermediate signal governing south-bound movements, is located 11,417 feet north of the point of accident. The overlap for signal 6204 extends to a point 2,850 feet north of signal 6177; when a south-bound train passes that point, signal 6204 displays a stop indication and signal 6212 displays an approach indication. When a north-bound train reaches a point 2,550 feet south of signal 6212, signal 6203, located at the north siding switch at Quincy, displays a stop indication, and signal 6177 displays an approach indication.

The automatic block signal system in this territory is of the overlap type. According to the statements of employees involved, signal 6212 displayed a green aspect when No. 238 passed it, and signal 6177 displayed a green aspect when No. 107 passed it. The investigation disclosed that assuming the signal system was working as intended, it was impossible for green aspects to be displayed by both signals 6212 and 6177 for the two trains involved in this accident.

Under a third possibility, if No. 107 entered the overlap north of signal 6177 prior to the time No. 238 passed signal 6212, and No. 238 entered the overlap south of signal 6212 prior to the time No. 107 passed signal 6177, then No. 107 would have received a yellow aspect at signal 6177 and No. 238 would have received a yellow aspect at signal 6212 and a red aspect at signal 6204.
