INVESTIGATION NO. 3072  
ST. LOUIS-SAN FRANCISCO RAILWAY COMPANY  
REPORT IN RE ACCIDENT  
NEAR REPUBLIC, MO., ON  
FEBRUARY 7, 1947

Railroad: St. Louis-San Francisco  
Date: February 7, 1947  
Location: Republic, Mo.  
Kind of accident: Derailment  
Train involved: Passenger  
Train number: 4  
Engine number: 1518  
Consist: 8 cars  
Estimated speed: 70 m. p. h.  
Operation: Signal indications  
Track: Single; tangent; 0.80 percent ascending grade eastward  
Weather: Clear  
Time: 6:14 p. m.  
Casualties: 1 killed; 14 injured  
Cause: Broken rail

Accident near Republic, Mo., on February 7, 1947, caused  
by a broken rail.

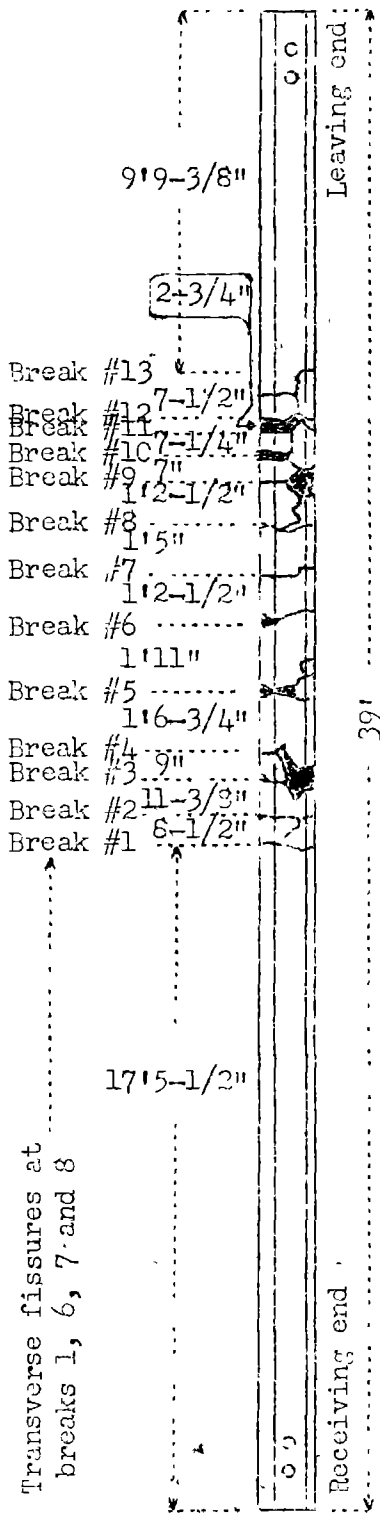
Sketch showing broken rail - north side of track

Shaded portions indicate missing fragments

After the accident a broken rail was found on the north side of the track. This rail was broken through the head, the web and the base at 13 locations. The first break occurred 17 feet 5-1/2 inches east of the receiving end of the rail. The receiving ends of the first break, and the fourth, fifth, sixth, eighth and ninth breaks, respectively, 28-7/8 inches, 47-5/8 inches, 70-5/8 inches, 102-1/8 inches and 116-5/8 inches eastward, were battered. At breaks Nos. 1, 6, 7 and 8, there were transverse fissures which covered, respectively, 18 percent, 6 percent, 5 percent and 10 percent of the cross-sectional area of the head of the rail. None of these fissures extended to the surface of the rail. The remaining portions of the breaks were new. The second, fourth, sixth, ninth and twelfth breaks occurred between ties, the fifth and eleventh breaks occurred at the eastern edges of ties, and the remainder occurred over ties. Apparently the failure of the rail at the location of the transverse fissures occurred when the front portion of the train passed over the rail, then the pieces between these breaks were forced out of normal alignment, and the derailment occurred. The other breaks evidently occurred as a result of the derailment.
