REPORT NO. 3274
ST. LOUIS-SAN FRANCISCO RAILWAY COMPANY
IN RE ACCIDENT
NEAR SEVENTY-SIX, MO., ON
SEPTEMBER 12, 1949

Accident near Seventy-Six, Mo., on September 12, 1949,
caused by the collapse of a bridge.

Report No. 3274
 St. Louis-San Francisco Railway
 Seventy-Six, Mo.
 September 12, 1949

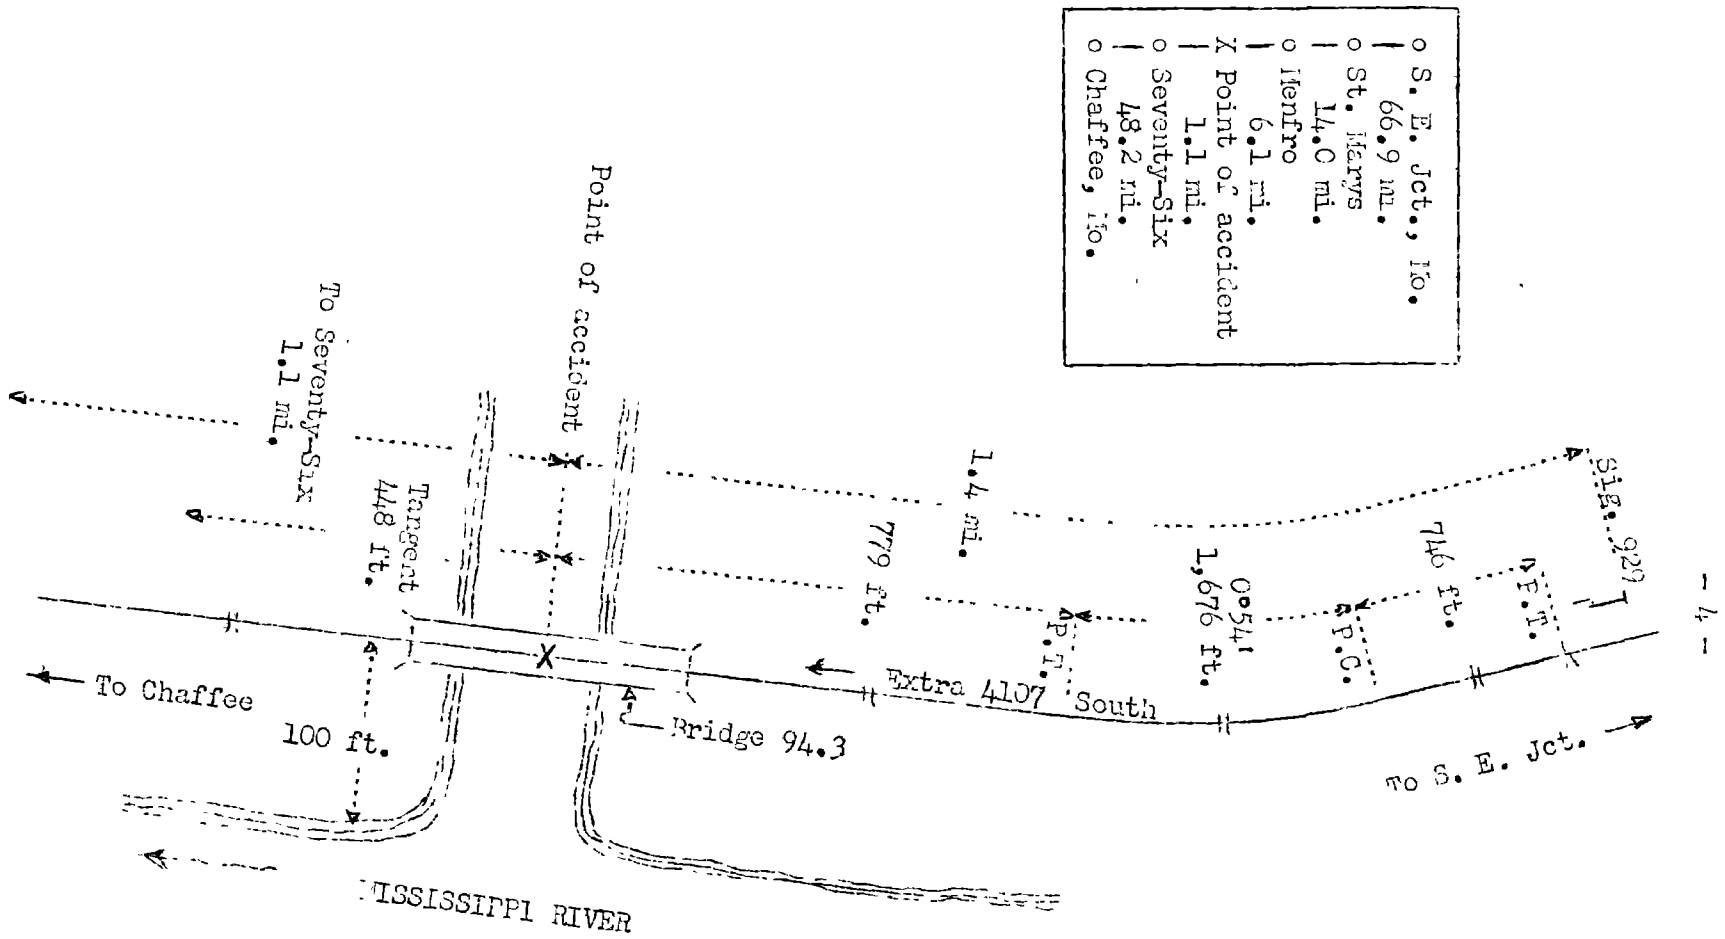
Examination of the bridge after the accident occurred disclosed that five bents had collapsed, and as a result the engine and the first six cars had dropped into the stream. From north to south, bents 1, 2, and 3 and two panels of the deck were intact. The piles in bent 4 were broken. Bents 5, 6, and 7 were carried away by the stream. Three of the six piles in bent 8 were in place and the last four bents and the three panels of the deck were intact. Three piles of bent 4 were removed, and the driven ends were found to be excessively broomed. The high water mark was approximately 17 feet below the base of the rail, but the bed of the stream had been washed away to a depth of 15 feet below its normal level. Examination of the track north of the bridge and of the equipment of Extra 4107 South disclosed no condition which would have caused or have contributed to the cause of the accident. There was no indication that drift had become lodged against any of the bents.

The investigation disclosed that normally there is no water flowing under Bridge 94.3, although usually there is backwater from the Mississippi River, which is about 100 feet east of the track. The stream descends toward the river at a rate of about 80 feet per mile. In the past, when there was sufficient rainfall to cause water to flow, its velocity under the bridge was sufficiently retarded by the backwater to prevent excessive scouring of the stream bed under the bridge. On the day of the accident a heavy rainfall occurred in the vicinity of Seventy-Six between 3:30 p. m. and the time the accident occurred. Members of the crew of Extra 4123 North, which passed over Bridge 94.3 about 2 hours 30 minutes before the accident occurred, said there was an abnormal rainfall while they were in the vicinity of Seventy-Six. However, they noticed no unusual condition of the bridge when they passed over it. There is no record of the amount of rainfall in the drainage area west of Bridge 94.3, but at Chester, Ill., about 15 miles north of Seventy-Six, the rainfall during the 24-hour period ending at 7 a. m., September 13, was 6 inches. The Mississippi River was at a low stage and there was very little backwater under the bridge. As a result, the velocity of the water flowing under the bridge was not retarded and the stream bed was scoured away. The piles of the center bents were about 40 feet in length. The record of penetration obtained when they were driven in 1926 was not available. However, the estimated penetration based on ravine section was 27 feet for bent 4, 21 feet for bent 5, 15 feet for bent 6, 14 feet for bent 7, and 18 feet for bent 8. Since the stream bed was washed away to a maximum depth of 15 feet,

there was not sufficient penetration remaining of the piles of the center bents to hold the bridge in place under a moving train. Apparently the track and the bridge were in normal alignment and surface as Extra 4107 South approached it and the enginemen were not aware of its weakened condition, as no action was taken to stop the train. The train was not stopped at signal 929, which, apparently, displayed an aspect to proceed.
