INTERSTATE COMMERCE COMMISSION

REPORT OF THE DIRECTOR OF THE BUREAU OF SAFETY IN RE
INVESTIGATION OF AN ACCIDENT WHICH OCCURRED ON
THE ST. LOUIS-SAN FRANCISCO RAILWAY AT SMELTZER,
ARK , ON AUGUST 5, 1931.

September 25, 1931.

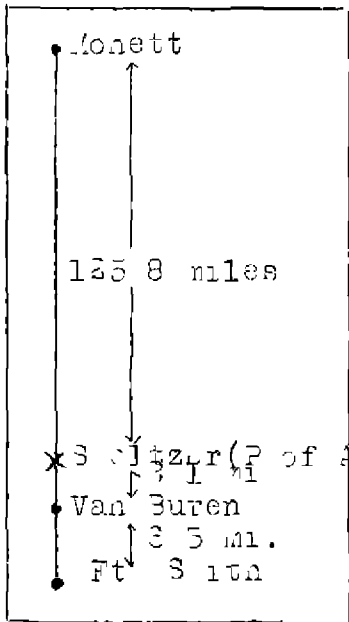
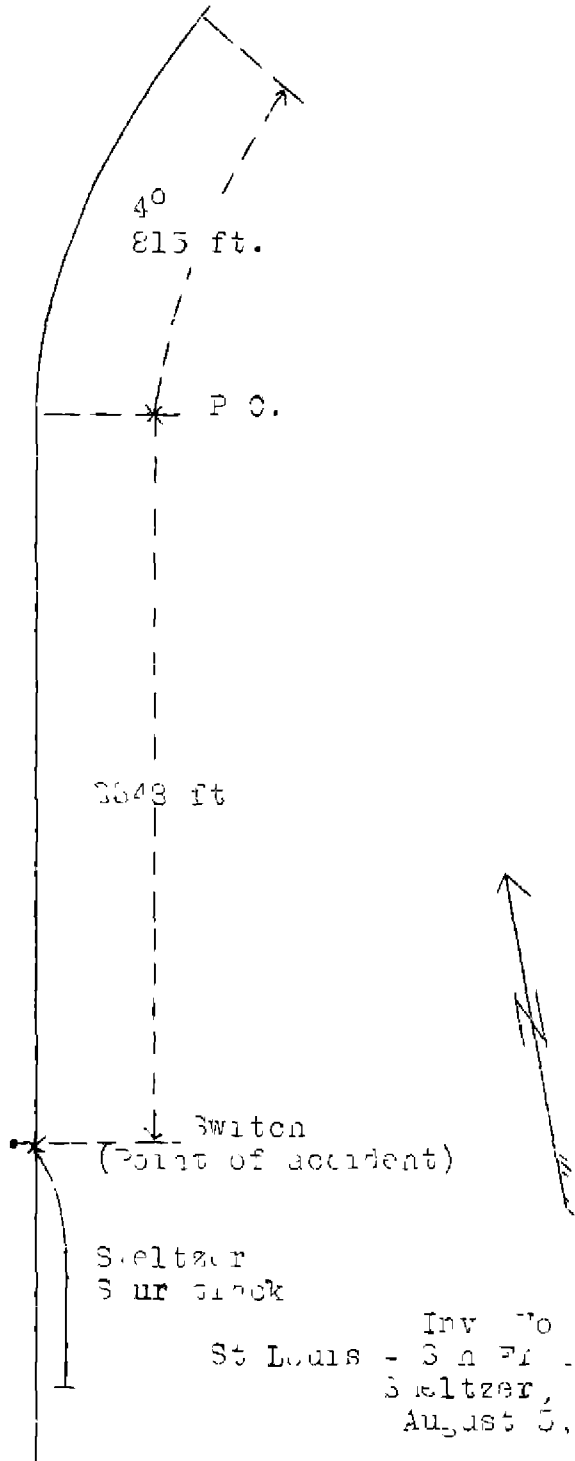
Inv No 1717
 St Louis - San Francisco Ry
 Seltzer, Ark
 August 5, 1931

Seltzer
 5 hr track

There was a flange mark on the bolt head of a rail joint on the gauge side of the west rail at a point 23 feet south of the switch points, and another flange mark on the outside of the base of the east rail of the main track starting at a point 23½ feet from the switch point and continuing along the base of the rail for about 2 feet, where it dropped off to the ties, marking them for a distance of 98 feet, following which the track was torn up.

This accident was caused by the defective condition of a facing-point switch, apparently due to malicious tampering.

After the accident the connecting rod was found to have been disconnected from the stem or gooseneck of the main post of the switch stand, the washer and cotter key were missing and could not be found, but the cotter-key hole was bright, indicating that the cotter key had only recently been removed, and there were marks to indicate that the connecting rod had been pried off. The switch was so constructed that even with no washer or cotter key in place, the connecting rod probably would not work off of its own accord as a result of vibration from passing trains. The switch was lined for the main track and locked, with the switch lamp burning and displaying a green indication to the
