ACCIDENT ON THE  
ST. LOUIS-SAN FRANCISCO RAILWAY

WEST TULSA, OKLA.

SEPTEMBER 14, 1938

INVESTIGATION NO. 2292

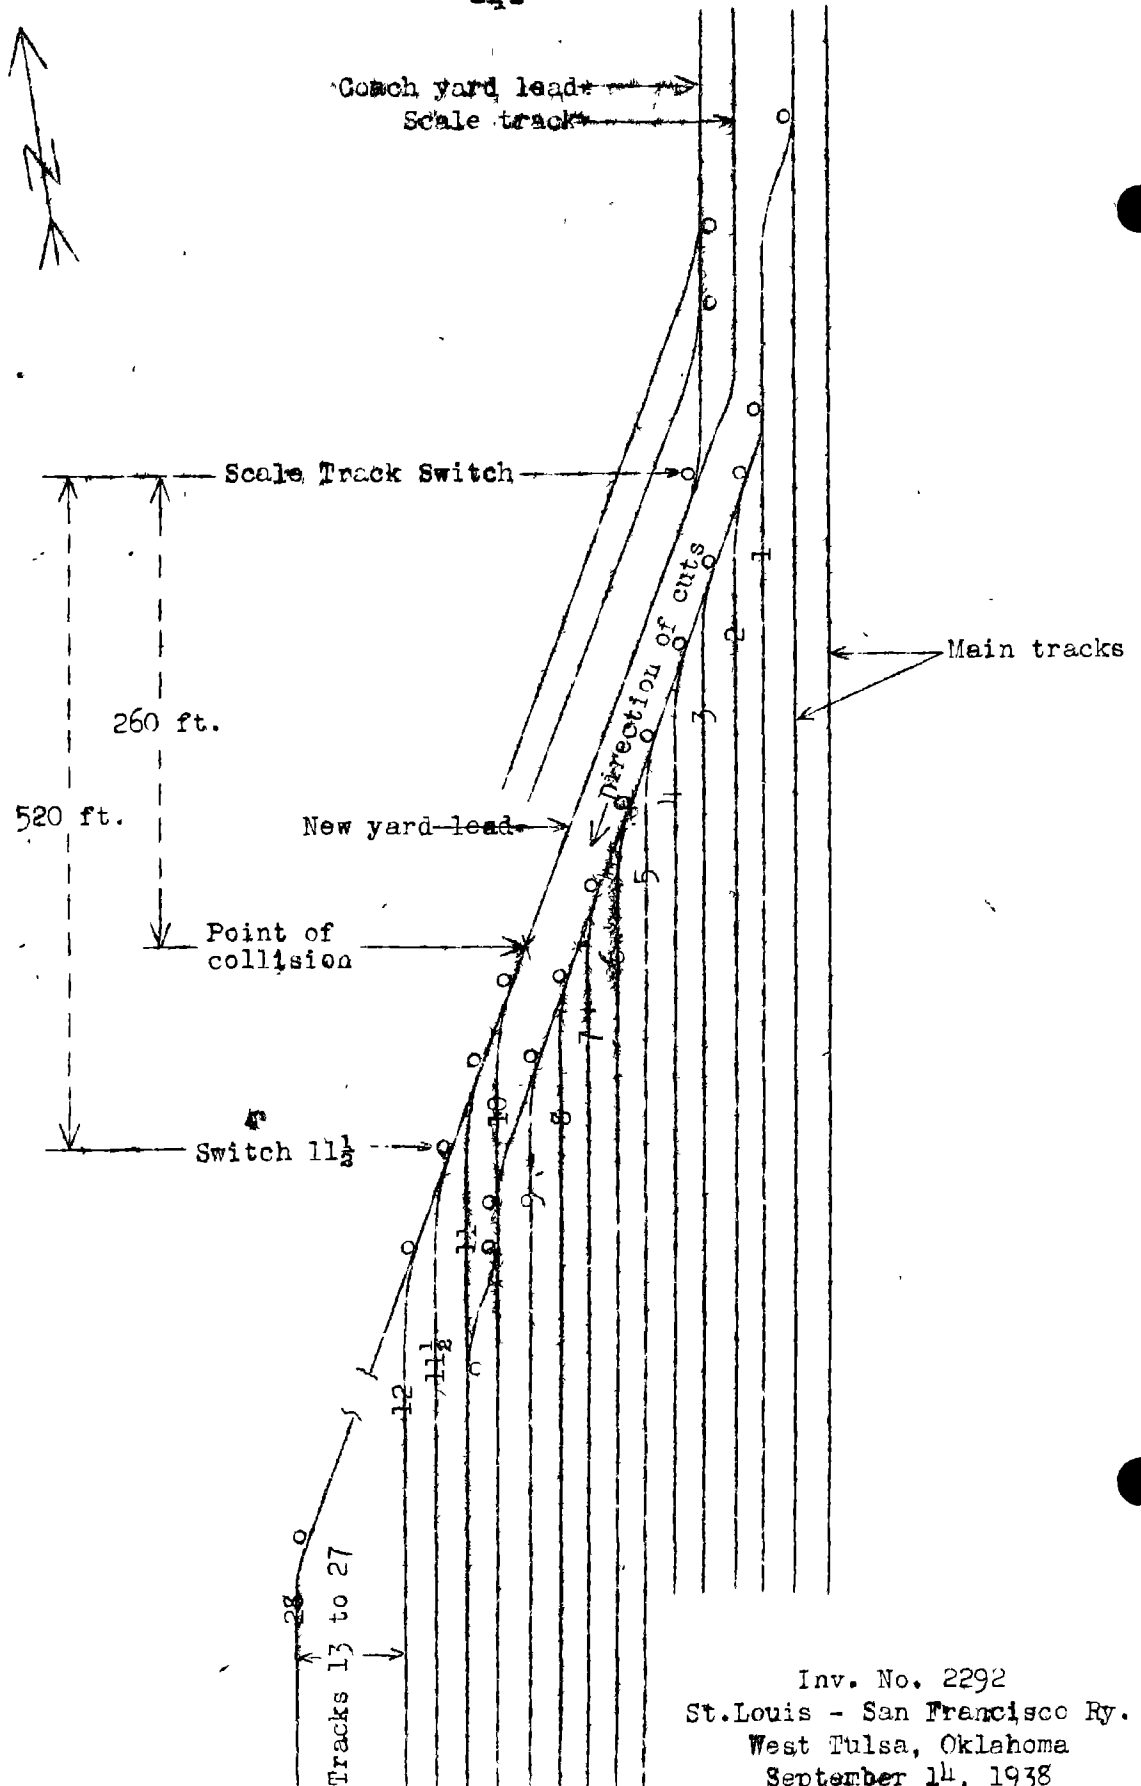
Inv. No. 2292  
St. Louis - San Francisco Ry.  
West Tulsa, Oklahoma  
September 14, 1938

This accident occurred in the West Tulsa yard located in the Tulsa Terminal which extends between Red Fork and Dawson, Okla., a distance of 8.8 miles. At West Tulsa the main yard lies west of the main tracks and consists of 29 tracks which extend northward and southward and vary in length from 721 feet to 8,020 feet. These tracks are numbered from east to west consecutively from 1 to 11, then a track designated 11½ is followed by tracks 12 to 28, inclusive. At the north end of the yard, tracks 1 to 11 are served by one lead while tracks 11½ to 28 are served by another lead known as the New Yard lead. Northward from a point about opposite the switch leading to track 4 the New Yard lead is known as the Coach Yard lead, and from this same point a scale track branches off the New Yard lead and parallels the Coach Yard lead. The New Yard lead is tangent and the grade is practically level. The accident occurred on the New Yard lead at a point approximately 260 feet south of the scale track switch.

proceeded on the New Yard lead extension of the Coach Yard lead a distance of approximately 520 feet to the switch leading to track 11 $\frac{1}{2}$  where it stopped to permit the proper lining of that switch. While standing at that point it was struck by a cut of cars being shoved by engine 3804.
