INVESTIGATION NO 3009
TENNESSEE CENTRAL RAILWAY COMPANY
REPORT IN RE ACCIDENT
NEAR OZONE, TENN., ON
AUGUST 2, 1946

Kind of accident: Head-end collision

Accident near Ozone, Tenn., on August 2, 1946, caused by
failure to provide adequate protection for the move-
ment of a track motor-car.

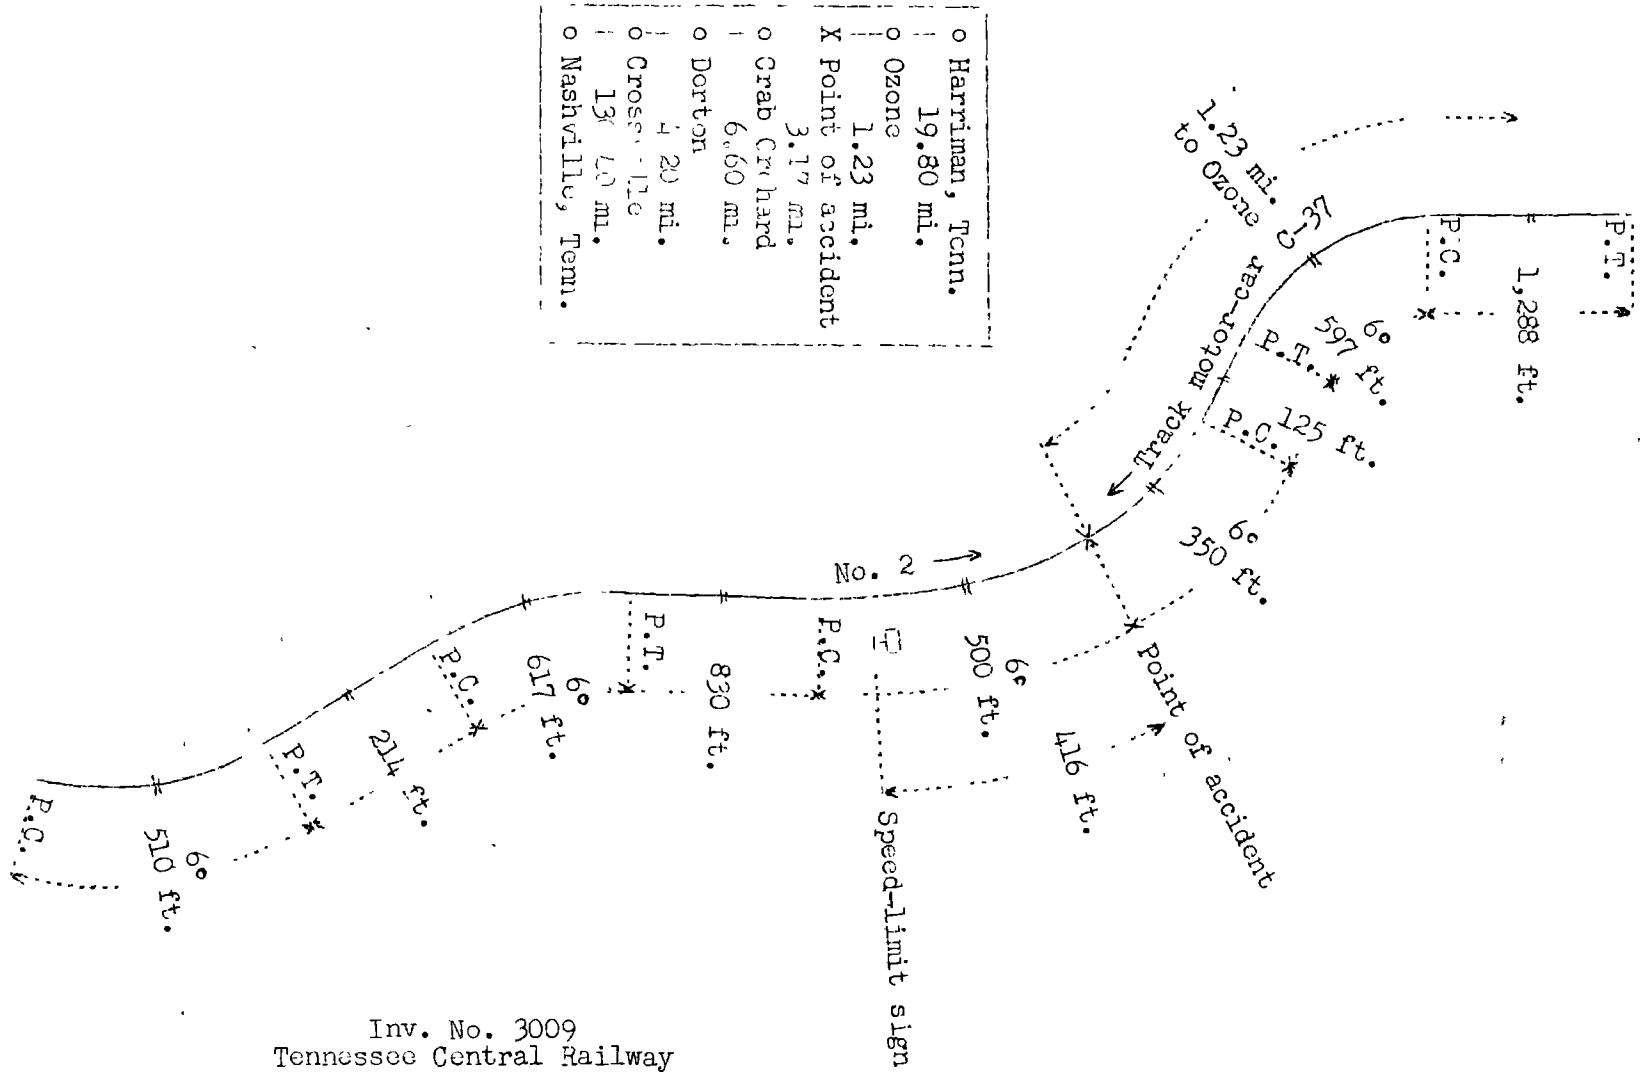
Inv. No. 3009
Tennessee Central Railway
Ozone, Tenn.
August 2, 1946

This accident occurred on that part of the Eastern Division extending between Nashville and Harriman, Tenn., 165.4 miles, a single-track line, over which trains are operated by timetable and train orders. There is no block system in use. The accident occurred on the main track at a point 144.37 miles east of Nashville and 1.23 miles west of the station at Ozone. From the west there are, in succession, a 6° curve to the left 510 feet in length, a tangent 214 feet, a 6° curve to the right 617 feet, a tangent 830 feet and a 6° curve to the left 500 feet to the point of accident and 350 feet eastward. From the east there are, in succession, a tangent 1,298 feet in length, a 6° curve to the left 597 feet, a tangent 125 feet and the curve on which the accident occurred. The grade is 0.5 percent descending eastward.
