ACCIDENT ON THE  
TERMINAL RAILROAD ASSOCIATION OF ST. LOUIS

EAST ST. LOUIS, ILL.

DECEMBER 25, 1939

INVESTIGATION NO. 2400

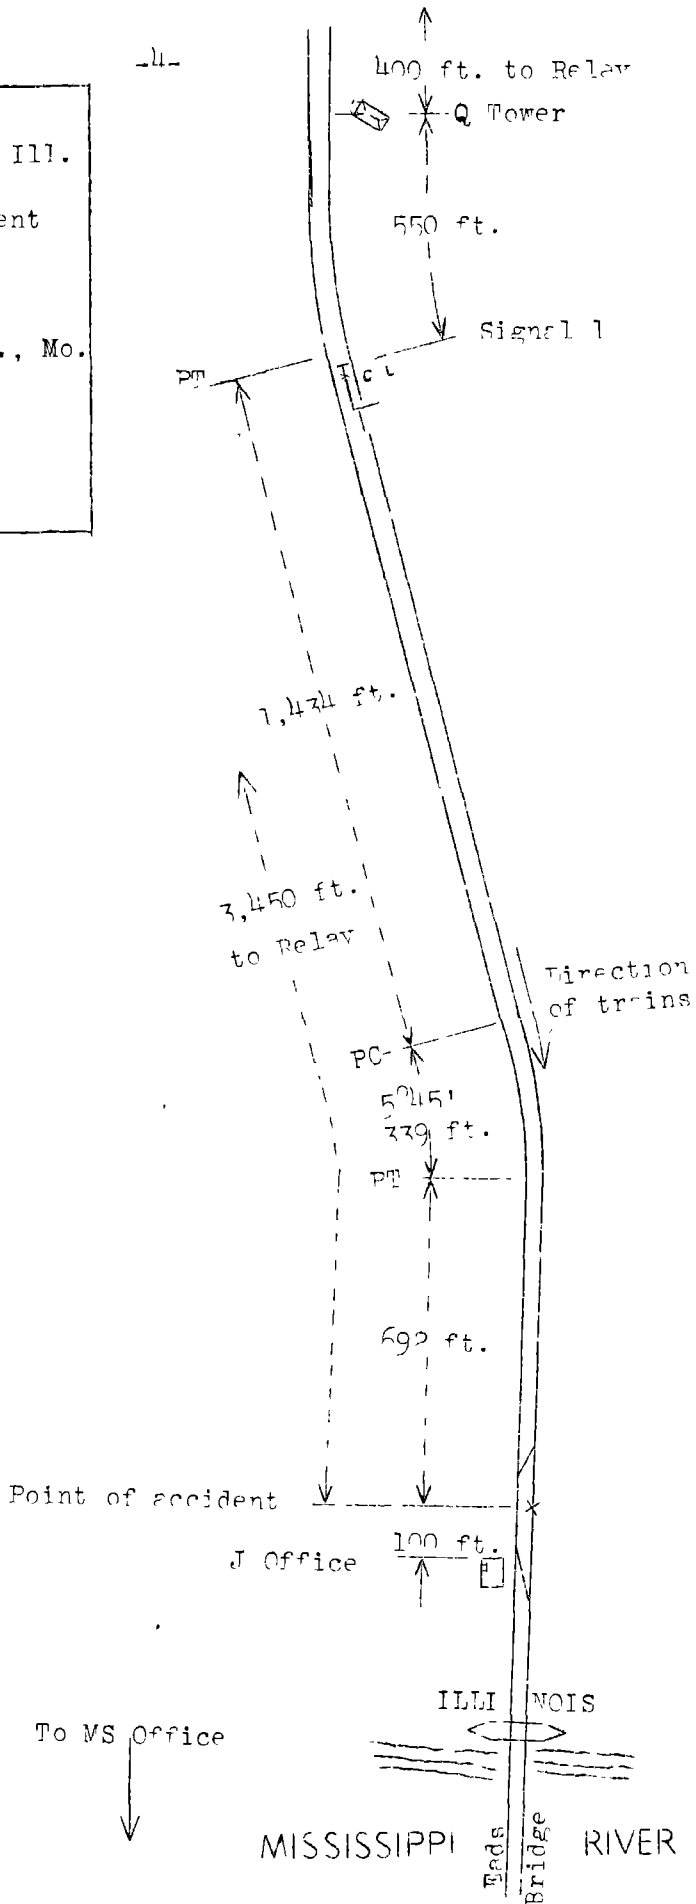
Inv. No. 2400  
 Terminal R.R. Association of St. Louis  
 East St. Louis, Illinois  
 December 25, 1939

o	Relay Station	East St. Louis, Ill.	0.65 mi.
X	Point of accident		0.59 mi.
o	Washington Ave., Mo.		2.11 mi.
o	Union Station,	St. Louis, Mo.
