ACCIDENT ON THE
LINE OF THE
TERMINAL RAILROAD ASSOCIATION OF ST. LOUIS

EAST ST. LOUIS, ILL.

JULY 12, 1940

INVESTIGATION NO. 2435

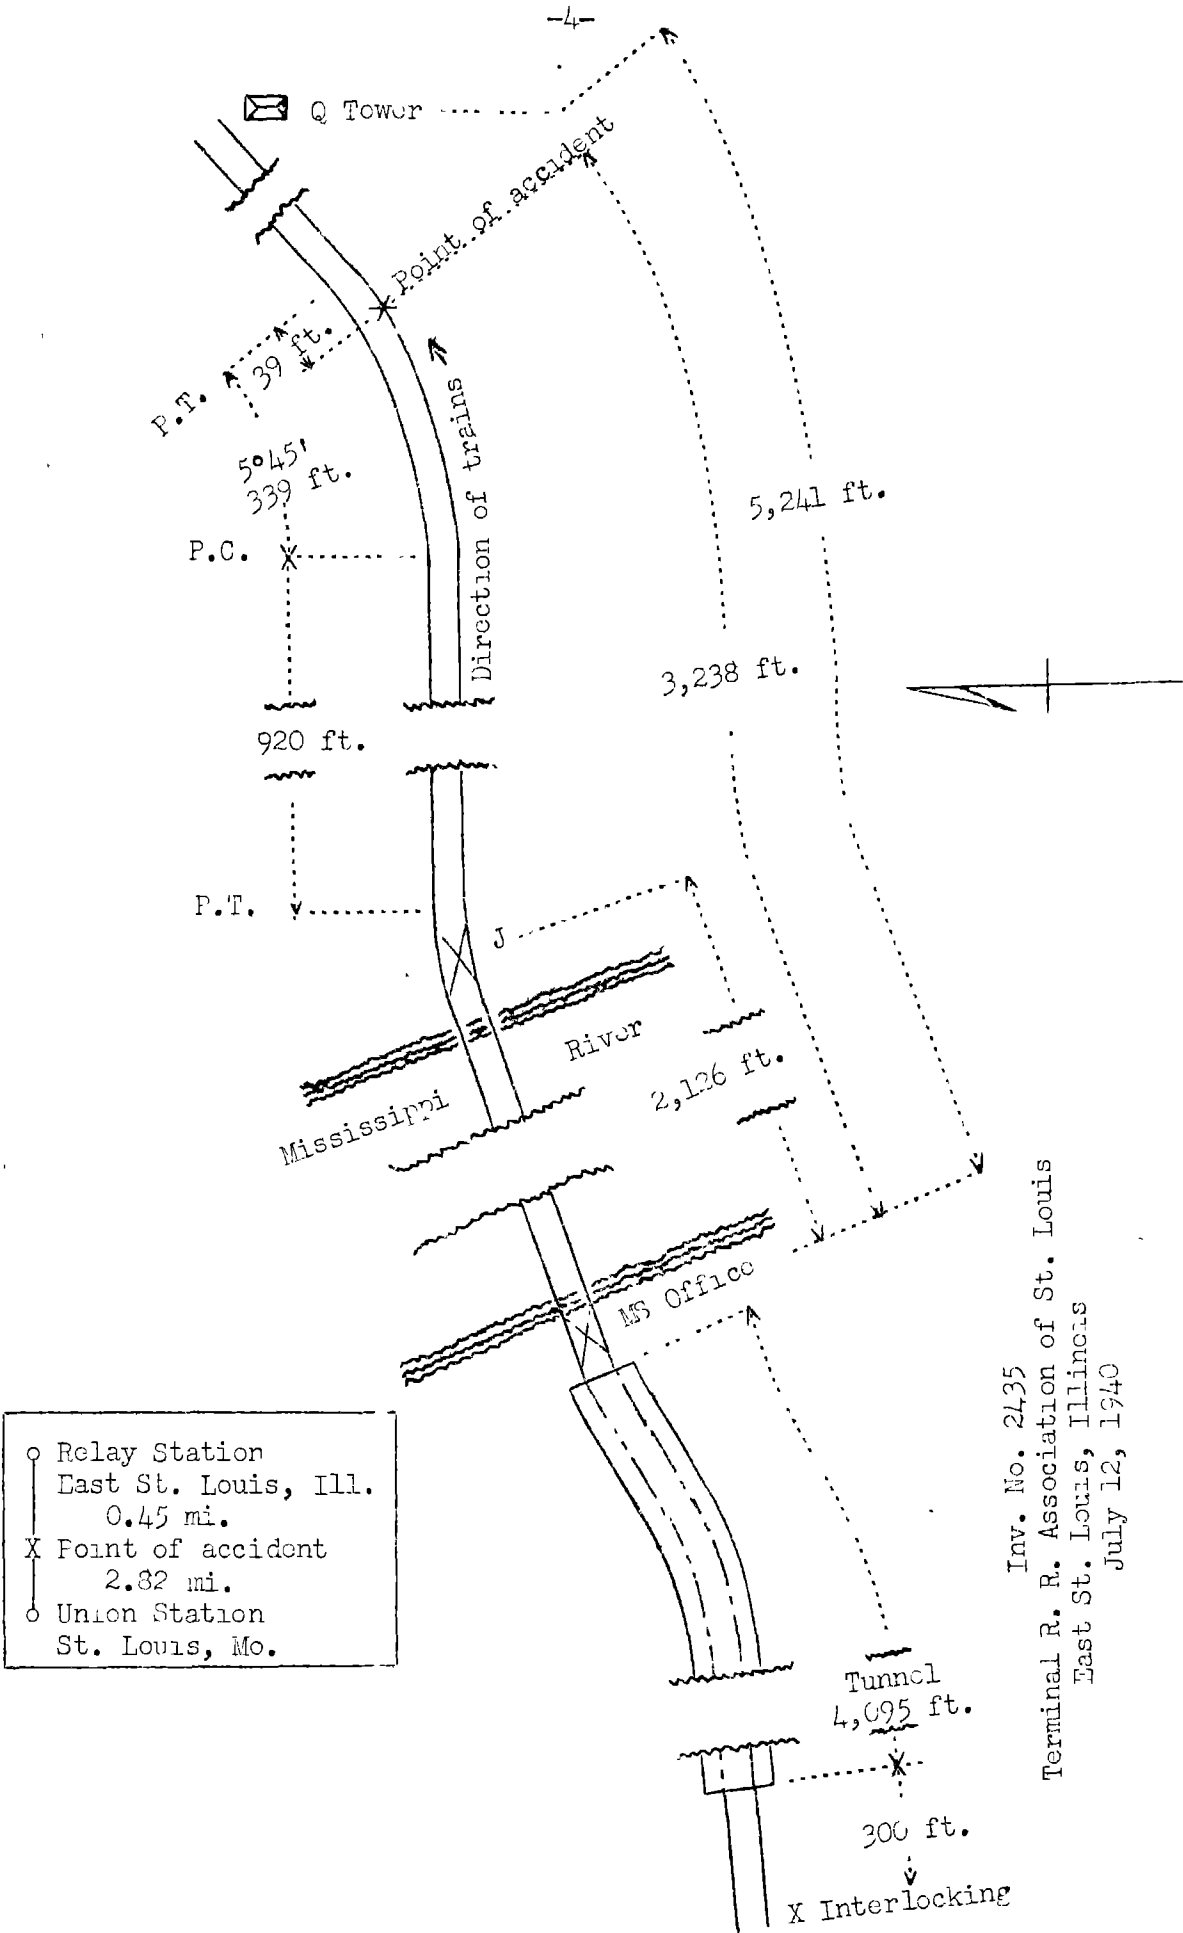
Inv. No. 2435
 Terminal R. R. Association of St. Louis
 East St. Louis, Illinois
 July 12, 1940

| X | Point of accident |
