ACCIDENT ON THE
TERMINAL RAILROAD ASSOCIATION OF ST. LOUIS

MADISON, ILL.

JANUARY 27, 1939

INVESTIGATION NO. 2324

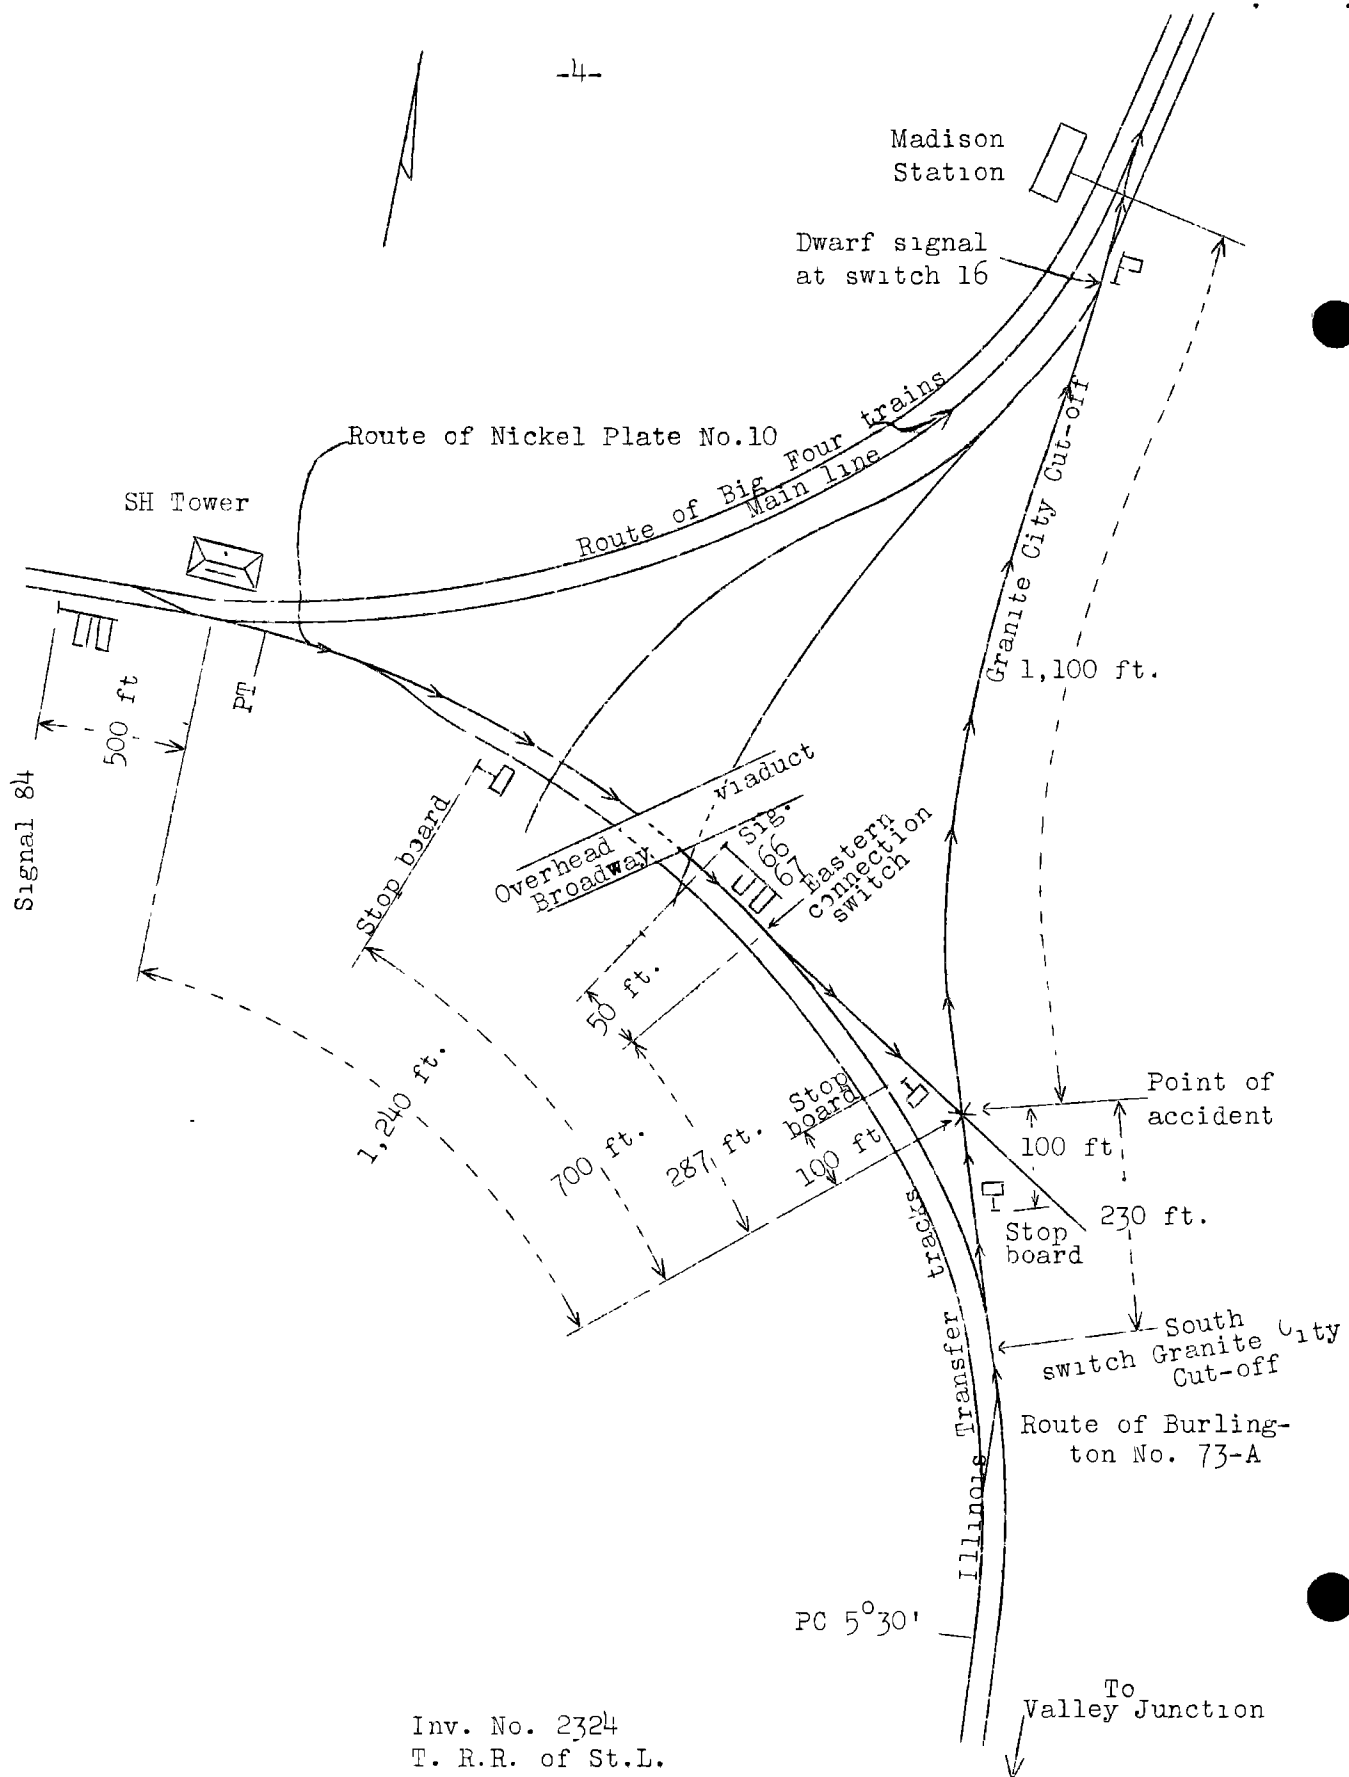
Inv. No. 2324
 T. R.R. of St.L.
 Madison, Ill.
 Jan. 27, 1939

The tracks involved cross at an angle of 32 degrees. The stop sign for northward movements on the Granite City Cut-off is located to the right of the track and 100 feet south of the crossing. The sign for eastward movements on the Eastern Connection is located to the right of the track and 100 feet west of the crossing. They bear the words "RAILROAD CROSSING STOP," and at the time of the accident these signs were badly weather-beaten although legible. All Burlington trains approaching from the south are required to stop at the switch leading to the Granite City Cut-off and call SH Tower from a telephone near the switch for instructions regarding which route to use and when to proceed. The train crews must line and reline the switches.

Switch 65 leading to the Eastern Connection, located 287 feet west of the crossing is operated by the towerman at SH Tower. A two-arm, upper-quadrant, semaphore signal is located to the north of the westward track and approximately 50-feet west of the switch; it is a route signal only and does not govern movements over the crossing. The top arm, signal 67, governs eastward movements to Illinois Transfer westward track, and the lower arm, signal 66, governs the entrance to the Eastern Connection. The normal aspects displayed by the signals are red; when the switch is lined for a movement to the Eastern Connection signal 66 displays a green aspect. The normal position of the switch is for an Illinois Transfer movement. Track indicators are provided in the tower to indicate when trains are moving over switch 65 which leads to the Eastern Connection and switch 16 which is located at the north end of the Granite City Cut-off; no means are provided, however, to indicate when trains are on the crossing.
