## INTERSTATE COMMERCE COMMISSION

REPORT OF THE DIRECTOR OF THE BUREAU OF SAFETY IN RE  
INVESTIGATION OF AN ACCIDENT WHICH OCCURRED ON THE  
TRACKS OF THE TERMINAL RAILROAD ASSOCIATION OF  
ST. LOUIS AT ST. LOUIS, MO., ON AUGUST 21, 1931

October 2, 1931.

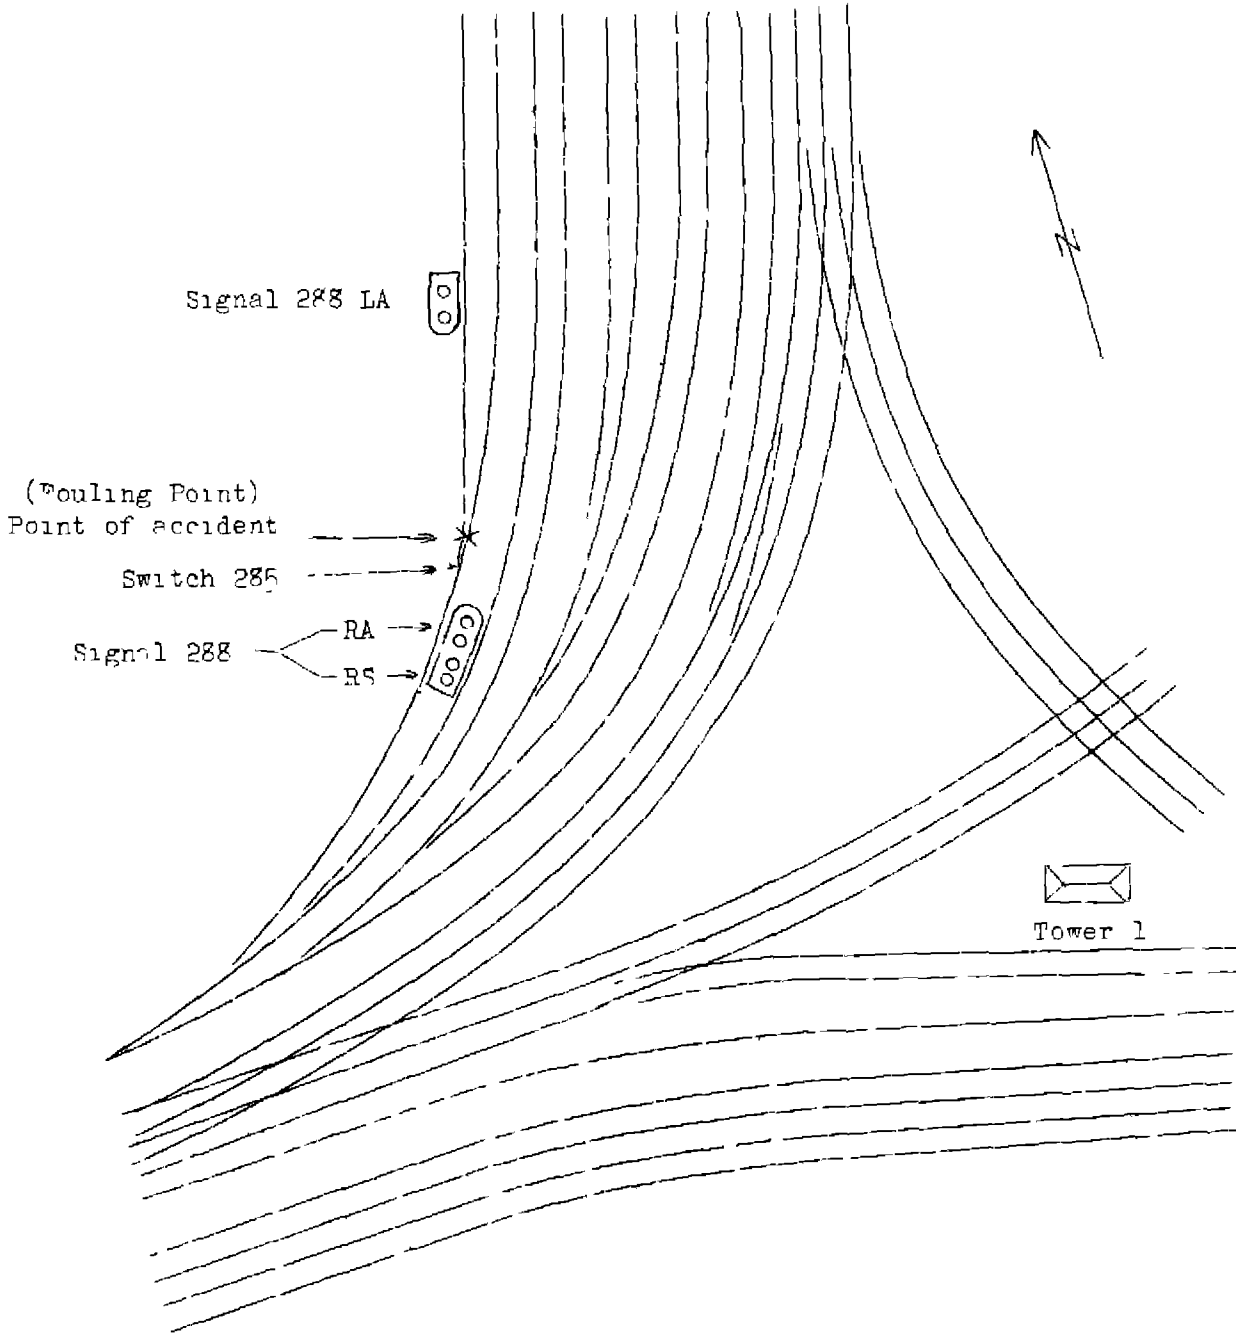
Inv No. 1721  
Terminal R.R. Association  
of St. Louis,  
St Louis, Mo  
Aug 21, 1931

This accident occurred on the East District, which extends between East St. Louis, Ill., and Theresa Ave., St. Louis, Mo., a distance of about 5 miles. In this district there are seven main tracks, the general directions of which are east and west, and there are several tracks which lead from the main tracks to the St. Louis Union Station tracks, these latter tracks extending practically north and south. The station tracks are numbered consecutively, from east to west, tracks 32 to 1, and in addition there are other station tracks, farther west, which are lettered from A to J, inclusive, and the accident occurred at the fouling point where tracks C and D diverge as they lead towards the station. Entrance to tracks C and D is over a single lead track on which there is a sharp curve to the left, leading towards the station, the maximum curvature being about  $15^{\circ}$ , and there is a No. 7 frog at the switch where these two tracks diverge, this switch being numbered 285.

288 RB, are green and yellow; a green indication of this signal indicates that the track for which switch 285 is set is clear, a yellow indication is displayed by this signal when the track for which this switch is set is occupied. Green over green, therefore, indicates that the track which is being entered, either track C or track D, is clear, green over yellow indicates that the track being entered is occupied by cars, and the movement must be made prepared to stop short of such cars. Northward from switch 285 for a distance of about five rail-lengths, to a point a short distance south of the station platforms, there is a track circuit on both tracks C and D for fouling protection. The arrangement of the interlocking is such that when this section of track is occupied and the circuit is shunted, switch 285 can not be operated and the green indication of signal 288 RB can not be displayed. An indicator in the interlocking machine in the tower gives the leverman information whether this section is clear or occupied, a green light is displayed when the track is clear, and this light is extinguished when the track circuit is shunted. The outbound starting signal on track D, signal 288 LA, is located about 13 feet north of the insulated joint in the west rail of track D which separates the fouling track circuit from the station track circuit. The track circuits on the station tracks extend to within about one rail-length from the bumping posts. The track and signal apparatus were maintained in good condition.

already occupying that track. The engine was then uncoupled from the cars, moved a few feet away from them, and stopped to await a signal indication on starting signal 288 LA, which would authorize it to move out of this track. At the point where the engine stopped it fouled track C and it was standing at this point when it was struck by IC train No. 13.

This accident was caused by the failure of a track relay to be shunted by a switch engine, due to sand on the rails, which permitted a route to be lined up and clear signals to be displayed for a conflicting movement.

The rules provided that sand should not be used over movable parts of an interlocking plant unless absolutely necessary. Subsequent to the accident the Maintenance of Way and Interlocking Departments were notified to have track walkers and maintainers watch the matter and to remove and also report promptly any sand deposited. In addition, a general notice was issued, under date of August 28, reading as follows
