INTERSTATE COMMERCE COMMISSION

ACCIDENT OF THE

TERMINAL RAILROAD ASSOCIATION OF ST. LOUIS

INVESTIGATION NO. 2097

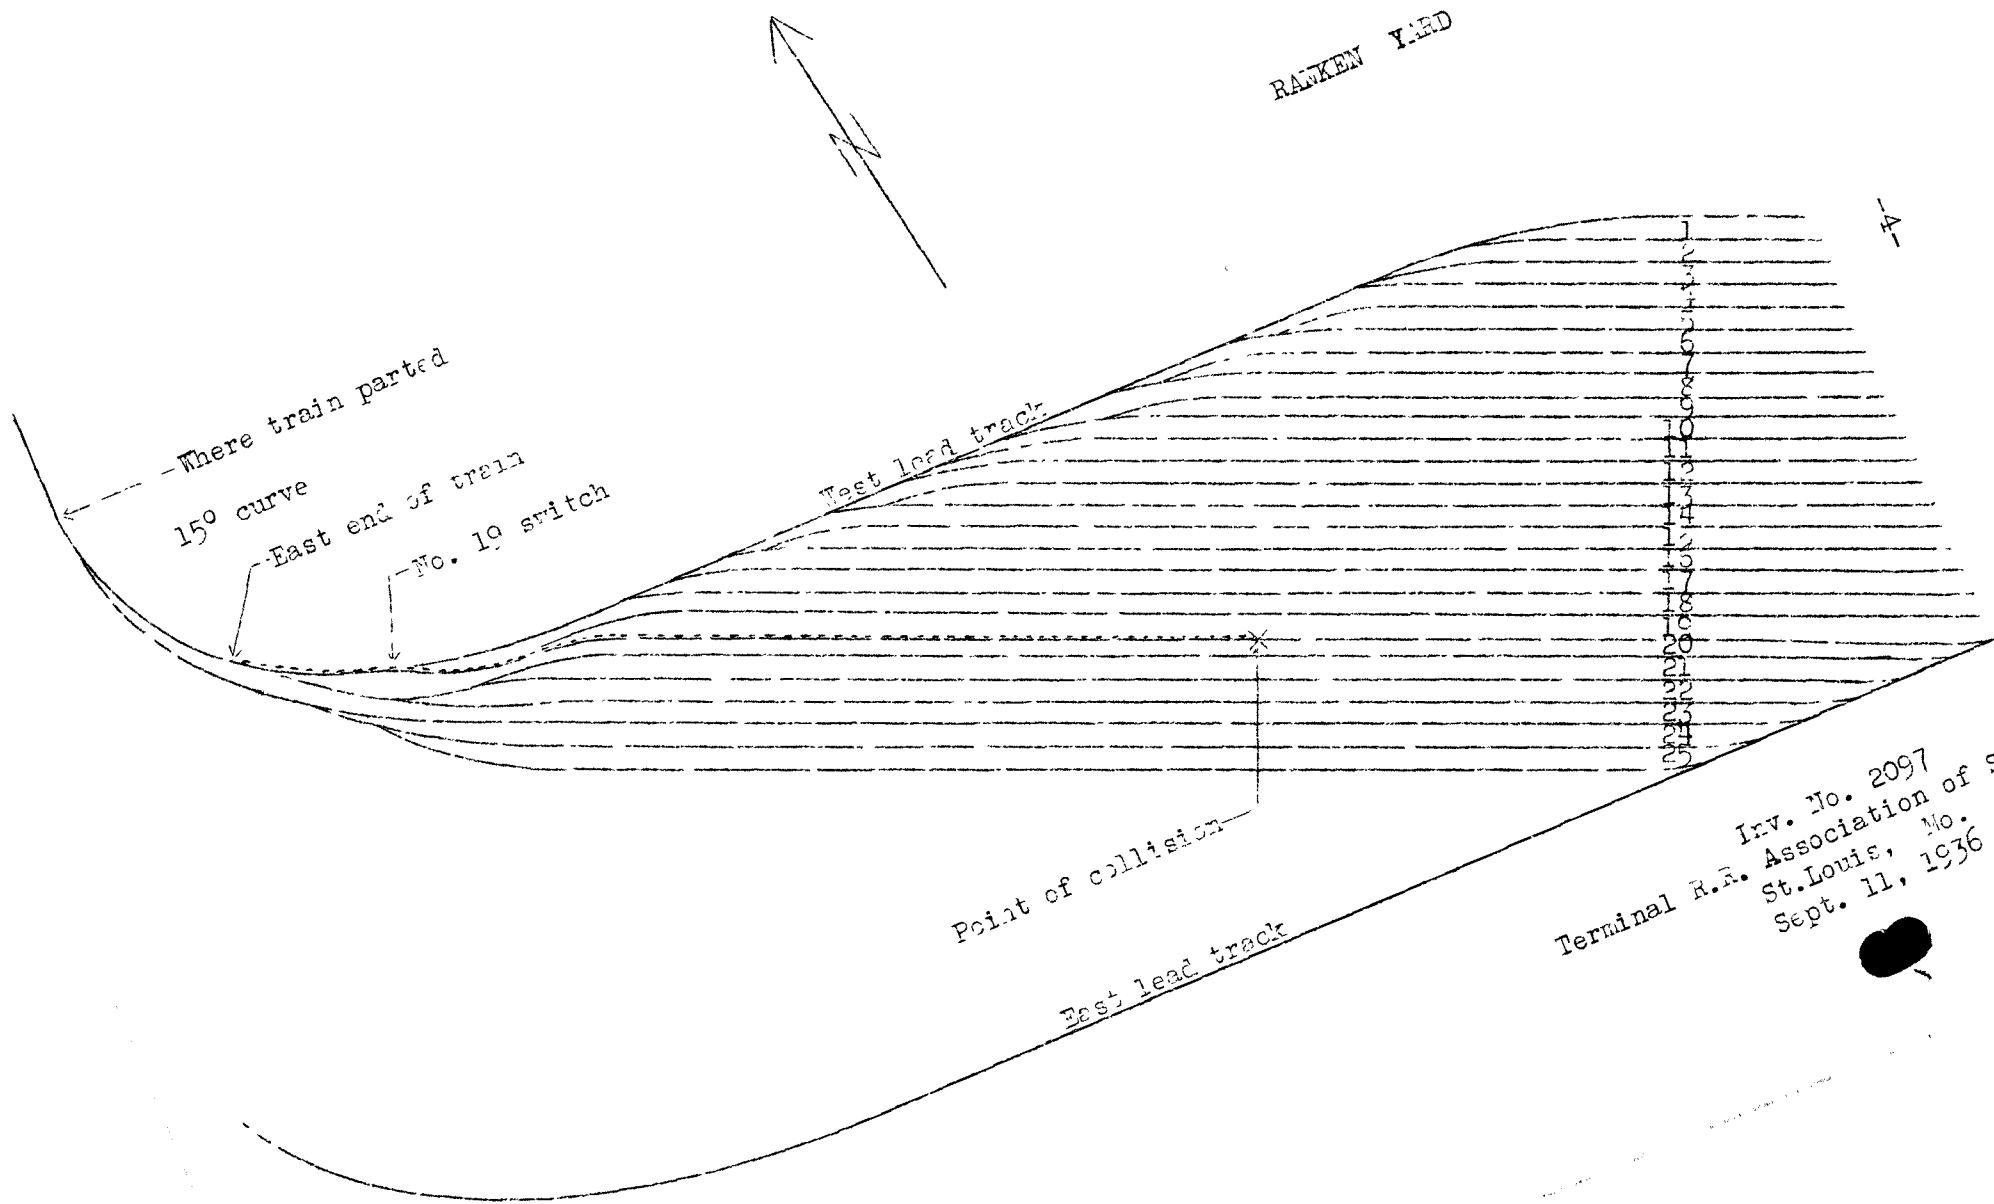
Inv. No. 2097
 Terminal R.R. Association of St. Louis,
 St. Louis, Mo.
 Sept. 11, 1936

Where train parted

Point of collision
