REPORT OF THE DIRECTOR
BUREAU OF SAFETY

ACCIDENT ON THE
TERMINAL RAILROAD ASSOCIATION OF ST. LOUIS

ST. LOUIS, MO.

INVESTIGATION NO. 2421

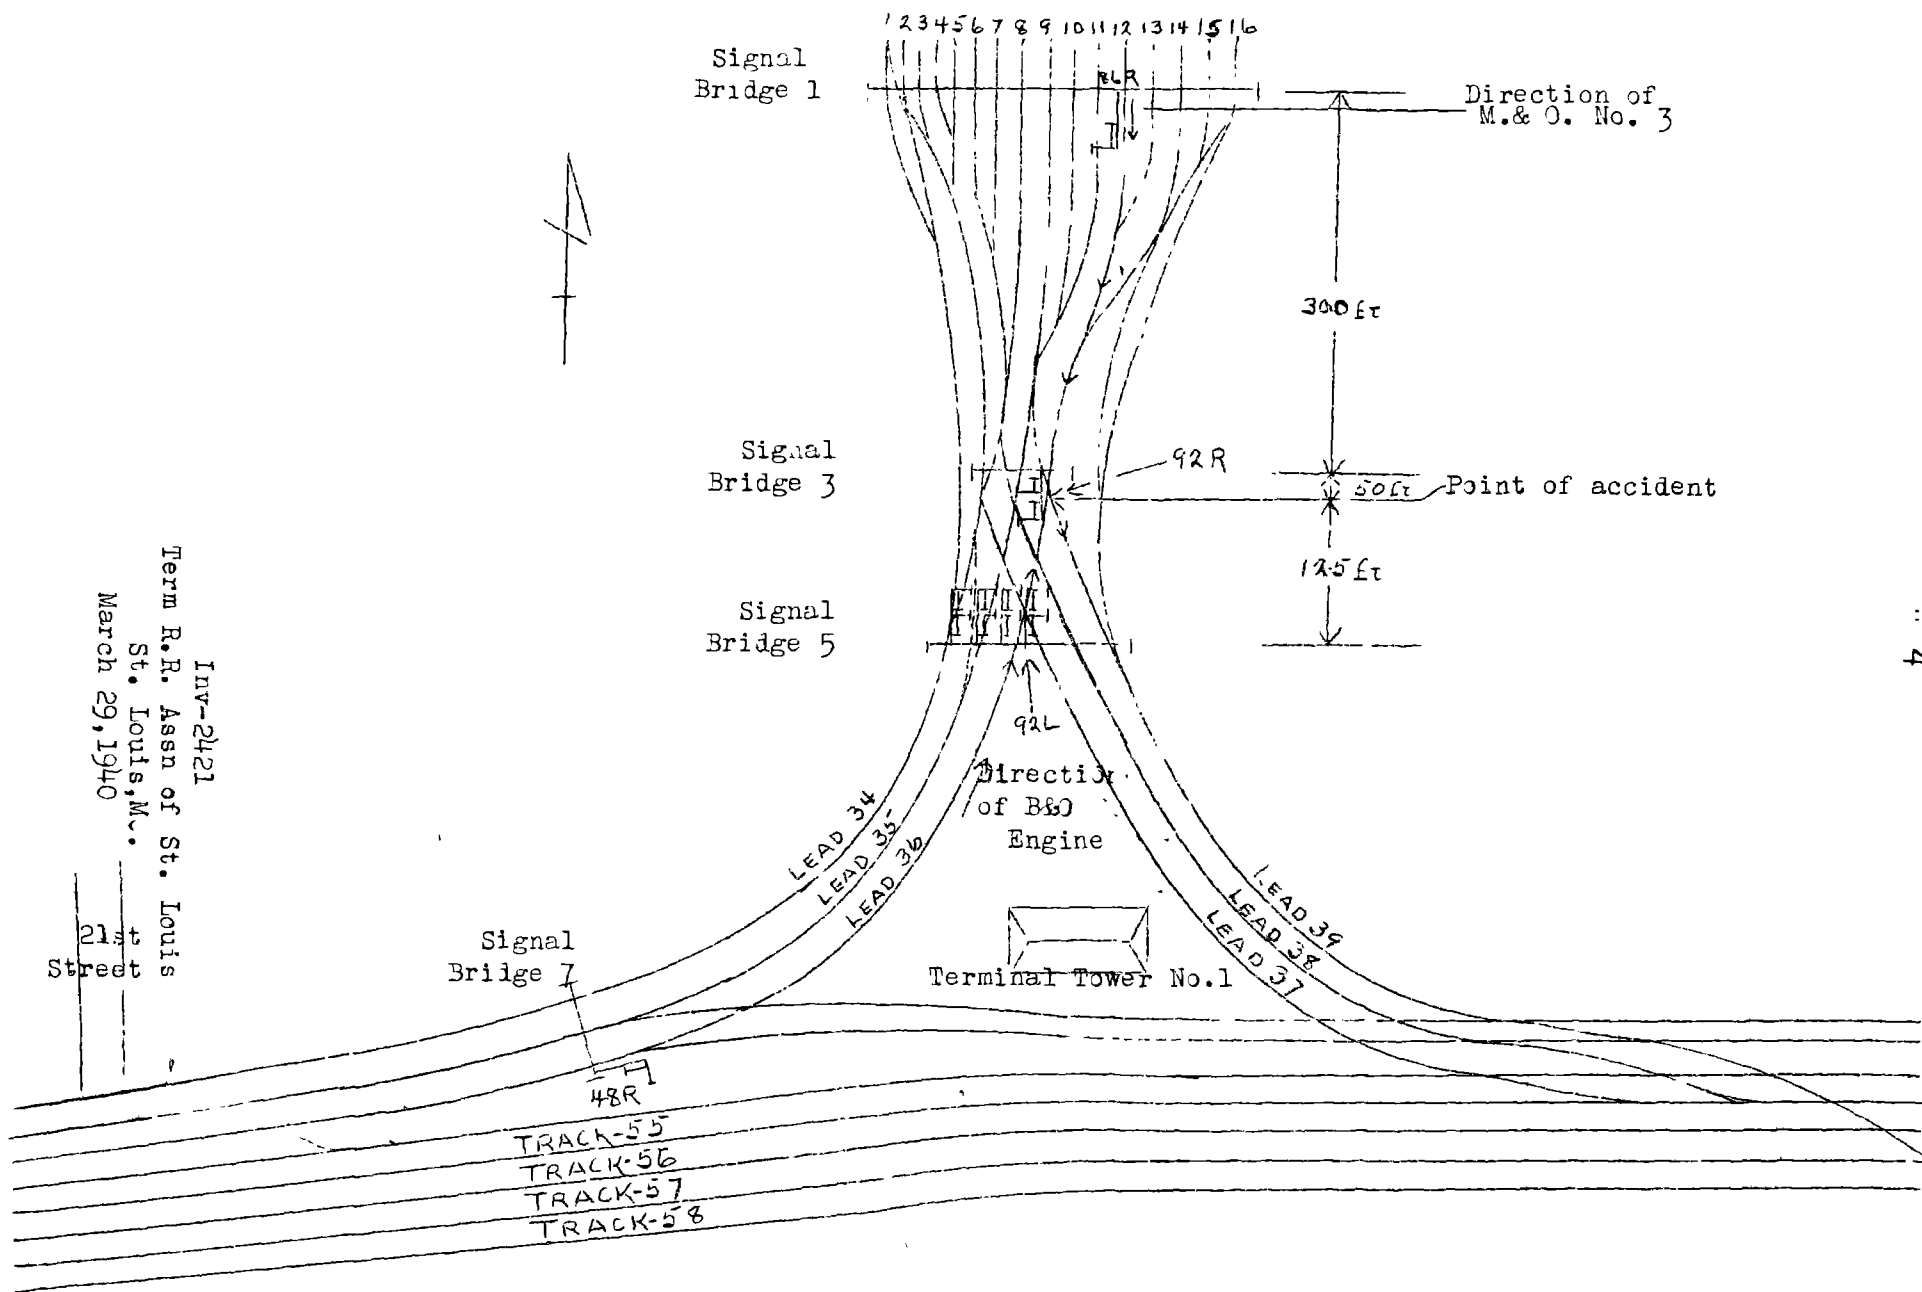
Inv-2421
Term R.R. Assn of St. Louis
St. Louis, Mo.
March 29, 1940

According to the evidence, routes were lined simultaneously for out-bound M. & O. No. 3 from station track 12 to lead track 39 and for in-bound P. R. R. engines from lead track 35 to station track 8 and for in-bound B. & O. engine 5209 from main track 57 to lead track 36 as far as signal bridge 5. B. & O. engine 5209 was destined to station track 15 and since that route conflicted with the route for M. & O. No. 3 it was necessary to hold engine 5209 at signal 92L on bridge 5 until out-bound M. & O. No. 3 was clear of signal bridge 5. However, the B. & O. engine drifted by signal 92L and, while moving at a speed of about 1 mile per hour, collided with M. & O. No. 3.

The engineman of the B. & O. engine was an extra passenger engineman and his last trip into the union station prior to the day of the accident was on July 22, 1939. For this reason he said he was taking extra precaution and was moving at a low rate of speed approaching bridge 5. After a Pennsylvania Railroad engine on lead track 35 passed signal bridge 5 all signals on that bridge displayed stop indications and then a signal which he thought at the time was the signal governing the route for his engine was cleared. He called the signal as clear to his fireman and permitted the engine to drift by signal bridge 5 until the fireman observed the M. & O. train approaching and called a warning to stop. The fireman's view of signal 92L was obscured because of track curvature until the tender was directly under the signal; the fireman then observed that the signal was in stop position but since the engine tender was under the signal he concluded that it had been restored to stop position. Subsequent to the accident the engineman of engine 5209 was of the opinion that he mistook a clear signal displayed on lead track 35 at signal bridge 5 for the signal governing movements on lead track 36 and that he had passed the signal for lead track 36 when it was in stop position. Approaching signal bridge 5 from the south there are three tracks to a point approximately 75 feet south of the signal bridge and from this point there are four tracks and signal bridge 5 has four signals. Because of track curvature and because the four signals on bridge 5 could be seen from the vicinity where there were only three tracks, an engineman of an engine moving northward on lead track 36 might mistake the third signal from the left end of the signal bridge as the signal governing movements on lead track 36, whereas the fourth signal governs lead track 36.
