REPORT NO. 3444  
TEXAS AND NEW ORLEANS RAILROAD COMPANY  
· IN RE ACCIDENT  
NEAR HUMBLE, TEX., ON  
DECEMBER 14, 1951

Date:	December 14, 1951
Railroad:	Texas and New Orleans
Location:	Humble, Tex.
Kind of accident:	Deraillment
Train involved:	Passenger
Train number:	27
Engine number:	626
Consist:	7 cars
Estimated speed:	50 m. p. h.
Operation:	Timetable and train orders
Track:	Single; tangent; vertical curve
Weather:	Misting
Time:	6:23 a. m.
Casualties:	24 injured
Cause:	Broken rail

Accident near Humble, Tex., on December 14, 1951, caused  
by a broken rail.

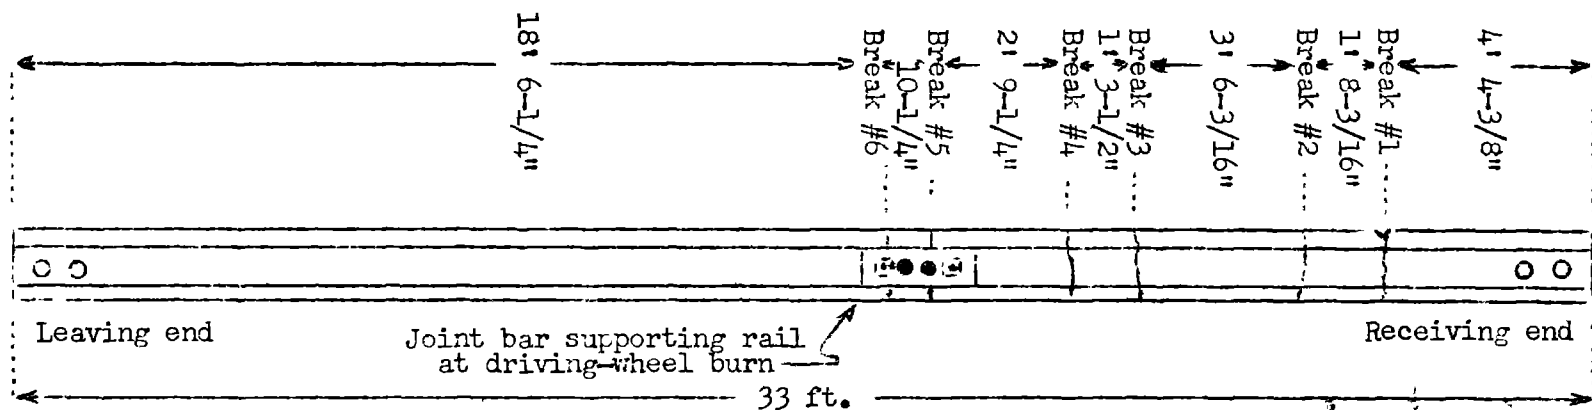
Sketch showing broken rail - north side of track

After the accident occurred, a broken rail was found on the north side of the track at the point of derailment. This rail was broken into seven pieces. Breaks occurred at points 4 feet 4-3/8 inches, 6 feet 9/16 inch, 9 feet 6-3/4 inches, 10 feet 10-1/4 inches, 13 feet 7-1/2 inches and 14 feet 5-3/4 inches from the receiving end of the rail. The first piece of the rail remained in place and bolted to the

adjoining rail east of the point of accident. The second piece was found about 70 feet west of the point of accident and 49 feet north of the track. The third to the sixth pieces, inclusive, were moved outward and lay near the ends of the ties. The seventh piece remained bolted to the next rail and was found in the embankment under the shoulder of the fill. At break No. 1 the west end of the first piece was battered down  $3/16$  inch and the east end of the second piece was battered down  $5/8$  inch. The batter on the rail ends at the first break indicates that the rail was broken by a previous train and that the other breaks occurred during the derailment of No. 27. At the first break there was a driving-wheel burn on the top of the head of the rail. Under this burn there was a progressive fracture, which covered 48 percent of the cross-sectional area of the head of the rail. This fracture had progressed through the web and into the base. It could not have been visually detected before the complete break occurred. There were driving-wheel burns on the head of the rail at each of the other breaks but examination disclosed no evidence of fracture from this cause. The east end of the third piece of the rail was flange-marked near the gage side of the head. The base of this piece of the rail was chipped by the heads of some of the spikes when this piece was overturned during the derailment. Inspection of the right front wheel of the front truck of the fourth car disclosed an indentation on the flange and an abrasion about  $2-3/8$  inches long and  $1/8$  inch deep in the tread of the wheel. The right rear wheel of this truck was similarly marked. These marks corresponded with the marks on the rail. Apparently the wheels of the front truck of the fourth car dislodged the second piece of the rail and then struck and displaced the third piece of the rail.

on which the accident occurred. The tape used for recording purposes on the rail-defect detector car indicated that the rail which failed in the instant case was defective at each of seven driving-wheel burns on the rail. The car was stopped at that point and observation of the rail was made by the operator. However, the rail was not marked for removal and no subsequent tests were made. Joint bars were applied by the section foreman at a driving-wheel burn 13 feet 7-1/2 inches from the receiving end of the rail, but joint bars were not applied at the burn where the first break occurred.
