ACCIDENT ON THE
TEXAS & NEW ORLEANS RAILROAD

SHREVEPORT, LA.

June 26, 1937

INVESTIGATION NO. 2182

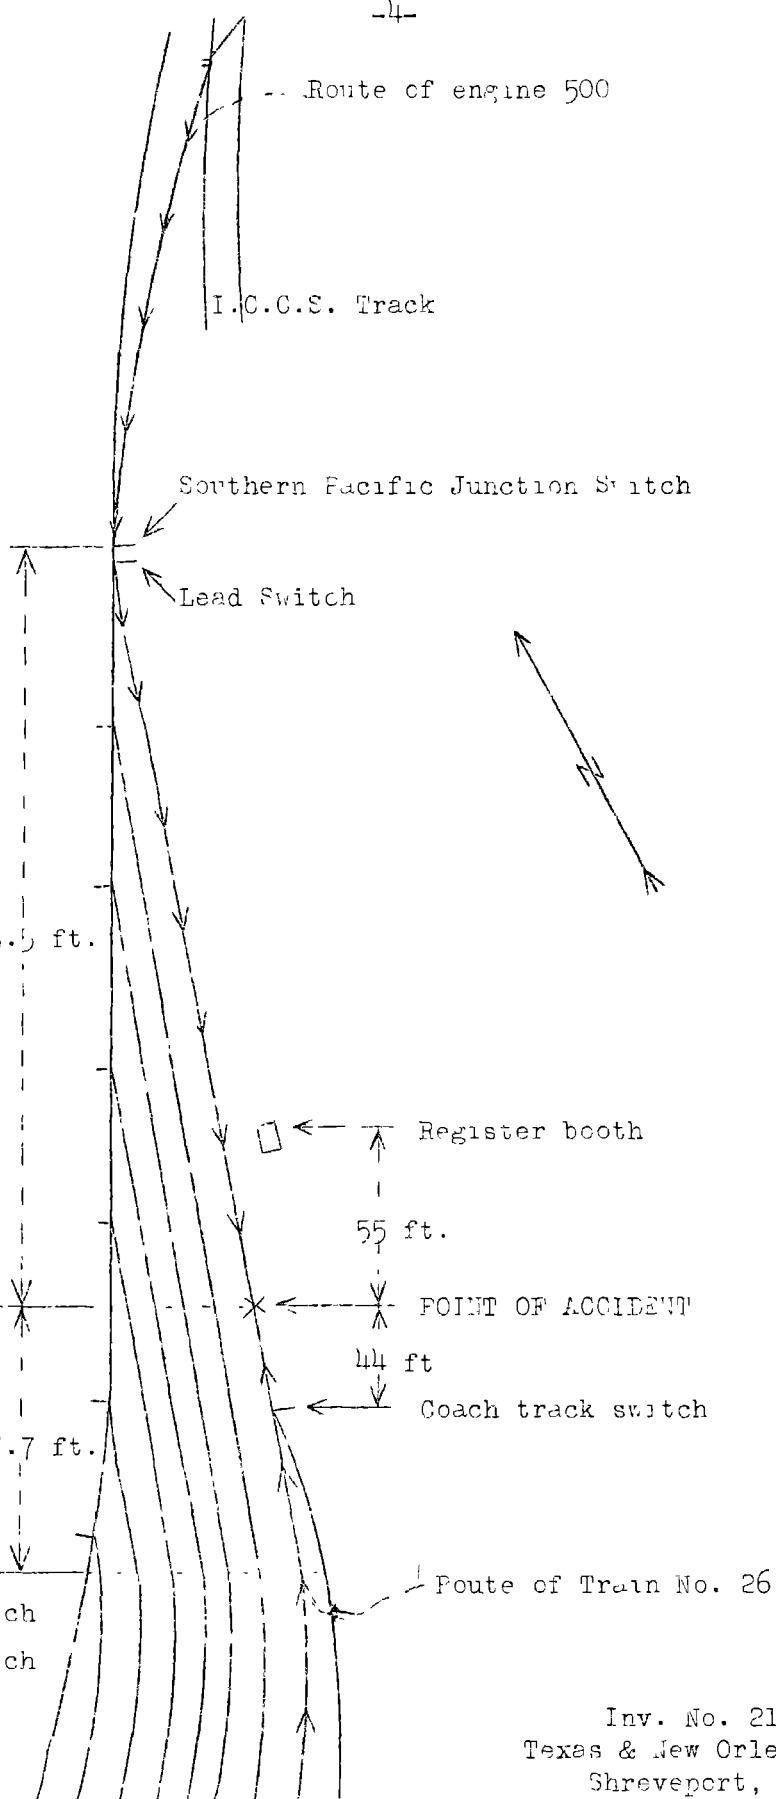
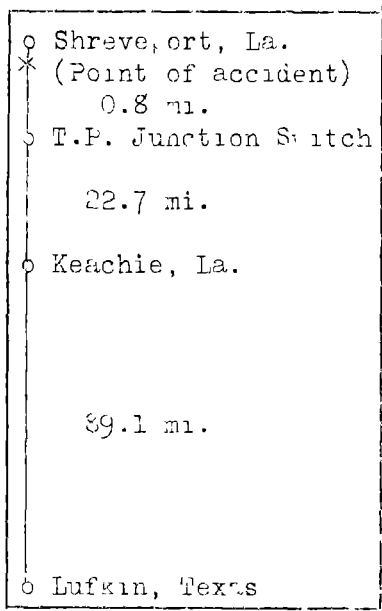
Inv. No. 2182
 Texas & New Orleans R.R.
 Shreveport, La.
 June 26, 1937

3,327 ft to T&P Jct. switch
 1,836 ft to KCs Jct. switch
