INVESTIGATION NO. 3118
TEXAS AND NEW ORLEANS RAILROAD COMPANY
REPORT IN RE ACCIDENT
NEAR WENDELL, TEX., ON
JULY 19, 1947

Accident near Wendell, Tex., on July 19, 1947, caused by failure to provide adequate protection for the inferior train, and by failure to operate the superior train in accordance with signal indications.

Inv. No. 3118
 Texas and New Orleans Railroad
 Wendell, Tex.
 July 11, 1947

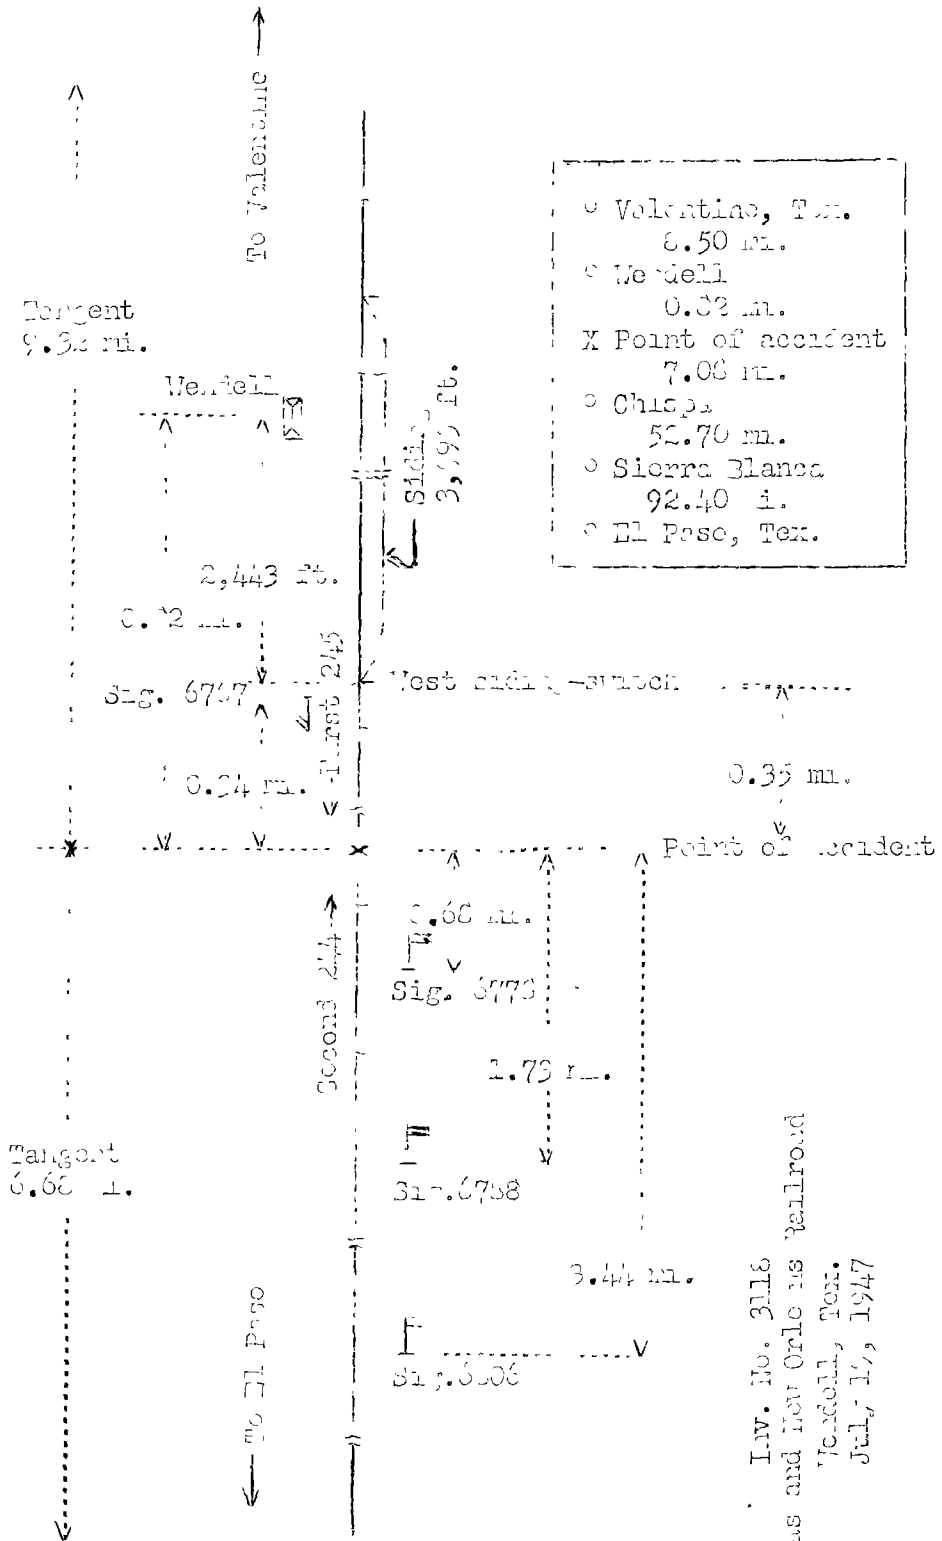
- Valentia, Tex. 8.50 mi.
- Wendell 0.32 mi.
- X Point of accident 7.08 mi.
- Chispa 52.70 mi.
- Sierra Blanca 92.40 i.
- El Paso, Tex.
