INVESTIGATION NO. 3013  
TEXAS AND NEW ORLEANS RAILROAD COMPANY  
REPORT IN RE ACCIDENT  
AT FEODORA, TEX., ON  
AUGUST 12, 1946

Inv. No. 3013  
Texas and New Orleans Railroad  
Feodora, Tex.  
August 12, 1946

Location of Accident and Method of Operation

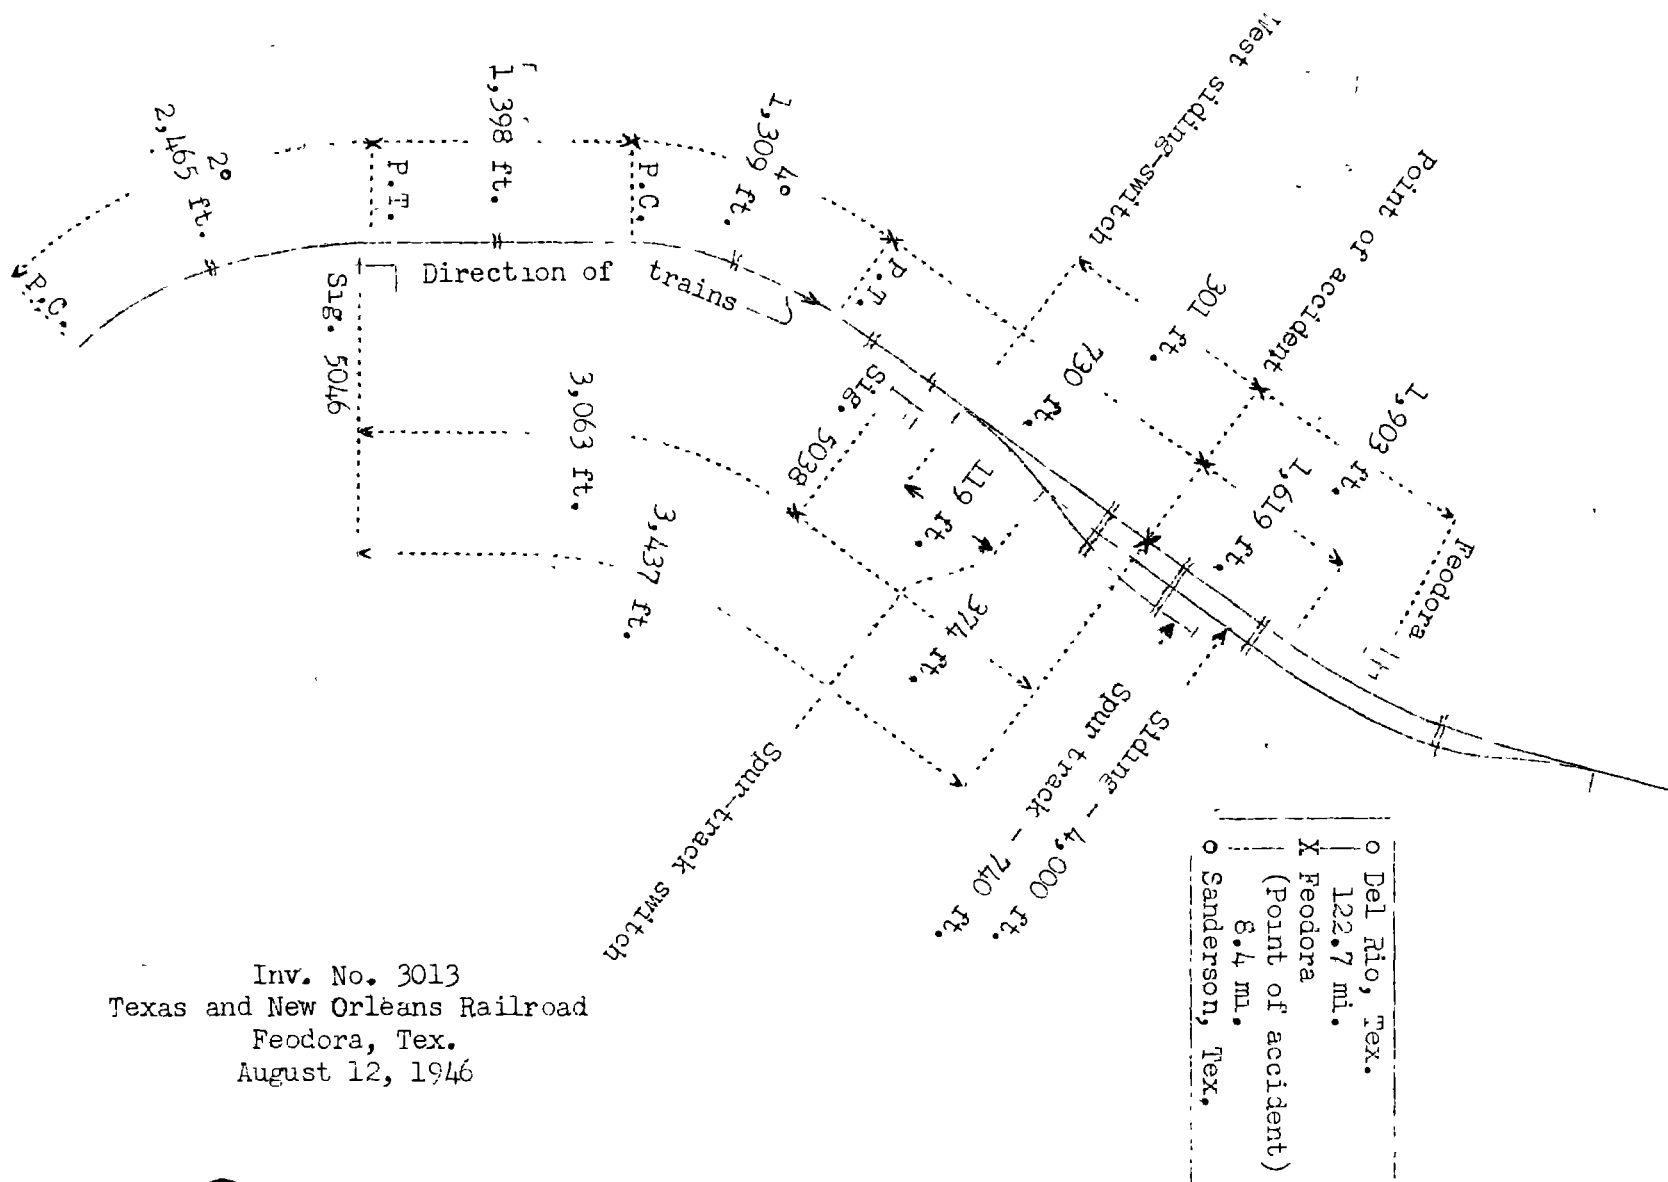
This accident occurred on that part of the San Antonio Division extending between Sanderson and Del Rio, Tex., 131.1 miles, a single-track line in the vicinity of the point of accident, over which trains are operated by timetable, train orders and an automatic block-signal system. At Feodora, 8.4 miles east of Sanderson, a siding 4,000 feet in length parallels the main track on the south. The west switch of this siding is 2,204 feet west of the station. A spur track 740 feet in length parallels the siding on the south. The spur-track switch is facing-point for east-bound movements, and is 119 feet east of the west siding-switch. The accident occurred on the main track at a point 1,903 feet west of the station and 301 feet east of the west siding-switch. From the west there are, in succession, a 2° curve to the right 2,465 feet in length, a tangent 1,398 feet, a 4° curve to the right 1,309 feet and a tangent 730 feet to the point of accident and 1,619 feet eastward. The grade for east-bound trains varies between 0.40 and 0.64 percent descending 2,500 feet, then it is, successively, practically level 1,500 feet, 0.90 percent descending 800 feet and 1.00 percent descending 808 feet to the point of accident and 192 feet eastward.

Distant signal 5046 and home signal 5038, governing east-bound movements, are, respectively, 3,437 feet and 374 feet west of the point of accident. Signal 5046 is of the one-arm, two-indication, lower-quadrant, semaphore type. Signal 5038 is of the two-arm, three-indication, lower-quadrant, semaphore type. These signals are approach lighted. The involved aspects and corresponding indications of these signals are as follows:

Work Extra 977, an east-bound work extra, consisting of engine 977, 17 ballast cars loaded with slag, and a caboose, departed from Sanderson at 3:45 a. m., passed signal 5046, which displayed proceed-with-caution, passed signal 5038, which displayed stop, and while moving at an estimated speed of 20 miles per hour it struck First 244 at a point 374 feet east of signal 5038.
