RAILROAD ACCIDENT INVESTIGATION

REPORT NO. 4161

THE TEXAS AND PACIFIC RAILWAY COMPANY

MARCH 3, 1969

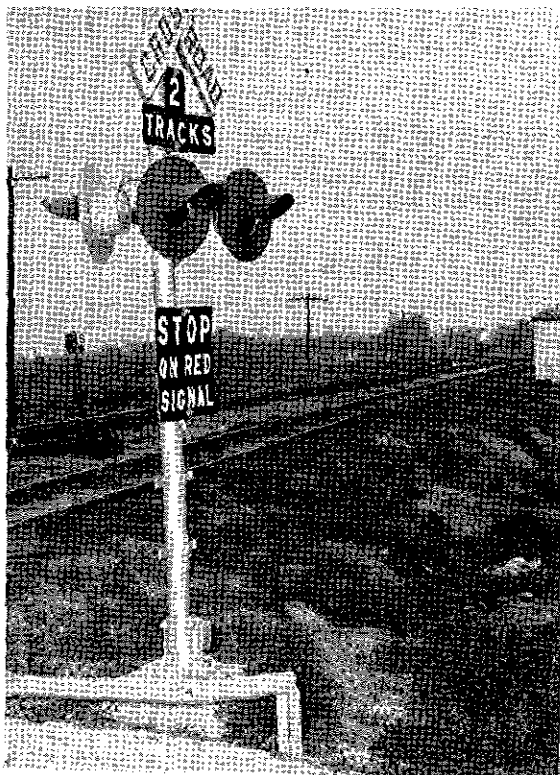
View of approaching westbound train from Barton Street, 39 feet south of the crossing center.

As the vehicle on Queeny Drive turns northward onto Barton Street, the driver's view of an approaching westbound train is obstructed by the oak tree until his vehicle reaches a point on Barton Street about 50 feet from the main track. Immediately afterward, while his vehicle is approaching the main track at a distance of about 48 feet, the driver's view of any westbound locomotive approaching the crossing at a distance between 687 and 1200 feet is obstructed by an abandoned railroad concrete telephone booth located 161 feet east of Barton Street and 33 feet south of the main track.

9 Although the crossing is well protected by automatic crossing-warning signals, protection for northbound highway vehicles on Barton Street is somewhat diminished by the presence of an oak tree and an abandoned railroad telephone booth in the southeast angle of the crossing. The tree and telephone booth obstructs the view between a northbound highway vehicle and a westbound train approaching the crossing, and this obstructed view apparently was a factor in the accident.
