INTERSTATE COMMERCE COMMISSION

REPORT OF THE DIRECTOR OF THE BUREAU OF SAFETY IN RE
INVESTIGATION OF AN ACCIDENT WHICH OCCURRED ON
THE TEXAS & PACIFIC RAILWAY AT CECILE, LA., ON
DECEMBER 14, 1931.

February 8, 1932.

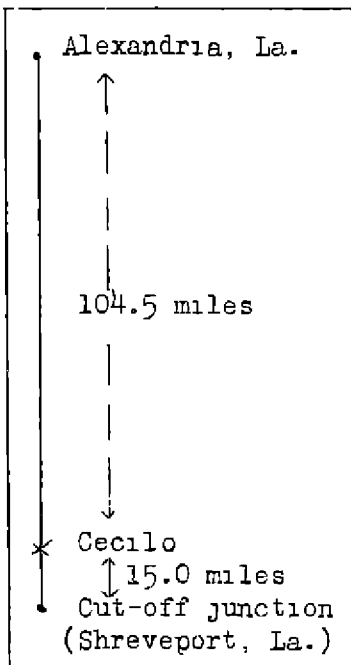
Inv. No 1744
Texas & Pacific Ry.,
Cecile, La.
Dec. 14, 1931

7°30'
669 ft.

Tangent Track
5.9 miles

Station
board

590 ft.

Point of accident
