## INTERSTATE COMMERCE COMMISSION

REPORT OF THE DIRECTOR OF THE BUREAU OF SAFETY CONCERNING  
AN ACCIDENT WHICH OCCURRED ON THE TEXAS & PACIFIC RAIL-  
WAY AT DALLAS, TEX., ON OCTOBER 11, 1932.

December 12, 1932.

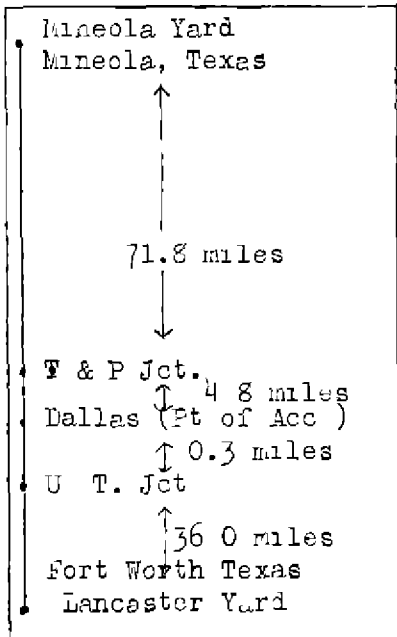
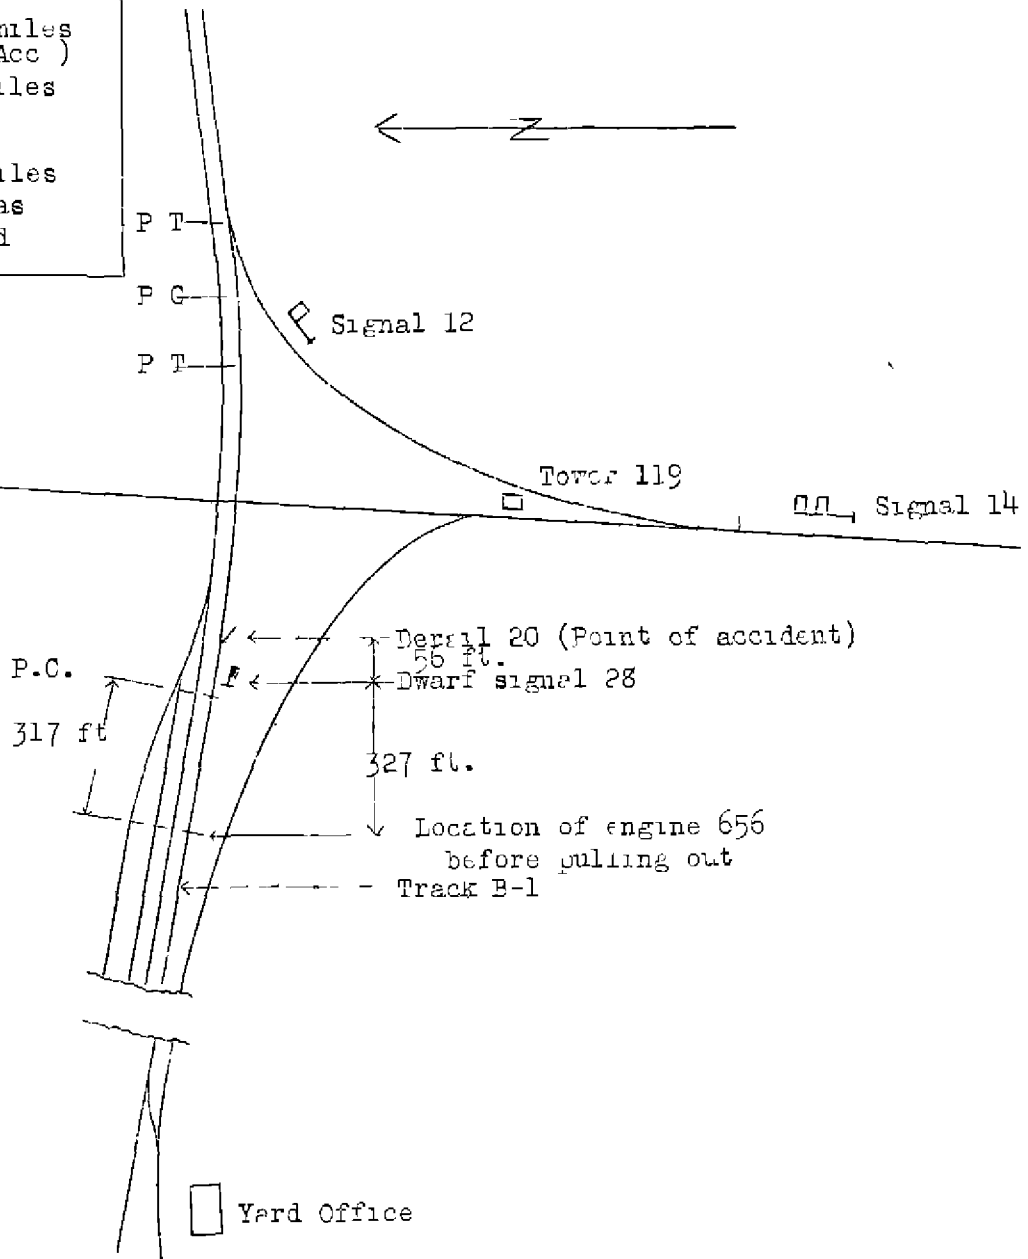
Inv No. 1789  
Texas & Pacific R.R.,  
Dallas, Texas  
Oct 11, 1932

Tower 119 is located within the southern part of the wye, near the junction of the west leg with the east leg, the telegraph office is located in the tower. Signals and switches are controlled by an electric interlocking plant, detector bars are not used but detector track circuits are in use on all tracks and approach and route locking are used on certain tracks. Signal 28, however, is direct lever-controlled, and it is possible to change its indication to stop and to open derail 20 directly in front of an approaching eastbound train, the signal can not be cleared unless the derail is reversed. The track circuit on track B-1 extends eastward from a point about 9 feet east of signal 28, and also extends in on the east leg of the wye as far as signal 12. Signal 12 is located 430 feet from the junction of the east leg with track B-1,

and 1,260 feet from the north end of tower 119. Signal 14 is located 225 feet south of the south switch of the east leg of the wye. The mechanical locking is such that lever 12 can not be reversed unless lever 30 is normal, with the derail in derailing position. Night indications are red, yellow, and green, for stop, caution, and proceed, respectively
