INTERSTATE COMMERCE COMMISSION

REPORT OF THE DIRECTOR OF THE BUREAU OF SAFETY CONCERNING AN
ACCIDENT ON THE TEXAS AND PACIFIC RAILWAY NEAR GLADEWATER,
TEXAS, ON JANUARY 13, 1933.

Inv. No. 1805
 Texas & Pacific Railway
 Gladewater, Texas
 January 13, 1913.

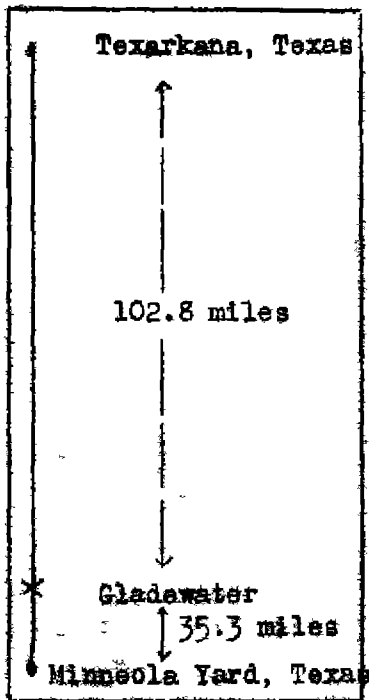
Section Foreman Tallent, on whose section the accident occurred, passed over his section on January 12 but did not find anything wrong with the track in the vicinity of the point of accident. He examined the broken rail after the accident and at the point where he thought it first failed there was a transverse fissure about $1\frac{1}{4}$ inches in diameter.

General Roadmaster Gamble stated that the rail which failed was rolled in December, 1926, and laid in the track in January, 1927. It was located on the north side of the track and was broken in six pieces, the first fracture being 20 feet 10 inches from the receiving end of the rail. This end of the rail remained intact but from this point westward the rail was torn out for some distance, while the marks on the ties showed plainly that the derailment occurred at this point. At the broken end of the portion of rail still remaining in the track there was a transverse fissure approximately $1\frac{1}{4}$ inches in diameter and, in addition, at the ends of three other broken sections there were also transverse fissures, all over 1 inch in diameter. The records indicated that there was no previous transverse-fissure rail failure in that particular heat. He said that had the rail been broken before train No. 15 arrived the signals would have been displaying stop indications, as the temperature was about 28 or 30 degrees and at this temperature the rail would have contracted so that the broken ends could not come in contact with each other, especially as the break was square; also the first break was between the ties so that there was no possibility of a tie plate forming contact for the passage of electric current. From all indications the engine broke the rail and the engine and first car passed safely over it; the second piece, 1 foot 5 inches in length, then became dislodged resulting in the derailment, the other breaks occurring under the derailed cars. According to the sketch of the broken rail furnished in connection with this investigation, the rail broke at a point 20 feet 10 inches from its receiving end; the succeeding three pieces were 1 foot $5\frac{1}{4}$ inches, 1 foot $4\frac{5}{8}$ inches, and 1 foot 9 inches in length, followed by a missing section 11 feet $11\frac{3}{8}$ inches in length, with two pieces making up the leaving portion 1 foot $9\frac{1}{4}$ inches in length. The transverse fissures were evident at the first four points of rupture.

An examination of the broken rail made by the Commission's inspectors disclosed that at the first point of rupture, the transverse fissure was about 1 1/8 inches in depth and 1 3/8 inches in length which extended towards the outside of the head of the rail. The outline of the top of the fissure was discolored, indicating that it had reached the surface.
